Profile/Photo Observation Report

Street:	FOXCROFT STREET	Flow Control:	Not Controlled
City:	Hobart, IN	Year Renewed:	
Location:	Light Highway	Tape/Media #:	
Purpose:	Routine Assessment	Dia/Height:	12"
Use:	Sanitary	Material:	VCP
Drain Area:	NA	Lining:	
Category:	NA		
Comment:	R_M at 161 ft debris .Flow direction wrong		
Location Details:		Direction of Survey:	Downstream
US MH:	M-108-027	DS MH:	M-108-017
		Total Length Surveyed (ft):	163.2

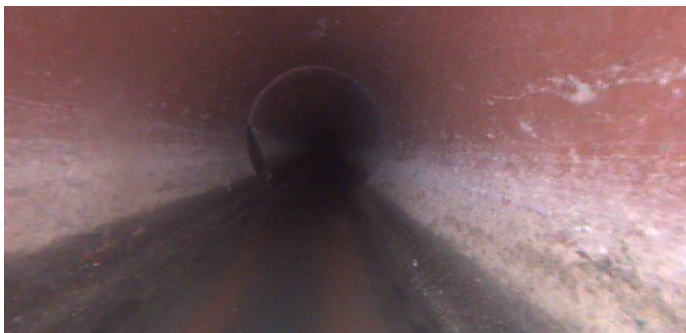
Code: **AMH**
Description: **Manhole**

Distance (ft): **.0**
Structural Grade: **0**
O&M Grade: **0**
Clock Start/From:
Clock To:
1st Value:
2nd Value:
Value Percent:
Continuous Index:
Within 8" of Joint: **NO**
Remarks: **M-108-027**

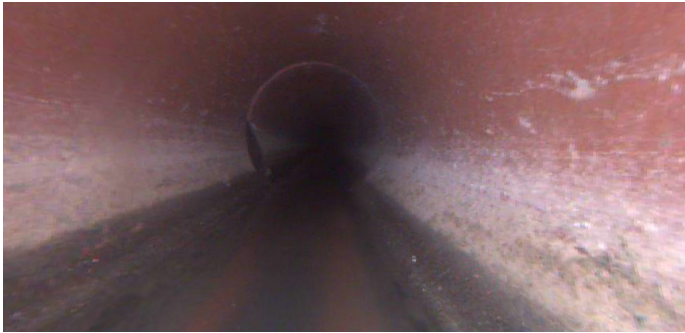
Code:	MWL
Description:	Water Level

Distance (ft):	.0
Structural Grade:	0
O&M Grade:	0
Clock Start/From:	
Clock To:	
1st Value:	
2nd Value:	
Value Percent:	5.000
Continuous Index:	
Within 8" of Joint:	NO
Remarks:

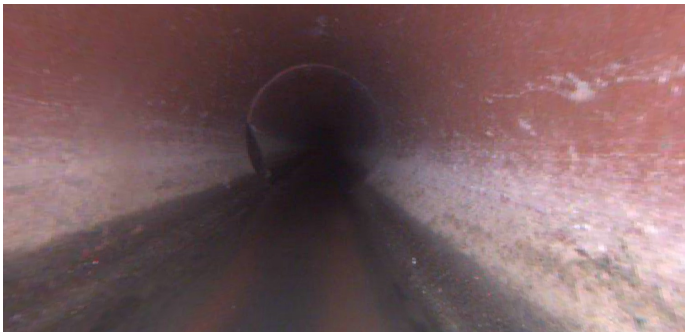
Code:	DAGS
Description:	Deposits Attached Grease

Distance (ft):	.0
Structural Grade:	0
O&M Grade:	2
Clock Start/From:	7
Clock To:	5
1st Value:	
2nd Value:	
Value Percent:	5.000
Continuous Index:	S01
Within 8" of Joint:	YES
Remarks:	WANDER

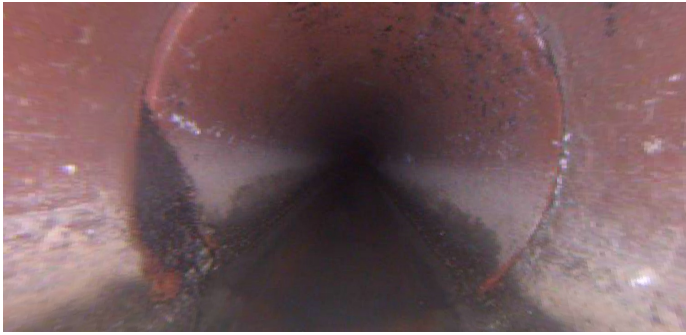
Code: **RFJ**
Description: **Roots Fine Joint**

Distance (ft): **2.5**
Structural Grade: **0**
O&M Grade: **1**
Clock Start/From: **7**
Clock To: **9**
1st Value:
2nd Value:
Value Percent:
Continuous Index:
Within 8" of Joint: **YES**
Remarks:

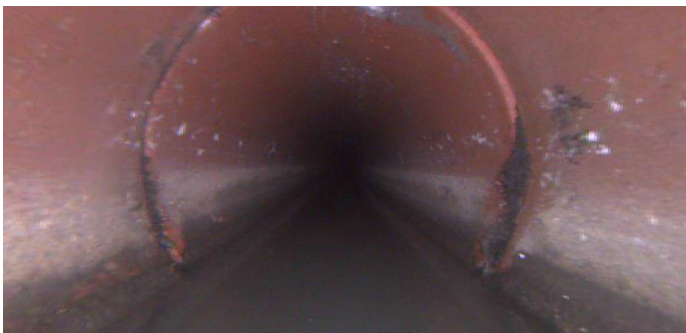
Code: **RFJ**
Description: **Roots Fine Joint**

Distance (ft): **7.3**
Structural Grade: **0**
O&M Grade: **1**
Clock Start/From: **7**
Clock To: **5**
1st Value:
2nd Value:
Value Percent:
Continuous Index: **S02**
Within 8" of Joint: **YES**
Remarks: **WANDER**

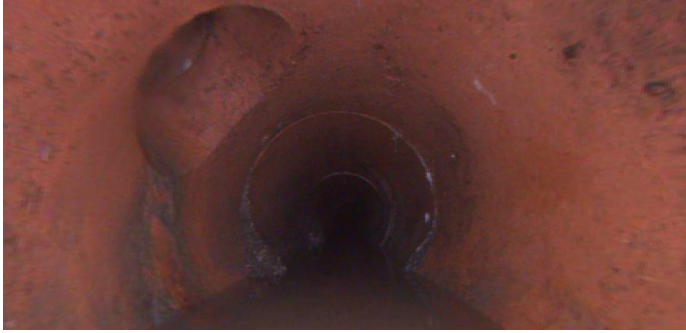
Code: **TF**
Description: **Tap Factory**

Distance (ft): **38.5**
Structural Grade: **0**
O&M Grade: **0**
Clock Start/From: **10**
Clock To:
1st Value: **4.000**
2nd Value:
Value Percent:
Continuous Index:
Within 8" of Joint:
Remarks:

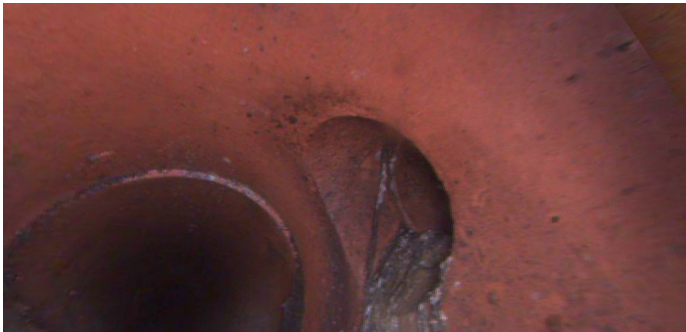
Code: **TF**
Description: **Tap Factory**

Distance (ft): **40.9**
Structural Grade: **0**
O&M Grade: **0**
Clock Start/From: **2**
Clock To:
1st Value: **4.000**
2nd Value:
Value Percent:
Continuous Index:
Within 8" of Joint:
Remarks:

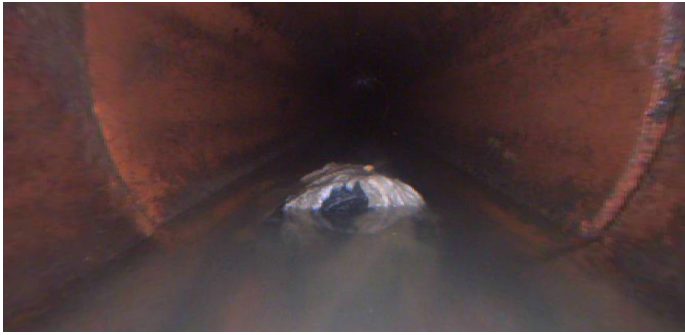
Code: **MGO**
Description: **General Observation**

Distance (ft): **136.8**
Structural Grade: **0**
O&M Grade: **0**
Clock Start/From:
Clock To:
1st Value:
2nd Value:
Value Percent:
Continuous Index:
Within 8" of Joint: **NO**
Remarks: **TOILET TISSUE; UNKNOWN DEPOSIT**

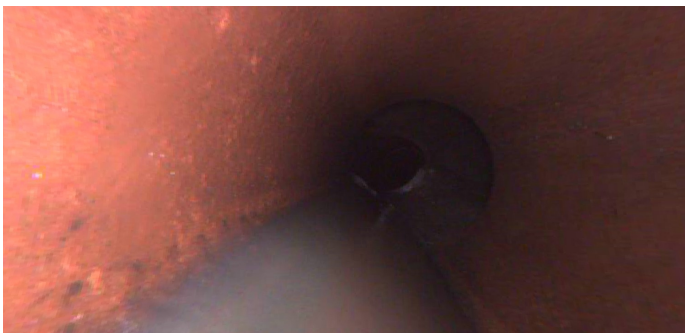
Code: **MSA**
Description: **Abandoned Survey**

Distance (ft): **163.2**
Structural Grade: **0**
O&M Grade: **0**
Clock Start/From:
Clock To:
1st Value:
2nd Value:
Value Percent:
Continuous Index:
Within 8" of Joint: **NO**
Remarks: **ROBOT TURNED OVER**

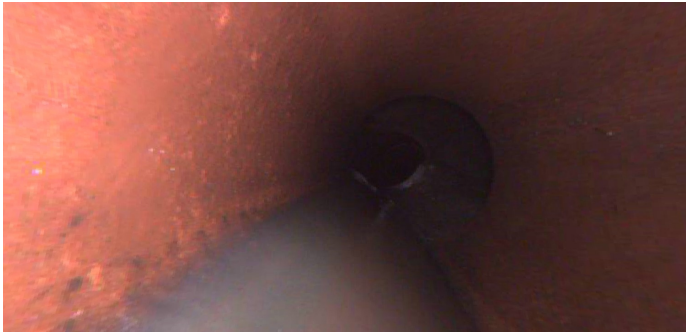
Code: **RFJ**
Description: **Roots Fine Joint**

Distance (ft): **163.2**
Structural Grade: **0**
O&M Grade: **1**
Clock Start/From: **7**
Clock To: **5**
1st Value:
2nd Value:
Value Percent:
Continuous Index: **F02**
Within 8" of Joint: **YES**
Remarks: **WANDER**

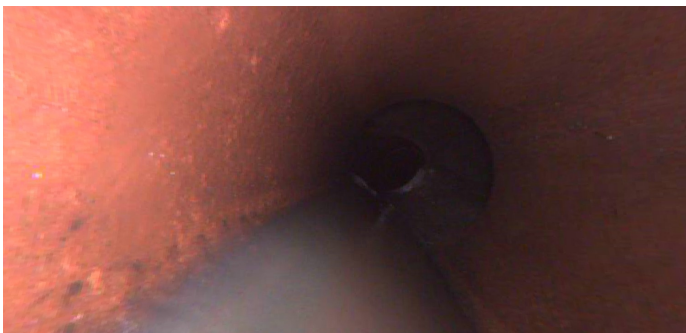
Code: **DAGS**
Description: **Deposits Attached Grease**

Distance (ft): **163.2**
Structural Grade: **0**
O&M Grade: **2**
Clock Start/From: **7**
Clock To: **5**
1st Value:
2nd Value:
Value Percent: **5.000**
Continuous Index: **F01**
Within 8" of Joint: **YES**
Remarks: **WANDER**
