Profile/Photo Observation Report

Date:	04/13/2018	Weather:		Coding:	PACP 6.0
Pipe Length (ft):	181.5	Owner:	NA	Pre Clean:	Not Known
P.O.#:		Surveyor:	Jen Costello	PSR:	P-503-057-074
Customer:		Clean Date:	01/01/1900	Shape:	C

Street:	N COLORADO ST & W 38TH AVE	Flow Control:	Not Controlled
City:	Hobart, IN	Year Renewed:	
Location:	Other	Tape/Media #:	
Purpose:	Not Known	Dia/Height:	10"
Use:	Sanitary	Material:	VCP
Drain Area:	NA	Lining:	
Category:	NA		
Comment:

Location Details:		Direction of Survey:	Downstream
US MH:	M-503-057	DS MH:	M-503-074
		Total Length Surveyed (ft):	12.6

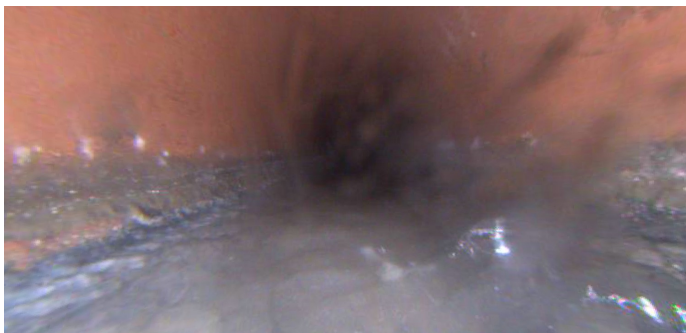
Code: **AMH**
Description: **Manhole**

Distance (ft): **.0**
Structural Grade: **0**
O&M Grade: **0**
Clock Start/From:
Clock To:
1st Value:
2nd Value:
Value Percent:
Continuous Index:
Within 8" of Joint: **NO**
Remarks: **M-503-057**

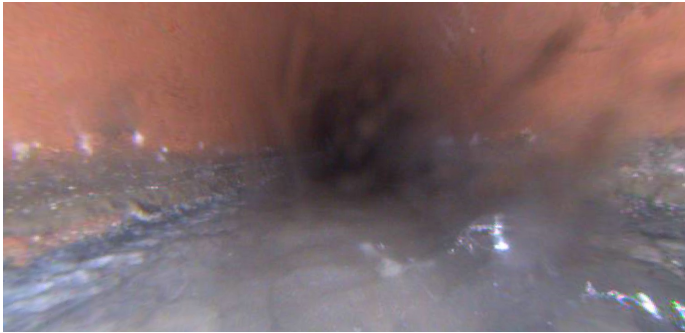
Code:	MWL
Description:	Water Level

Distance (ft):	.0
Structural Grade:	0
O&M Grade:	0
Clock Start/From:	
Clock To:	
1st Value:	
2nd Value:	
Value Percent:	20.000
Continuous Index:	
Within 8" of Joint:	NO
Remarks:

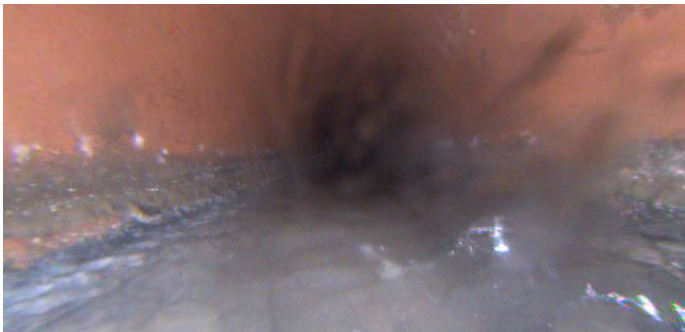
Code:	DAGS
Description:	Deposits Attached Grease

Distance (ft):	.0
Structural Grade:	0
O&M Grade:	2
Clock Start/From:	8
Clock To:	4
1st Value:	
2nd Value:	
Value Percent:	5.000
Continuous Index:	S01
Within 8" of Joint:	NO
Remarks:

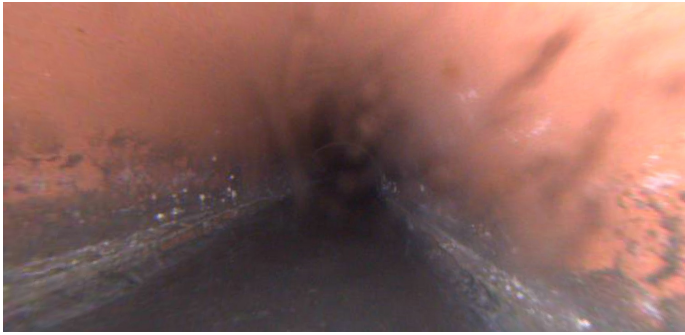
Code: **MSA**
Description: **Abandoned Survey**

Distance (ft): **12.6**
Structural Grade: **0**
O&M Grade: **0**
Clock Start/From:
Clock To:
1st Value:
2nd Value:
Value Percent:
Continuous Index:
Within 8" of Joint: **NO**
Remarks: **unknown**

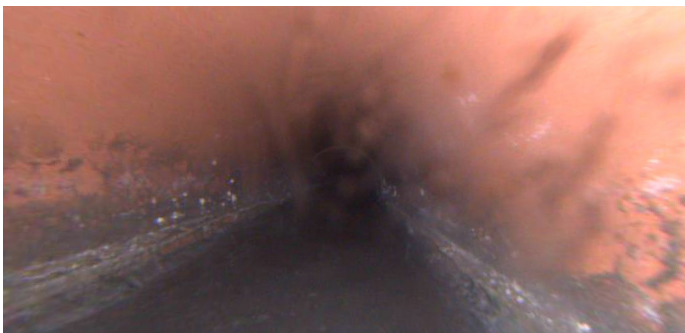
Code: **DAGS**
Description: **Deposits Attached Grease**

Distance (ft): **12.6**
Structural Grade: **0**
O&M Grade: **2**
Clock Start/From: **8**
Clock To: **4**
1st Value:
2nd Value:
Value Percent: **5.000**
Continuous Index: **F01**
Within 8" of Joint: **NO**
Remarks:
