## Profile/Photo Observation Report

Date:	<b>03/24/2018</b>	Weather:		Coding:	<b>PACP 6.0</b>
Pipe Length (ft):	<b>229.1</b>	Owner:	<b>NA</b>	Pre Clean:	<b>No Pre-Cleaning</b>
P.O.#:		Surveyor:	<b>Justin Gonzales</b>	PSR:	<b>P-108-026-027</b>
Customer:		Clean Date:	<b>01/01/1900</b>	Shape:	<b>C</b>

Street:	<b>ALLEY BETWEEN SWIFT ST &amp; ALABA</b>	Flow Control:	<b>Not Controlled</b>
City:	<b>Hobart, IN</b>	Year Renewed:	
Location:	<b>Light Highway</b>	Tape/Media #:	
Purpose:	<b>Routine Assessment</b>	Dia/Height:	<b>10"</b>
Use:	<b>Sanitary</b>	Material:	<b>VCP</b>
Drain Area:	<b>NA</b>	Lining:	
Category:	<b>NA</b>		
Comment:	<b>Flow direction wrong</b>		
Location Details:		Direction of Survey:	<b>Downstream</b>
US MH:	<b>M-108-027</b>	DS MH:	<b>M-108-026</b>
		Total Length Surveyed (ft):	<b>241.4</b>

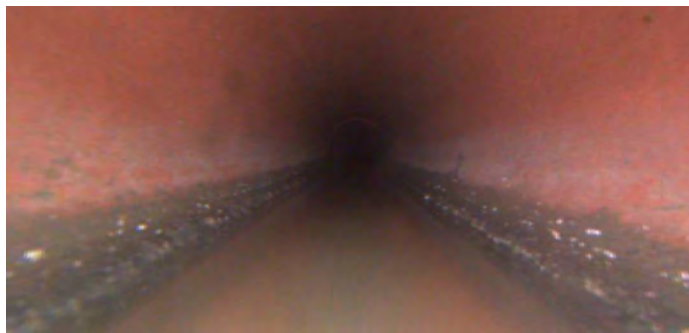
Code: **AMH**  
 Description: **Manhole**

Distance (ft): **.0**  
 Structural Grade: **0**  
 O&M Grade: **0**  
 Clock Start/From:  
 Clock To:  
 1st Value:  
 2nd Value:  
 Value Percent:  
 Continuous Index:  
 Within 8" of Joint: **NO**  
 Remarks: **M-108-027**

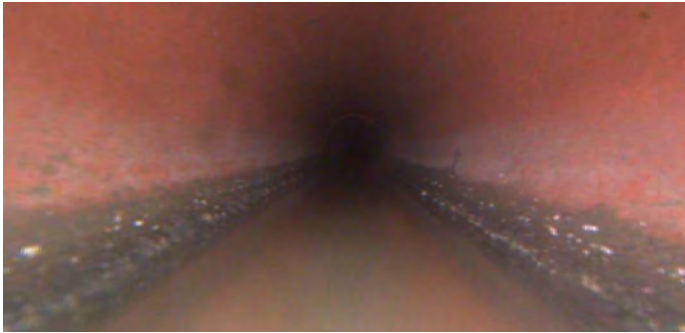
Code:	<b>MWL</b>
Description:	<b>Water Level</b>

Distance (ft):	<b>.0</b>
Structural Grade:	<b>0</b>
O&M Grade:	<b>0</b>
Clock Start/From:	
Clock To:	
1st Value:	
2nd Value:	
Value Percent:	<b>10.000</b>
Continuous Index:	
Within 8" of Joint:	<b>NO</b>
Remarks:

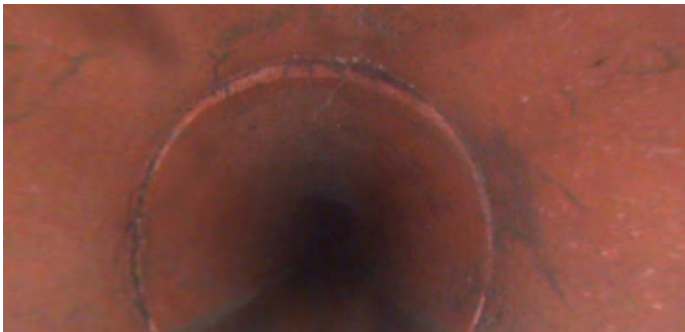
Code:	<b>RFJ</b>
Description:	<b>Roots Fine Joint</b>

Distance (ft):	<b>77.4</b>
Structural Grade:	<b>0</b>
O&M Grade:	<b>1</b>
Clock Start/From:	<b>8</b>
Clock To:	<b>4</b>
1st Value:	
2nd Value:	
Value Percent:	
Continuous Index:	
Within 8" of Joint:	<b>YES</b>
Remarks:

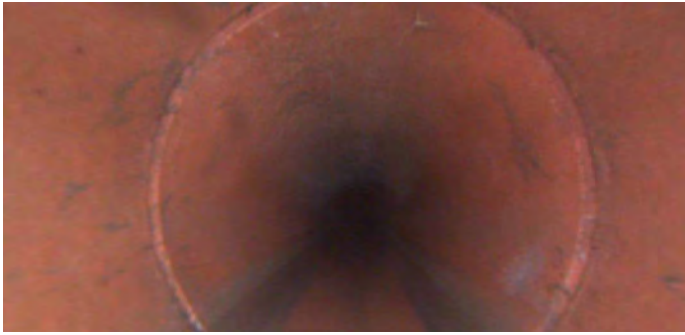
Code: **DAGS**  
Description: **Deposits Attached Grease**

Distance (ft): **82.9**  
Structural Grade: **0**  
O&M Grade: **2**  
Clock Start/From: **10**  
Clock To: **2**  
1st Value:  
2nd Value:  
Value Percent: **5.000**  
Continuous Index:  
Within 8" of Joint: **YES**  
Remarks:

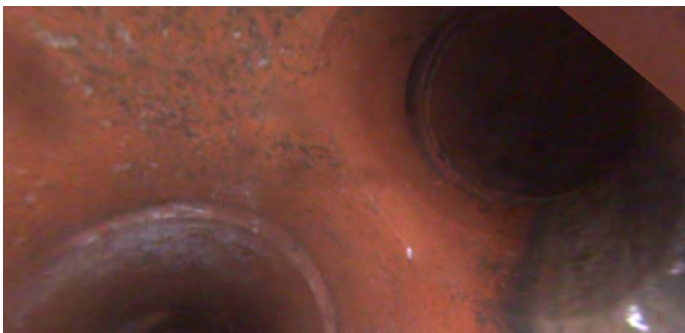
Code: **TF**  
Description: **Tap Factory**

Distance (ft): **90.0**  
Structural Grade: **0**  
O&M Grade: **0**  
Clock Start/From: **2**  
Clock To:  
1st Value: **4.000**  
2nd Value:  
Value Percent:  
Continuous Index:  
Within 8" of Joint:  
Remarks:

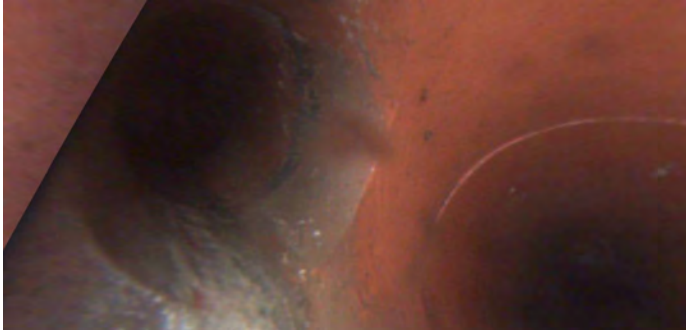
Code: **TF**  
Description: **Tap Factory**

Distance (ft): **92.2**  
Structural Grade: **0**  
O&M Grade: **0**  
Clock Start/From: **10**  
Clock To:  
1st Value: **4.000**  
2nd Value:  
Value Percent:  
Continuous Index:  
Within 8" of Joint:  
Remarks:

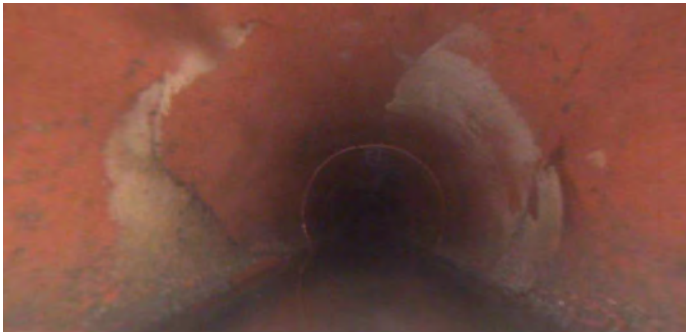
Code: **FM**  
Description: **Fracture Multiple**

Distance (ft): **96.6**  
Structural Grade: **4**  
O&M Grade: **0**  
Clock Start/From: **7**  
Clock To: **5**  
1st Value:  
2nd Value:  
Value Percent:  
Continuous Index:  
Within 8" of Joint:  
Remarks:

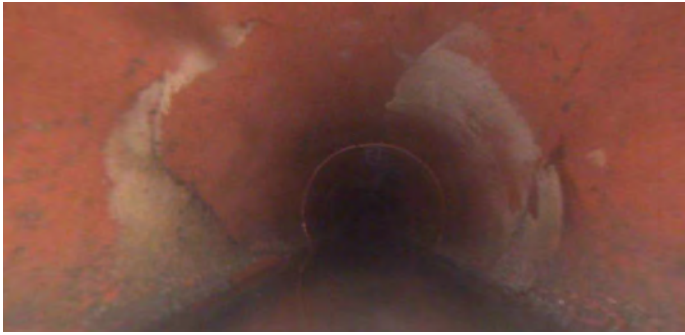
Code: **DAGS**  
Description: **Deposits Attached Grease**

Distance (ft): **96.6**  
Structural Grade: **0**  
O&M Grade: **2**  
Clock Start/From: **7**  
Clock To: **5**  
1st Value:  
2nd Value:  
Value Percent: **5.000**  
Continuous Index:  
Within 8" of Joint: **NO**  
Remarks:

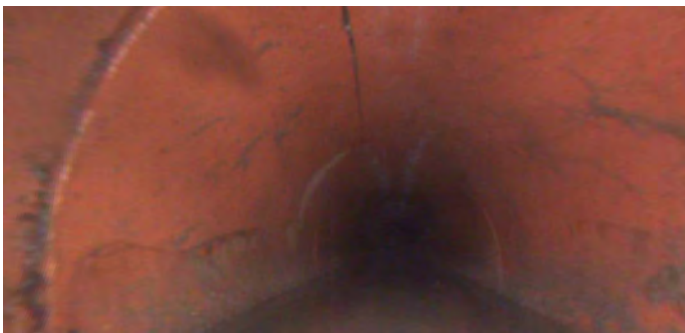
Code: **FM**  
Description: **Fracture Multiple**

Distance (ft): **98.2**  
Structural Grade: **4**  
O&M Grade: **0**  
Clock Start/From: **8**  
Clock To: **11**  
1st Value:  
2nd Value:  
Value Percent:  
Continuous Index:  
Within 8" of Joint: **YES**  
Remarks:

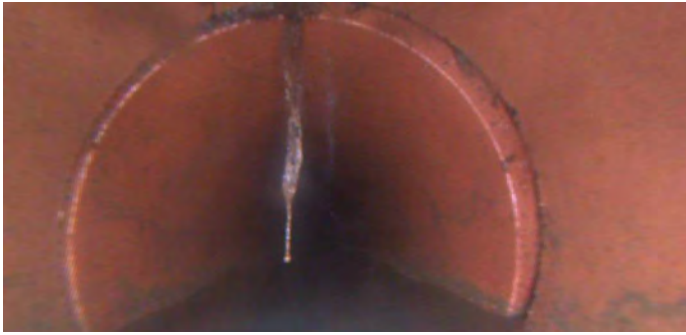
Code: **RFJ**  
Description: **Roots Fine Joint**

Distance (ft): **113.9**  
Structural Grade: **0**  
O&M Grade: **1**  
Clock Start/From: **12**  
Clock To:  
1st Value:  
2nd Value:  
Value Percent:  
Continuous Index:  
Within 8" of Joint: **YES**  
Remarks:

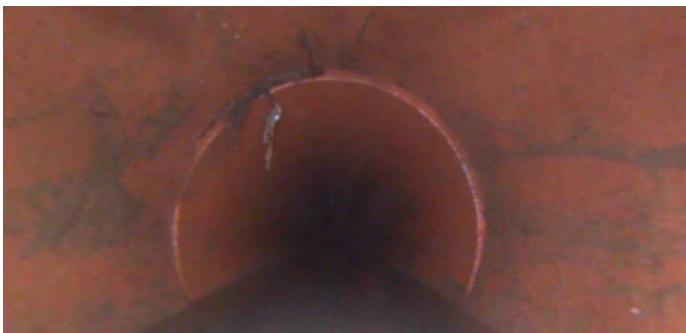
Code: **RFJ**  
Description: **Roots Fine Joint**

Distance (ft): **118.9**  
Structural Grade: **0**  
O&M Grade: **1**  
Clock Start/From: **10**  
Clock To: **12**  
1st Value:  
2nd Value:  
Value Percent:  
Continuous Index:  
Within 8" of Joint: **YES**  
Remarks:

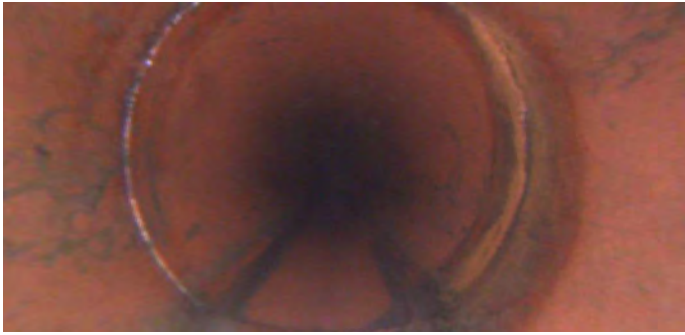
Code: **IS**  
Description: **Infil Stain**

Distance (ft): **140.3**  
Structural Grade: **0**  
O&M Grade: **0**  
Clock Start/From: **9**  
Clock To: **5**  
1st Value:  
2nd Value:  
Value Percent:  
Continuous Index:  
Within 8" of Joint: **YES**  
Remarks:

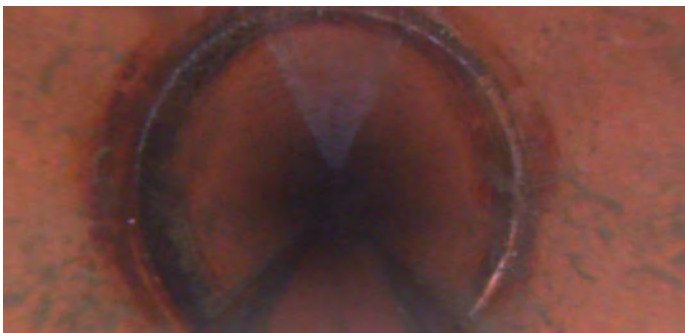
Code: **IS**  
Description: **Infil Stain**

Distance (ft): **151.0**  
Structural Grade: **0**  
O&M Grade: **0**  
Clock Start/From: **7**  
Clock To: **5**  
1st Value:  
2nd Value:  
Value Percent:  
Continuous Index:  
Within 8" of Joint: **YES**  
Remarks:

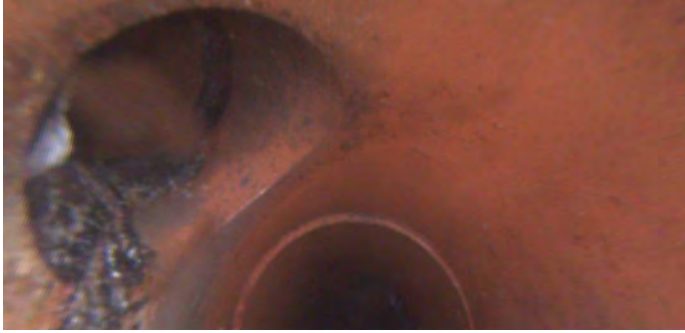
Code: **TF**  
Description: **Tap Factory**

Distance (ft): **163.3**  
Structural Grade: **0**  
O&M Grade: **0**  
Clock Start/From: **10**  
Clock To:  
1st Value: **4.000**  
2nd Value:  
Value Percent:  
Continuous Index:  
Within 8" of Joint:  
Remarks:

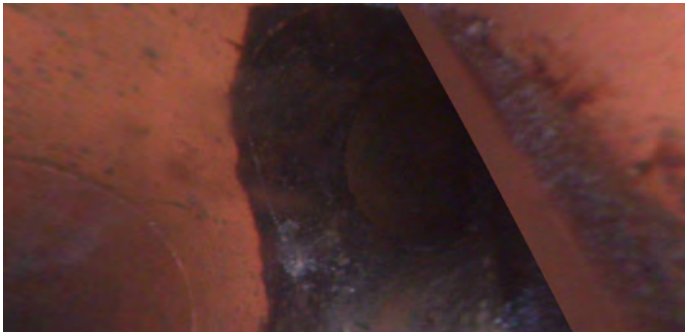
Code: **TF**  
Description: **Tap Factory**

Distance (ft): **165.7**  
Structural Grade: **0**  
O&M Grade: **0**  
Clock Start/From: **2**  
Clock To:  
1st Value: **4.000**  
2nd Value:  
Value Percent:  
Continuous Index:  
Within 8" of Joint:  
Remarks:
