Profile/Photo Observation Report

Date:	03/24/2018	Weather:		Coding:	PACP 6.0
Pipe Length (ft):	280.6	Owner:	NA	Pre Clean:	No Pre-Cleaning
P.O.#:		Surveyor:	Byrd Fitzgerald	PSR:	P-108-028-027
Customer:		Clean Date:	01/01/1900	Shape:	C

Street:	ALLEY BETWEEN SWIFT ST & ALABA	Flow Control:	Not Controlled
City:	Hobart, IN	Year Renewed:	
Location:	Light Highway	Tape/Media #:	
Purpose:	Routine Assessment	Dia/Height:	10"
Use:	Sanitary	Material:	VCP
Drain Area:	NA	Lining:	
Category:	NA		
Comment:	Flow direction wrong

Location Details:		Direction of Survey:	Downstream
US MH:	M-108-027	DS MH:	M-108-028
		Total Length Surveyed (ft):	288.8

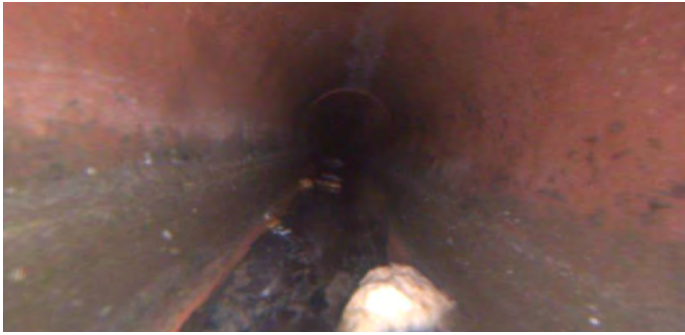
Code: **DSZ**
Description: **Deposits Settled Other**

Distance (ft): **1.7**
Structural Grade: **0**
O&M Grade: **2**
Clock Start/From: **6**
Clock To:
1st Value:
2nd Value:
Value Percent: **5.000**
Continuous Index: **S01**
Within 8" of Joint: **NO**
Remarks: **tissue/debris**

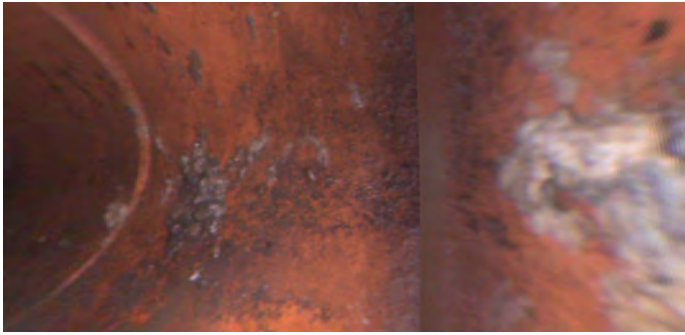
Code: **DAZ**
Description: **Deposits Attached Other**

Distance (ft): **78.9**
Structural Grade: **0**
O&M Grade: **2**
Clock Start/From: **7**
Clock To: **5**
1st Value:
2nd Value:
Value Percent: **5.000**
Continuous Index:
Within 8" of Joint: **NO**
Remarks: **at tap**

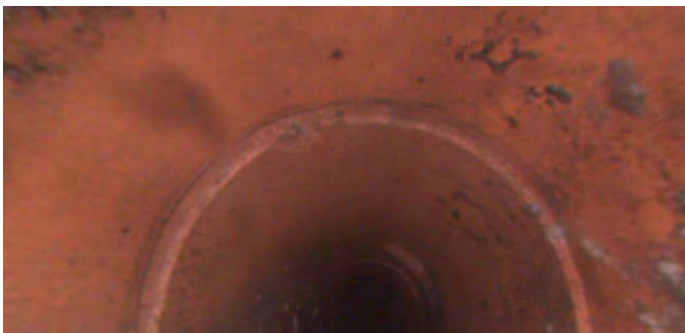
Code: **MGO**
Description: **General Observation**

Distance (ft): **79.1**
Structural Grade: **0**
O&M Grade: **0**
Clock Start/From:
Clock To:
1st Value:
2nd Value:
Value Percent:
Continuous Index:
Within 8" of Joint: **NO**
Remarks: **small chip at joint**

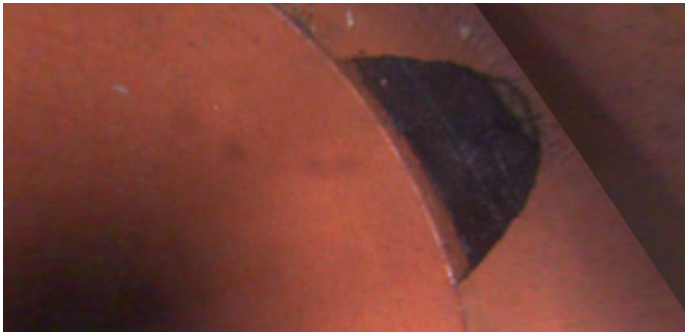
Code: **RPP**
Description: **Repair Patch**

Distance (ft): **81.6**
Structural Grade: **0**
O&M Grade: **0**
Clock Start/From: **1**
Clock To: **2**
1st Value:
2nd Value:
Value Percent:
Continuous Index:
Within 8" of Joint: **YES**
Remarks: **rubber**

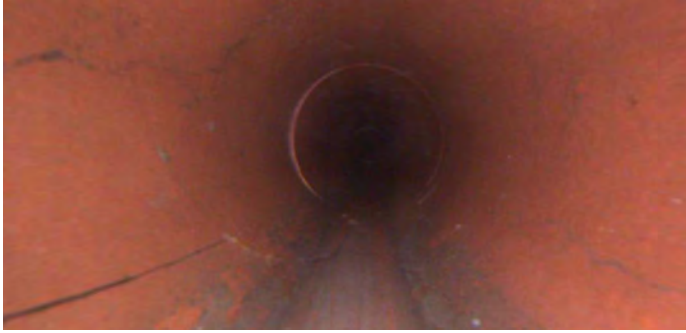
Code: **FS**
Description: **Fracture Spiral**

Distance (ft): **180.2**
Structural Grade: **3**
O&M Grade: **0**
Clock Start/From: **4**
Clock To: **8**
1st Value:
2nd Value:
Value Percent:
Continuous Index:
Within 8" of Joint:
Remarks:

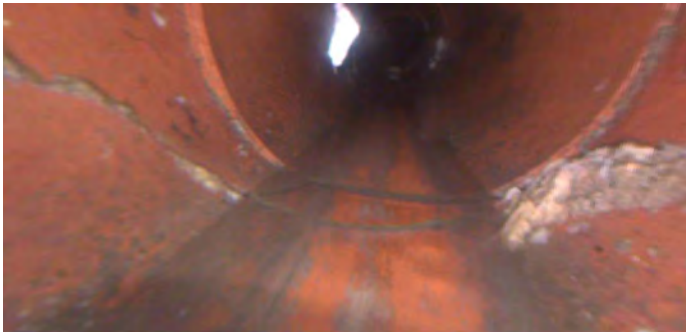
Code: **FM**
Description: **Fracture Multiple**

Distance (ft): **213.1**
Structural Grade: **4**
O&M Grade: **0**
Clock Start/From: **12**
Clock To: **12**
1st Value:
2nd Value:
Value Percent:
Continuous Index: **S02**
Within 8" of Joint: **YES**
Remarks:

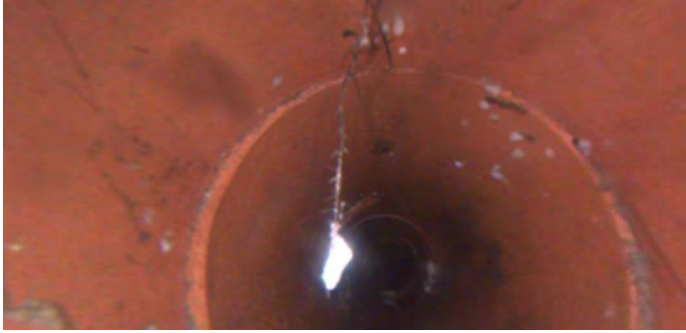
Code: **RFB**
Description: **Roots Fine Barrel**

Distance (ft): **213.1**
Structural Grade: **0**
O&M Grade: **2**
Clock Start/From: **12**
Clock To:
1st Value:
2nd Value:
Value Percent:
Continuous Index:
Within 8" of Joint: **NO**
Remarks: **near joint**

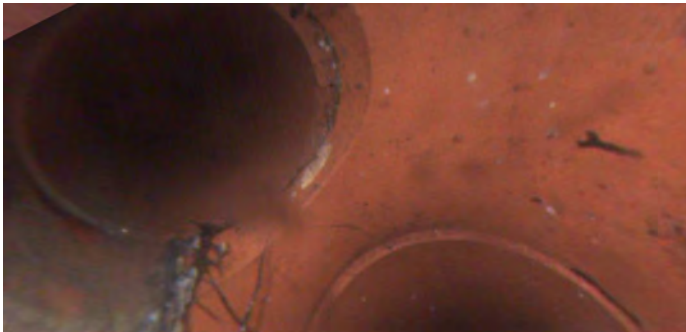
Code: **TFD**
Description: **Tap Factory Defective**

Distance (ft): **215.0**
Structural Grade: **0**
O&M Grade: **2**
Clock Start/From: **10**
Clock To:
1st Value: **4.000**
2nd Value:
Value Percent:
Continuous Index:
Within 8" of Joint:
Remarks: **roots**

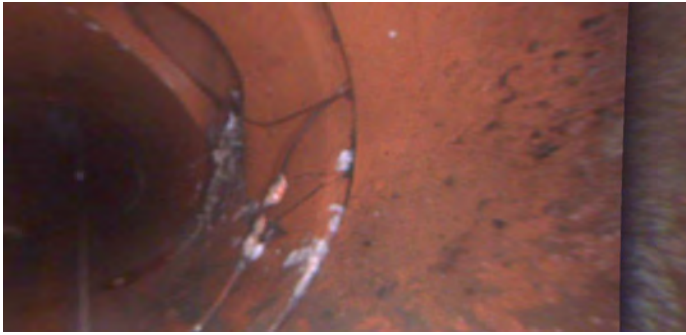
Code: **RML**
Description: **Roots Medium Lateral**

Distance (ft): **216.5**
Structural Grade: **0**
O&M Grade: **3**
Clock Start/From: **7**
Clock To: **10**
1st Value:
2nd Value:
Value Percent: **5.000**
Continuous Index:
Within 8" of Joint: **NO**
Remarks:

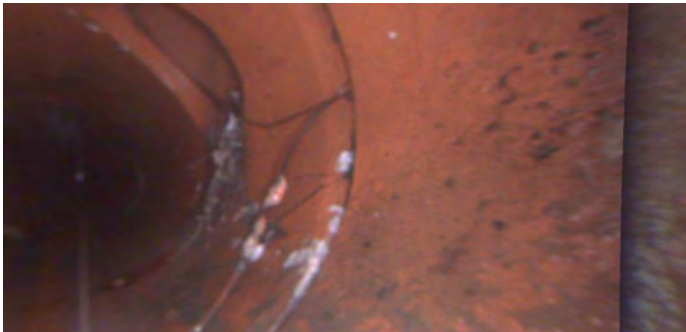
Code: **RFJ**
Description: **Roots Fine Joint**

Distance (ft): **216.5**
Structural Grade: **0**
O&M Grade: **1**
Clock Start/From: **9**
Clock To:
1st Value:
2nd Value:
Value Percent:
Continuous Index:
Within 8" of Joint: **YES**
Remarks:

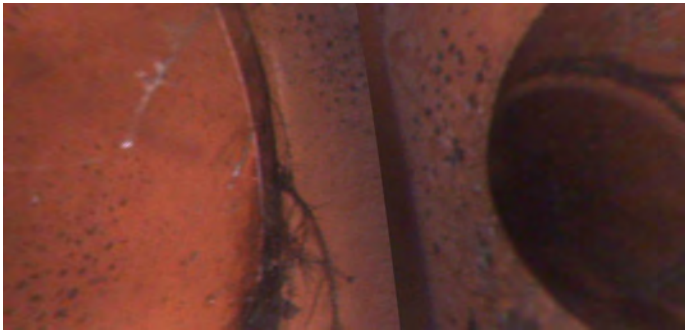
Code: **RFJ**
Description: **Roots Fine Joint**

Distance (ft): **218.0**
Structural Grade: **0**
O&M Grade: **1**
Clock Start/From: **7**
Clock To: **5**
1st Value:
2nd Value:
Value Percent:
Continuous Index:
Within 8" of Joint: **YES**
Remarks:

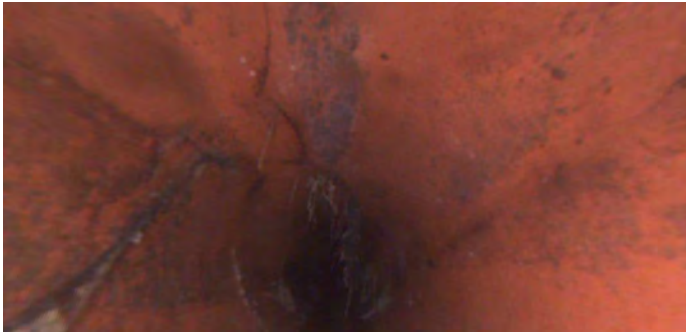
Code: **FM**
Description: **Fracture Multiple**

Distance (ft): **221.0**
Structural Grade: **4**
O&M Grade: **0**
Clock Start/From: **7**
Clock To: **9**
1st Value:
2nd Value:
Value Percent:
Continuous Index: **S03**
Within 8" of Joint:
Remarks: **in barrel**

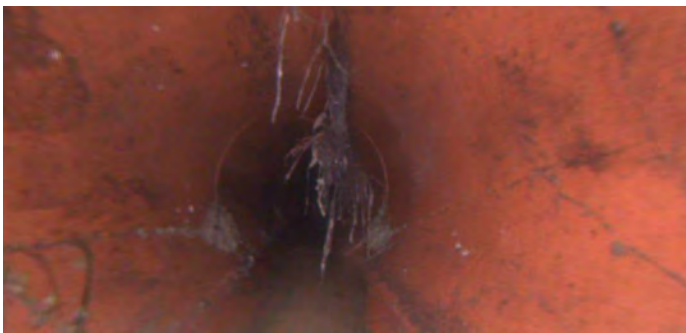
Code: **RMB**
Description: **Roots Medium Barrel**

Distance (ft): **221.9**
Structural Grade: **0**
O&M Grade: **4**
Clock Start/From: **7**
Clock To: **12**
1st Value:
2nd Value:
Value Percent: **5.000**
Continuous Index: **S04**
Within 8" of Joint: **NO**
Remarks: **from fractures**

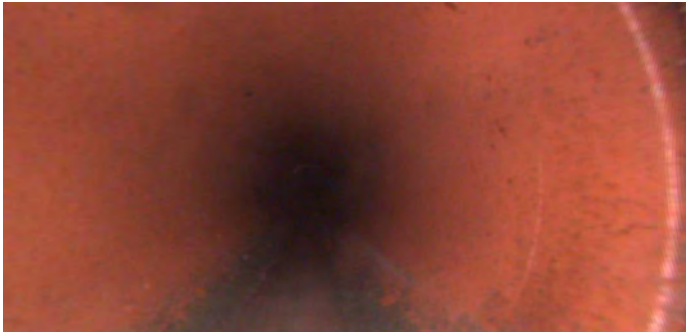
Code: **FM**
Description: **Fracture Multiple**

Distance (ft): **239.2**
Structural Grade: **4**
O&M Grade: **0**
Clock Start/From: **7**
Clock To: **9**
1st Value:
2nd Value:
Value Percent:
Continuous Index: **F03**
Within 8" of Joint:
Remarks: **in barrel**

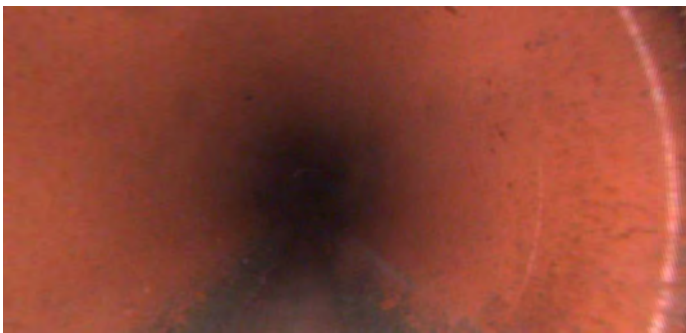
Code: **RMB**
Description: **Roots Medium Barrel**

Distance (ft): **239.2**
Structural Grade: **0**
O&M Grade: **4**
Clock Start/From: **7**
Clock To: **12**
1st Value:
2nd Value:
Value Percent: **5.000**
Continuous Index: **F04**
Within 8" of Joint: **NO**
Remarks: **from fractures**

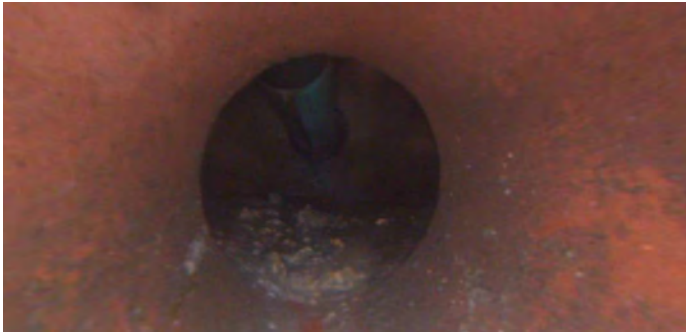
Code: **CM**
Description: **Crack Multiple**

Distance (ft): **284.7**
Structural Grade: **3**
O&M Grade: **0**
Clock Start/From: **12**
Clock To: **12**
1st Value:
2nd Value:
Value Percent:
Continuous Index: **F02**
Within 8" of Joint: **YES**
Remarks:

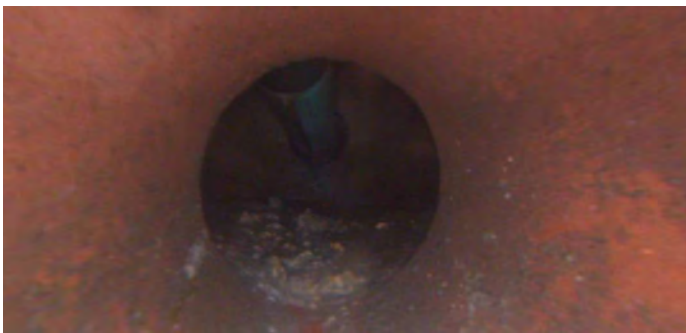
Code: **DSZ**
Description: **Deposits Settled Other**

Distance (ft): **284.7**
Structural Grade: **0**
O&M Grade: **2**
Clock Start/From: **6**
Clock To:
1st Value:
2nd Value:
Value Percent: **5.000**
Continuous Index: **F01**
Within 8" of Joint: **NO**
Remarks: **tissue/debris**
