Profile/Photo Observation Report

Street:	FOXCROFT STREET	Flow Control:	Not Controlled
City:	Hobart, IN	Year Renewed:	
Location:	Light Highway	Tape/Media #:	
Purpose:	Routine Assessment	Dia/Height:	10"
Use:	Sanitary	Material:	VCP
Drain Area:	NA	Lining:	
Category:	NA		
Comment:	Flow direction wrong

Location Details:		Direction of Survey:	Downstream
US MH:	M-108-027	DS MH:	M-108-028
		Total Length Surveyed (ft):	288.8

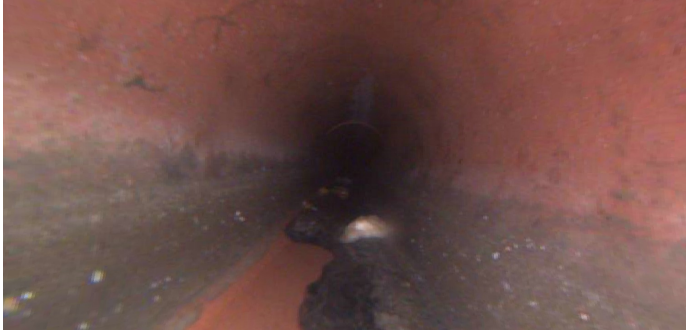
Code: **AMH**
Description: **Manhole**

Distance (ft): **.0**
Structural Grade: **0**
O&M Grade: **0**
Clock Start/From:
Clock To:
1st Value:
2nd Value:
Value Percent:
Continuous Index:
Within 8" of Joint: **NO**
Remarks: **M-108-027**

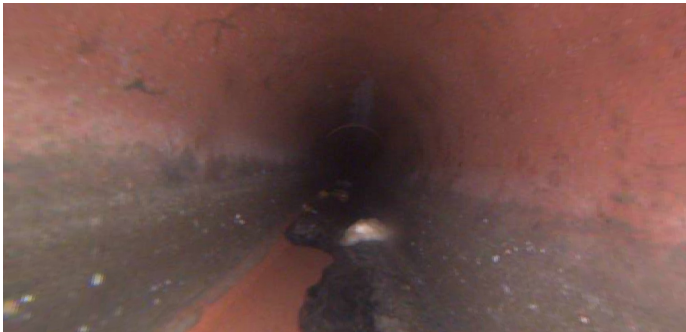
Code: **MWL**
Description: **Water Level**

Distance (ft): **.0**
Structural Grade: **0**
O&M Grade: **0**
Clock Start/From:
Clock To:
1st Value:
2nd Value:
Value Percent: **5.000**
Continuous Index:
Within 8" of Joint: **NO**
Remarks:

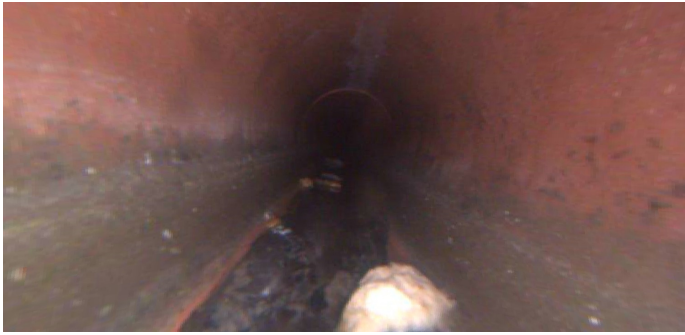
Code: **DSZ**
Description: **Deposits Settled Other**

Distance (ft): **1.7**
Structural Grade: **0**
O&M Grade: **2**
Clock Start/From: **6**
Clock To:
1st Value:
2nd Value:
Value Percent: **5.000**
Continuous Index: **S01**
Within 8" of Joint: **NO**
Remarks: **tissue/debris**

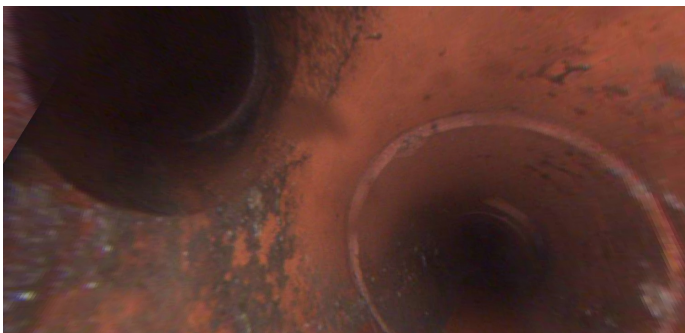
Code: **TF**
Description: **Tap Factory**

Distance (ft): **78.9**
Structural Grade: **0**
O&M Grade: **0**
Clock Start/From: **11**
Clock To:
1st Value: **4.000**
2nd Value:
Value Percent:
Continuous Index:
Within 8" of Joint: **YES**
Remarks:

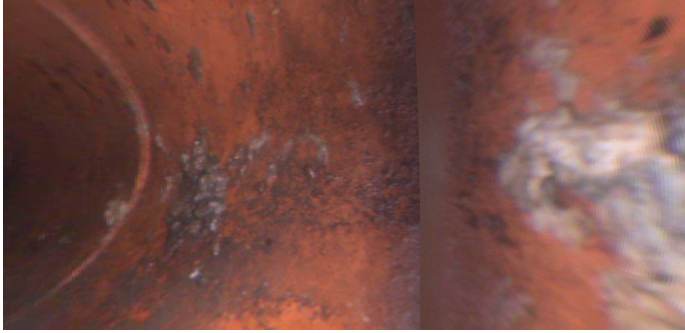
Code: **DAZ**
Description: **Deposits Attached Other**

Distance (ft): **78.9**
Structural Grade: **0**
O&M Grade: **2**
Clock Start/From: **7**
Clock To: **5**
1st Value:
2nd Value:
Value Percent: **5.000**
Continuous Index:
Within 8" of Joint: **NO**
Remarks: **at tap**

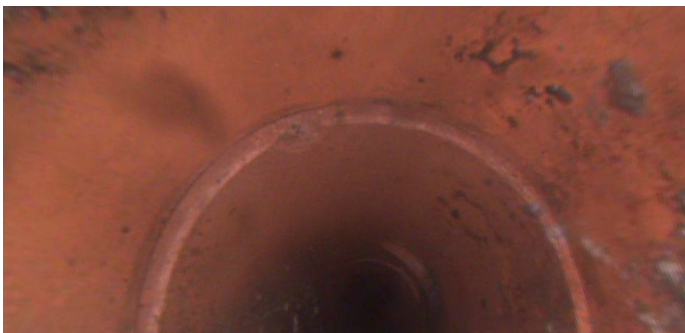
Code: **MGO**
Description: **General Observation**

Distance (ft): **79.1**
Structural Grade: **0**
O&M Grade: **0**
Clock Start/From:
Clock To:
1st Value:
2nd Value:
Value Percent:
Continuous Index:
Within 8" of Joint: **NO**
Remarks: **small chip at joint**

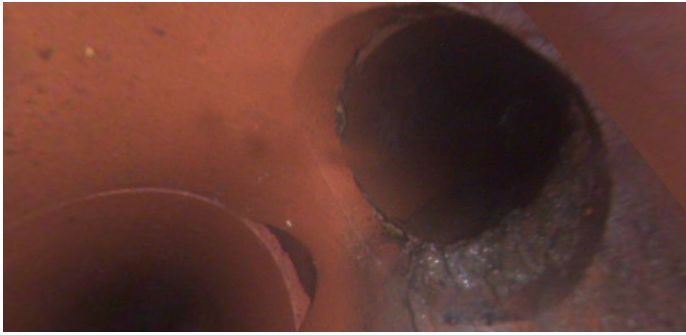
Code: **TF**
Description: **Tap Factory**

Distance (ft): **80.9**
Structural Grade: **0**
O&M Grade: **0**
Clock Start/From: **2**
Clock To:
1st Value: **4.000**
2nd Value:
Value Percent:
Continuous Index:
Within 8" of Joint:
Remarks:

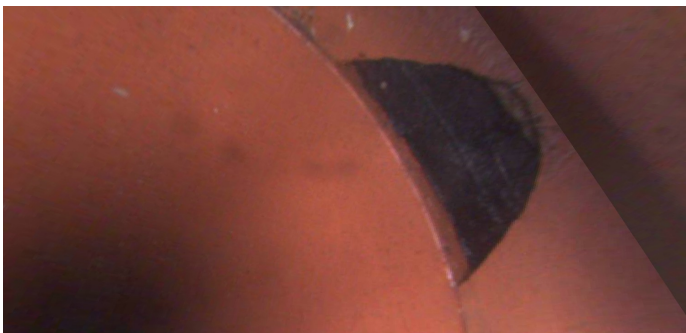
Code: **RPP**
Description: **Repair Patch**

Distance (ft): **81.6**
Structural Grade: **0**
O&M Grade: **0**
Clock Start/From: **1**
Clock To: **2**
1st Value:
2nd Value:
Value Percent:
Continuous Index:
Within 8" of Joint: **YES**
Remarks: **rubber**

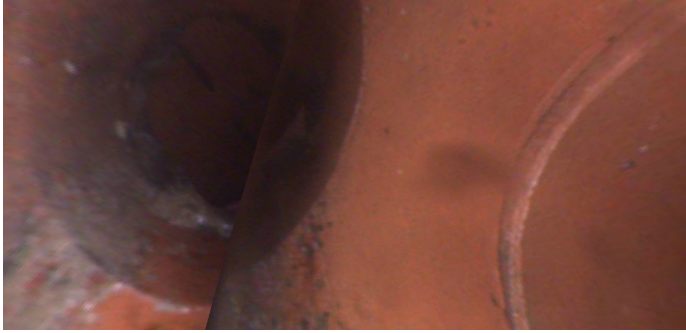
Code: **TF**
Description: **Tap Factory**

Distance (ft): **141.9**
Structural Grade: **0**
O&M Grade: **0**
Clock Start/From: **10**
Clock To:
1st Value: **4.000**
2nd Value:
Value Percent:
Continuous Index:
Within 8" of Joint: **YES**
Remarks:

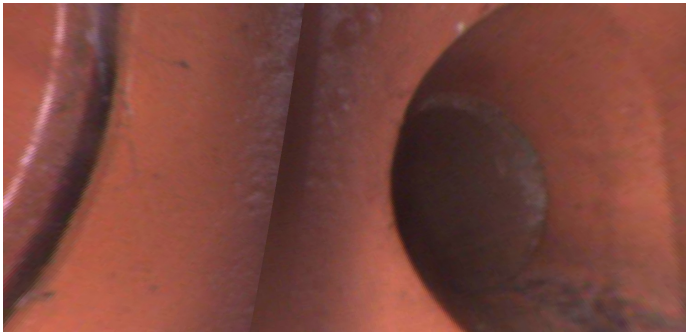
Code: **TF**
Description: **Tap Factory**

Distance (ft): **144.4**
Structural Grade: **0**
O&M Grade: **0**
Clock Start/From: **2**
Clock To:
1st Value: **4.000**
2nd Value:
Value Percent:
Continuous Index:
Within 8" of Joint: **YES**
Remarks:

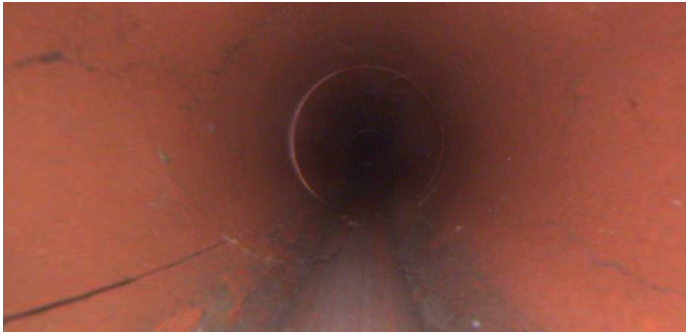
Code: **FS**
Description: **Fracture Spiral**

Distance (ft): **180.2**
Structural Grade: **3**
O&M Grade: **0**
Clock Start/From: **4**
Clock To: **8**
1st Value:
2nd Value:
Value Percent:
Continuous Index:
Within 8" of Joint:
Remarks:

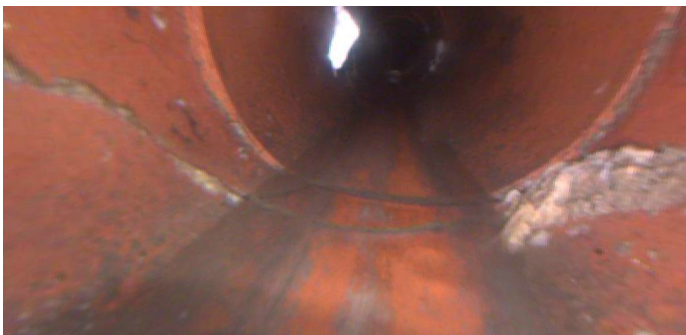
Code: **FM**
Description: **Fracture Multiple**

Distance (ft): **213.1**
Structural Grade: **4**
O&M Grade: **0**
Clock Start/From: **12**
Clock To: **12**
1st Value:
2nd Value:
Value Percent:
Continuous Index: **S02**
Within 8" of Joint: **YES**
Remarks:

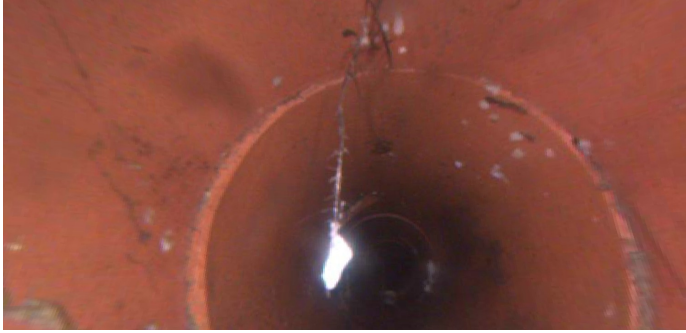
Code: **RFB**
Description: **Roots Fine Barrel**

Distance (ft): **213.1**
Structural Grade: **0**
O&M Grade: **2**
Clock Start/From: **12**
Clock To:
1st Value:
2nd Value:
Value Percent:
Continuous Index:
Within 8" of Joint: **NO**
Remarks: **near joint**

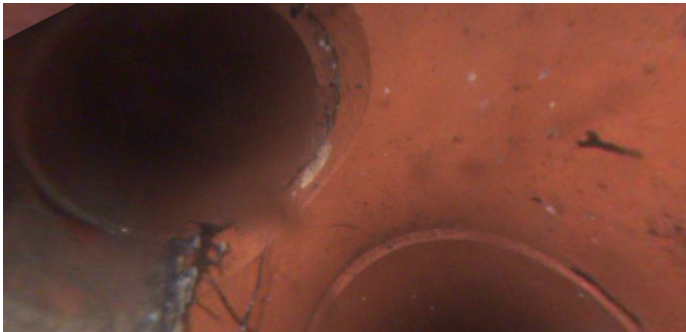
Code: **TFD**
Description: **Tap Factory Defective**

Distance (ft): **215.0**
Structural Grade: **0**
O&M Grade: **2**
Clock Start/From: **10**
Clock To:
1st Value: **4.000**
2nd Value:
Value Percent:
Continuous Index:
Within 8" of Joint:
Remarks: **roots**

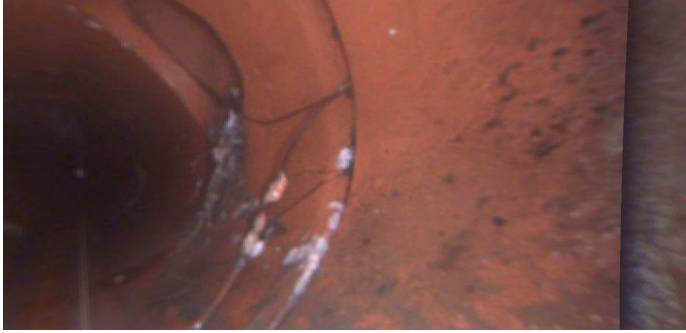
Code: **RML**
Description: **Roots Medium Lateral**

Distance (ft): **216.5**
Structural Grade: **0**
O&M Grade: **3**
Clock Start/From: **7**
Clock To: **10**
1st Value:
2nd Value:
Value Percent: **5.000**
Continuous Index:
Within 8" of Joint: **NO**
Remarks:

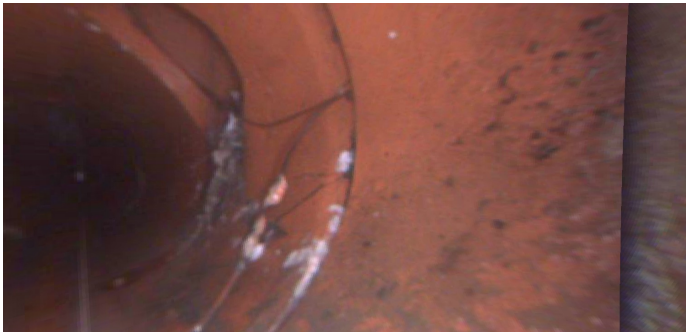
Code: **RFJ**
Description: **Roots Fine Joint**

Distance (ft): **216.5**
Structural Grade: **0**
O&M Grade: **1**
Clock Start/From: **9**
Clock To:
1st Value:
2nd Value:
Value Percent:
Continuous Index:
Within 8" of Joint: **YES**
Remarks:

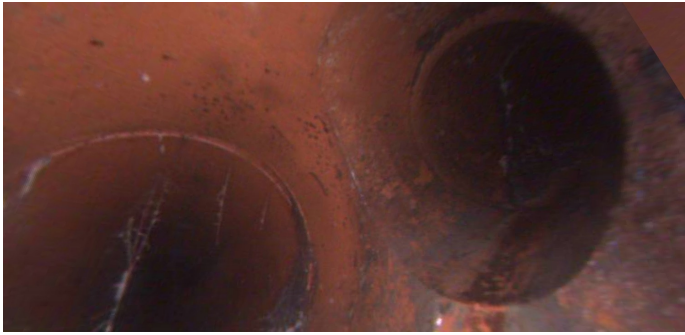
Code: **TF**
Description: **Tap Factory**

Distance (ft): **217.1**
Structural Grade: **0**
O&M Grade: **0**
Clock Start/From: **2**
Clock To:
1st Value: **4.000**
2nd Value:
Value Percent:
Continuous Index:
Within 8" of Joint:
Remarks:

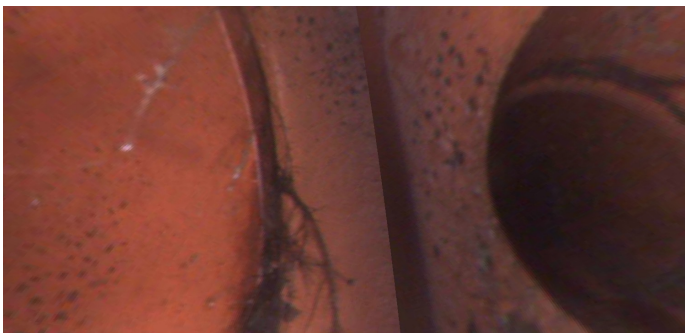
Code: **RFJ**
Description: **Roots Fine Joint**

Distance (ft): **218.0**
Structural Grade: **0**
O&M Grade: **1**
Clock Start/From: **7**
Clock To: **5**
1st Value:
2nd Value:
Value Percent:
Continuous Index:
Within 8" of Joint: **YES**
Remarks:

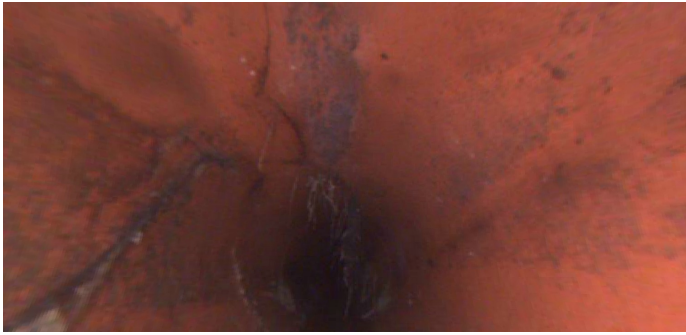
Code: **FM**
Description: **Fracture Multiple**

Distance (ft): **221.0**
Structural Grade: **4**
O&M Grade: **0**
Clock Start/From: **7**
Clock To: **9**
1st Value:
2nd Value:
Value Percent:
Continuous Index: **S03**
Within 8" of Joint:
Remarks: **in barrel**

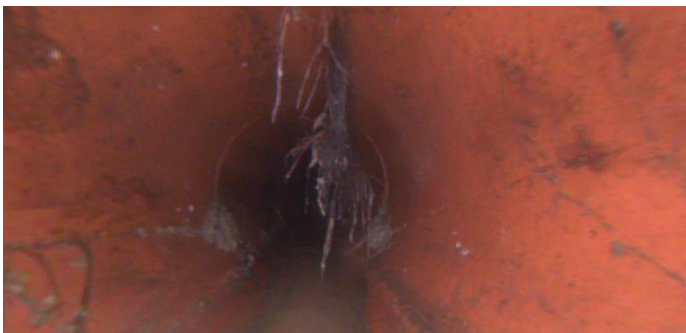
Code: **RMB**
Description: **Roots Medium Barrel**

Distance (ft): **221.9**
Structural Grade: **0**
O&M Grade: **4**
Clock Start/From: **7**
Clock To: **12**
1st Value:
2nd Value:
Value Percent: **5.000**
Continuous Index: **S04**
Within 8" of Joint: **NO**
Remarks: **from fractures**

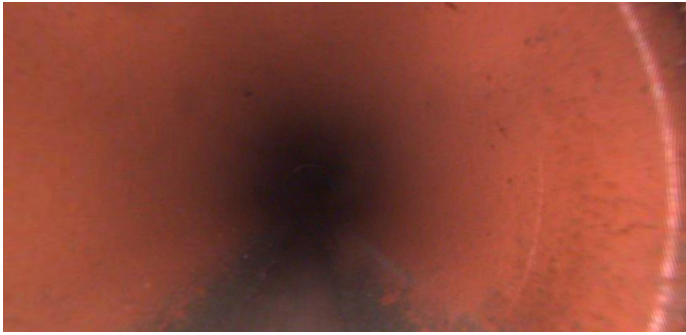
Code: **FM**
Description: **Fracture Multiple**

Distance (ft): **239.2**
Structural Grade: **4**
O&M Grade: **0**
Clock Start/From: **7**
Clock To: **9**
1st Value:
2nd Value:
Value Percent:
Continuous Index: **F03**
Within 8" of Joint:
Remarks: **in barrel**

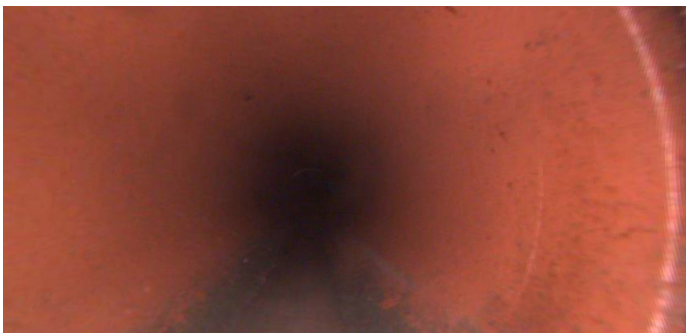
Code: **RMB**
Description: **Roots Medium Barrel**

Distance (ft): **239.2**
Structural Grade: **0**
O&M Grade: **4**
Clock Start/From: **7**
Clock To: **12**
1st Value:
2nd Value:
Value Percent: **5.000**
Continuous Index: **F04**
Within 8" of Joint: **NO**
Remarks: **from fractures**

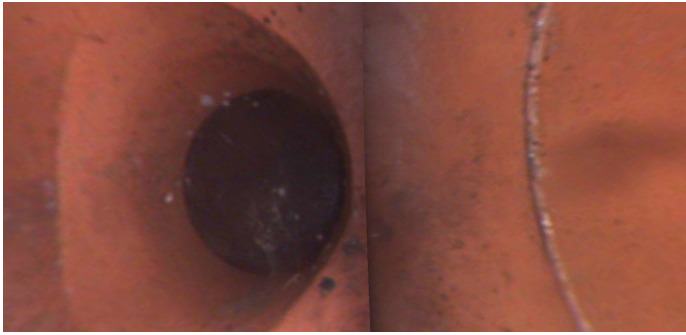
Code: **TFC**
Description: **Tap Factory Capped**

Distance (ft): **278.7**
Structural Grade: **0**
O&M Grade: **0**
Clock Start/From: **10**
Clock To:
1st Value: **4.000**
2nd Value:
Value Percent:
Continuous Index:
Within 8" of Joint: **YES**
Remarks:

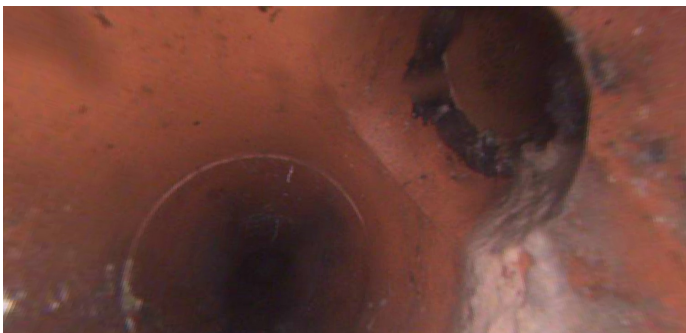
Code: **TF**
Description: **Tap Factory**

Distance (ft): **280.0**
Structural Grade: **0**
O&M Grade: **0**
Clock Start/From: **2**
Clock To:
1st Value: **4.000**
2nd Value:
Value Percent:
Continuous Index:
Within 8" of Joint: **YES**
Remarks:

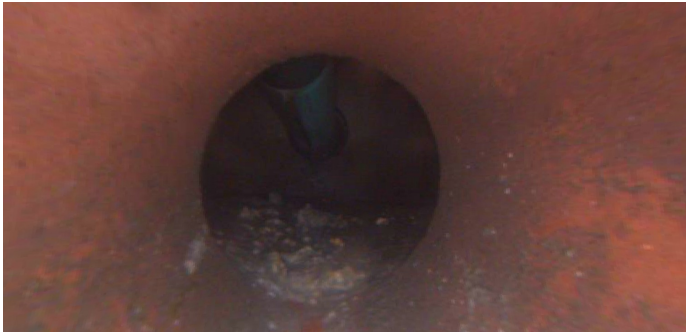
Code: **CM**
Description: **Crack Multiple**

Distance (ft): **284.7**
Structural Grade: **3**
O&M Grade: **0**
Clock Start/From: **12**
Clock To: **12**
1st Value:
2nd Value:
Value Percent:
Continuous Index: **F02**
Within 8" of Joint: **YES**
Remarks:

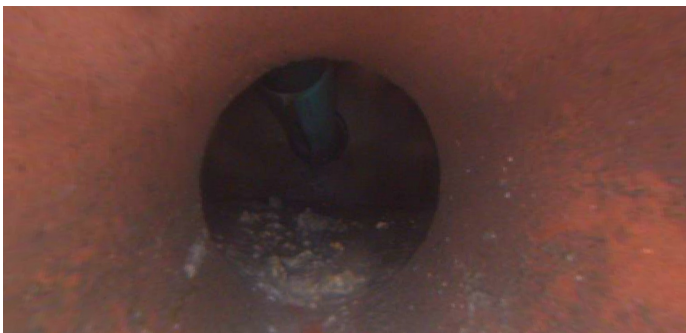
Code: **DSZ**
Description: **Deposits Settled Other**

Distance (ft): **284.7**
Structural Grade: **0**
O&M Grade: **2**
Clock Start/From: **6**
Clock To:
1st Value:
2nd Value:
Value Percent: **5.000**
Continuous Index: **F01**
Within 8" of Joint: **NO**
Remarks: **tissue/debris**

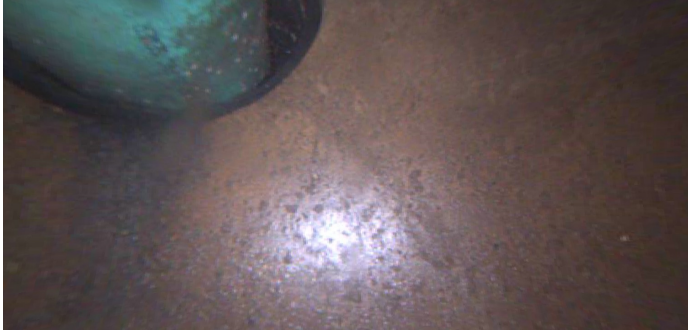
Code:	AMH
Description:	Manhole
Distance (ft):	288.8
Structural Grade:	0
O&M Grade:	0
Clock Start/From:	
Clock To:	
1st Value:	
2nd Value:	
Value Percent:	
Continuous Index:	
Within 8" of Joint:	NO
Remarks:	M-108-028
