Profile/Photo Observation Report

Date:	10/23/2021	Weather:		Coding:	PACP 6.0
Pipe Length (ft):		Owner:	Hobart, IN	Pre Clean:	Not Known
P.O.#:	990_1	Surveyor:	M. Pielacha	PSR:	P-108-050-028
Customer:	Hobart, IN	Clean Date:		Shape:	C

Location Details:		Direction of Survey:	Downstream
US MH:	M-108-28	DS MH:	M-108-50
		Total Length Surveyed (ft):	111.9

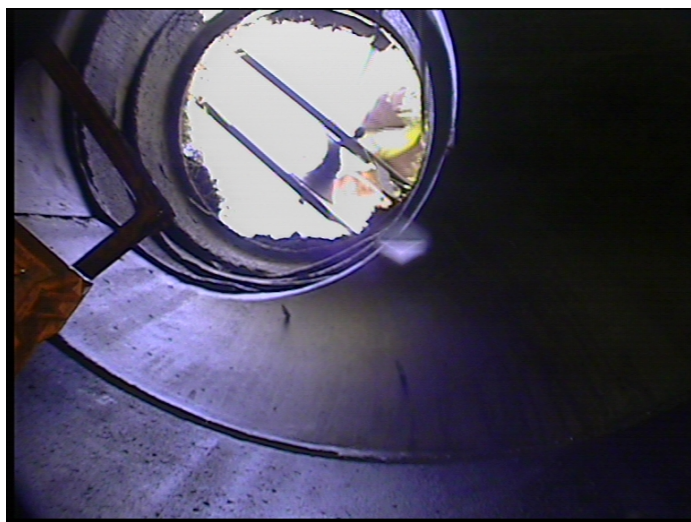
Code: **AMH**
Description: **Manhole**

Distance (ft): **.0**
Structural Grade: **0**
O&M Grade: **0**
Clock Start/From:
Clock To:
1st Value:
2nd Value:
Value Percent:
Continuous Index:
Within 8" of Joint: **NO**
Remarks: **M-108-28**

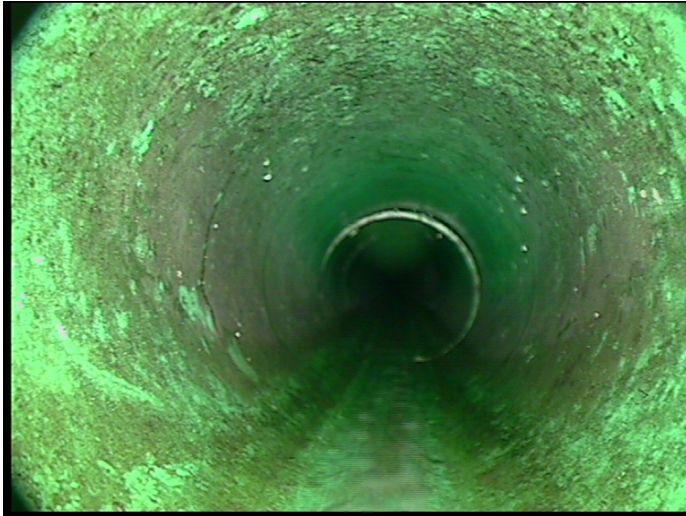
Code:	MWL
Description:	Water Level
Distance (ft):	.0
Structural Grade:	0
O&M Grade:	0
Clock Start/From:	
Clock To:	
1st Value:	
2nd Value:	
Value Percent:	5.000
Continuous Index:	
Within 8" of Joint:	NO
Remarks:

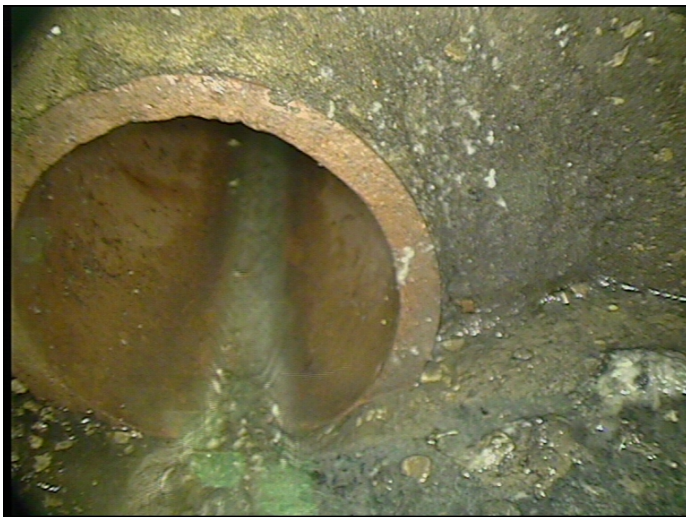
Code:	AMH
Description:	Manhole
Distance (ft):	111.9
Structural Grade:	0
O&M Grade:	0
Clock Start/From:	
Clock To:	
1st Value:	
2nd Value:	
Value Percent:	
Continuous Index:	
Within 8" of Joint:	NO
Remarks:	M-108-50
