Profile/Photo Observation Report

Date:	03/24/2018	Weather:		Coding:	PACP 6.0
Pipe Length (ft):	299.8	Owner:	NA	Pre Clean:	No Pre-Cleaning
P.O.#:		Surveyor:	Justin Gonzales	PSR:	P-108-027-029
Customer:		Clean Date:	01/01/1900	Shape:	C

Street:	SWIFT ST	Flow Control:	Not Controlled
City:	Hobart, IN	Year Renewed:	
Location:	Light Highway	Tape/Media #:	
Purpose:	Routine Assessment	Dia/Height:	12"
Use:	Sanitary	Material:	VCP
Drain Area:	NA	Lining:	
Category:	NA		
Comment:	Flow direction wrong		
Location Details:		Direction of Survey:	Upstream
US MH:	M-108-029	DS MH:	M-108-027
		Total Length Surveyed (ft):	296.3

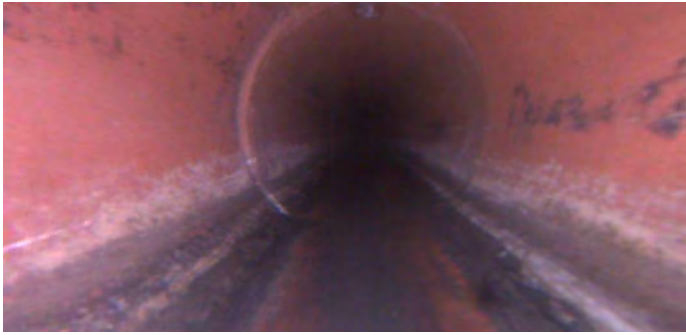
Code: **AMH**
Description: **Manhole**

Distance (ft): **.0**
Structural Grade: **0**
O&M Grade: **0**
Clock Start/From:
Clock To:
1st Value:
2nd Value:
Value Percent:
Continuous Index:
Within 8" of Joint: **NO**
Remarks: **M-108-027**

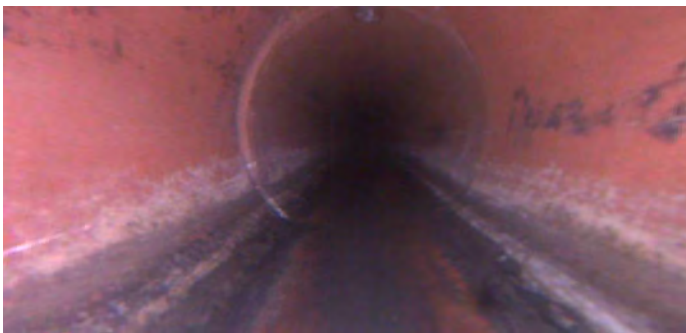
Code: **MWL**
Description: **Water Level**

Distance (ft): **.0**
Structural Grade: **0**
O&M Grade: **0**
Clock Start/From:
Clock To:
1st Value:
2nd Value:
Value Percent: **5.000**
Continuous Index:
Within 8" of Joint: **NO**
Remarks:

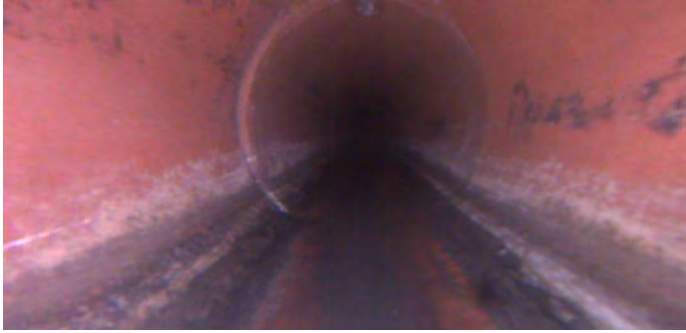
Code: **DAGS**
Description: **Deposits Attached Grease**

Distance (ft): **.0**
Structural Grade: **0**
O&M Grade: **2**
Clock Start/From: **7**
Clock To: **5**
1st Value:
2nd Value:
Value Percent: **5.000**
Continuous Index: **S01**
Within 8" of Joint: **YES**
Remarks: **WANDER**

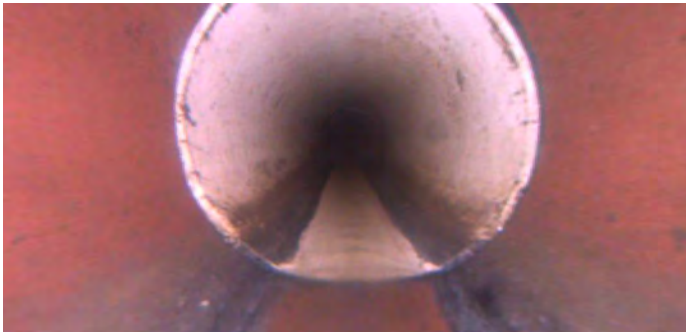
Code: **RPR**
Description: **Repair Point Pipe Replaced**

Distance (ft): **35.9**
Structural Grade: **0**
O&M Grade: **0**
Clock Start/From:
Clock To:
1st Value:
2nd Value:
Value Percent:
Continuous Index:
Within 8" of Joint: **NO**
Remarks: **VCP TO PVC**

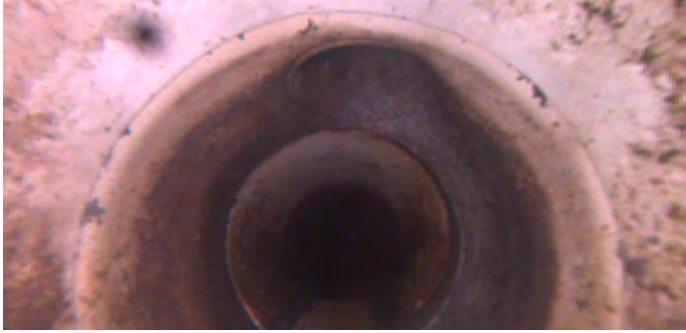
Code: **TF**
Description: **Tap Factory**

Distance (ft): **40.0**
Structural Grade: **0**
O&M Grade: **0**
Clock Start/From: **12**
Clock To:
1st Value: **4.000**
2nd Value:
Value Percent:
Continuous Index:
Within 8" of Joint:
Remarks:

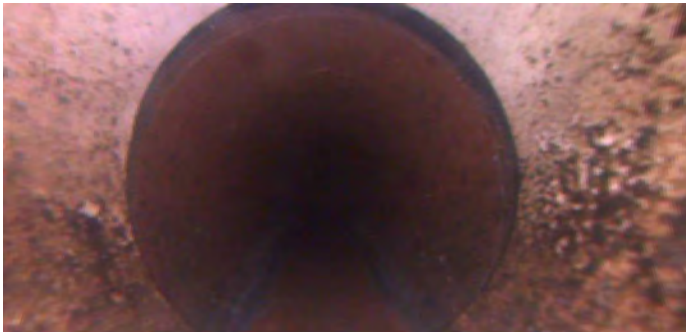
Code: **RPR**
Description: **Repair Point Pipe Replaced**

Distance (ft): **41.6**
Structural Grade: **0**
O&M Grade: **0**
Clock Start/From:
Clock To:
1st Value:
2nd Value:
Value Percent:
Continuous Index:
Within 8" of Joint: **NO**
Remarks: **PVC END**

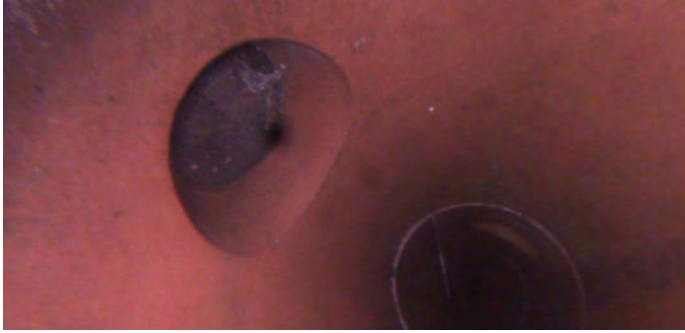
Code: **TFC**
Description: **Tap Factory Capped**

Distance (ft): **72.4**
Structural Grade: **0**
O&M Grade: **0**
Clock Start/From: **10**
Clock To:
1st Value: **4.000**
2nd Value:
Value Percent:
Continuous Index:
Within 8" of Joint:
Remarks:

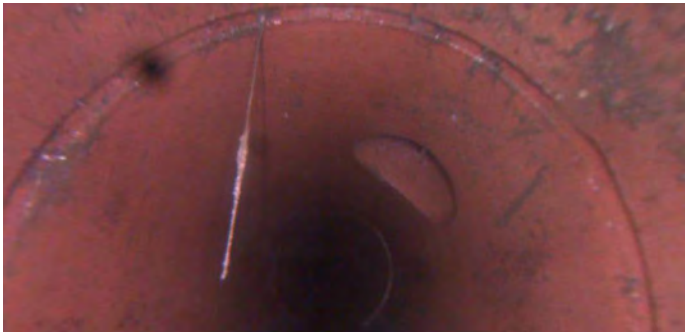
Code: **RFJ**
Description: **Roots Fine Joint**

Distance (ft): **73.9**
Structural Grade: **0**
O&M Grade: **1**
Clock Start/From: **11**
Clock To:
1st Value:
2nd Value:
Value Percent:
Continuous Index:
Within 8" of Joint: **YES**
Remarks:

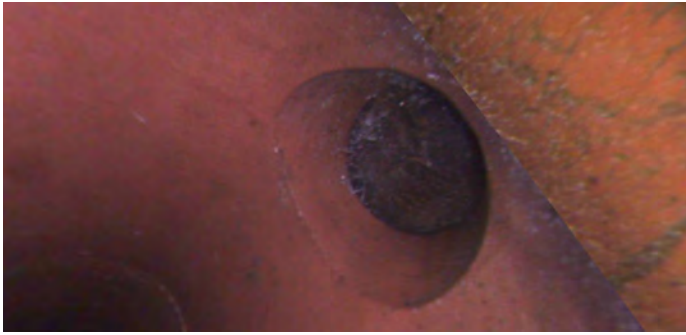
Code: **TFC**
Description: **Tap Factory Capped**

Distance (ft): **74.6**
Structural Grade: **0**
O&M Grade: **0**
Clock Start/From: **2**
Clock To:
1st Value: **4.000**
2nd Value:
Value Percent:
Continuous Index:
Within 8" of Joint:
Remarks:

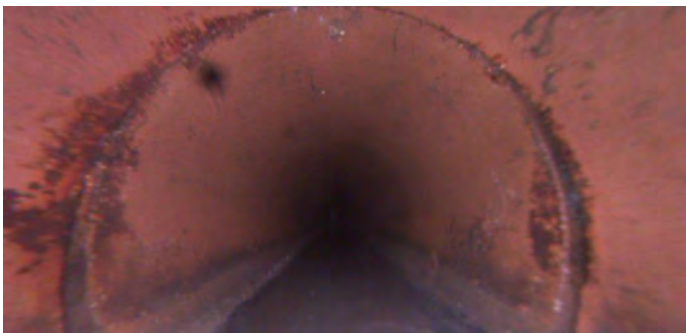
Code: **IS**
Description: **Infil Stain**

Distance (ft): **106.2**
Structural Grade: **0**
O&M Grade: **0**
Clock Start/From: **8**
Clock To: **4**
1st Value:
2nd Value:
Value Percent:
Continuous Index:
Within 8" of Joint: **YES**
Remarks:

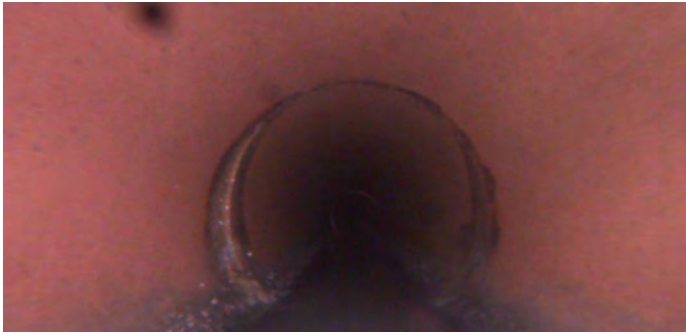
Code: **IS**
Description: **Infil Stain**

Distance (ft): **115.6**
Structural Grade: **0**
O&M Grade: **0**
Clock Start/From: **7**
Clock To: **5**
1st Value:
2nd Value:
Value Percent:
Continuous Index:
Within 8" of Joint: **YES**
Remarks:

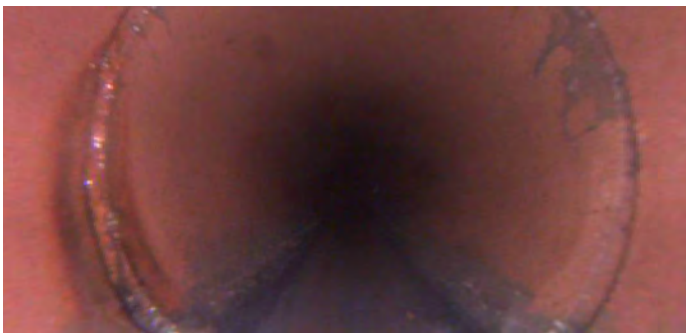
Code: **IS**
Description: **Infil Stain**

Distance (ft): **126.2**
Structural Grade: **0**
O&M Grade: **0**
Clock Start/From: **7**
Clock To: **10**
1st Value:
2nd Value:
Value Percent:
Continuous Index:
Within 8" of Joint: **YES**
Remarks:

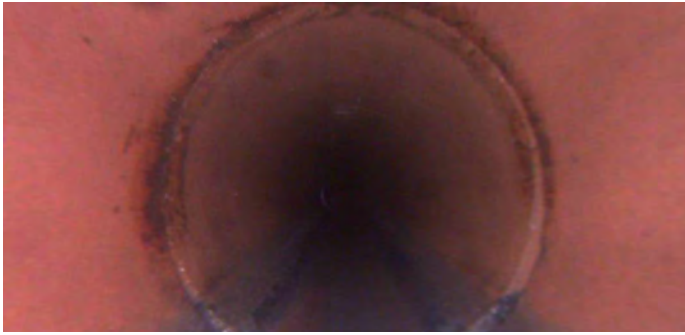
Code: **IS**
Description: **Infil Stain**

Distance (ft): **131.1**
Structural Grade: **0**
O&M Grade: **0**
Clock Start/From: **8**
Clock To: **4**
1st Value:
2nd Value:
Value Percent:
Continuous Index:
Within 8" of Joint: **YES**
Remarks:

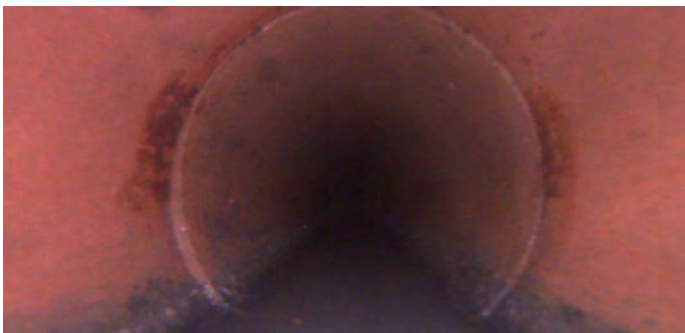
Code: **IS**
Description: **Infil Stain**

Distance (ft): **136.1**
Structural Grade: **0**
O&M Grade: **0**
Clock Start/From: **9**
Clock To: **3**
1st Value:
2nd Value:
Value Percent:
Continuous Index:
Within 8" of Joint: **YES**
Remarks:

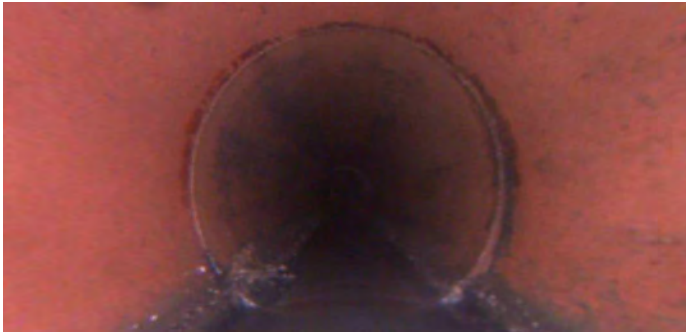
Code: **IW**
Description: **Infil Weeper**

Distance (ft): **141.0**
Structural Grade: **0**
O&M Grade: **2**
Clock Start/From: **7**
Clock To: **5**
1st Value:
2nd Value:
Value Percent:
Continuous Index: **S02**
Within 8" of Joint: **YES**
Remarks: **WANDER**

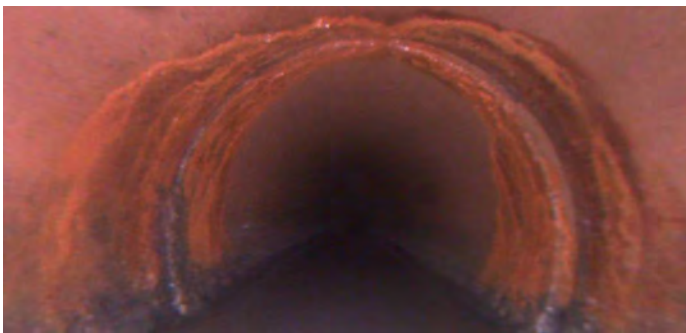
Code: **IS**
Description: **Infil Stain**

Distance (ft): **176.5**
Structural Grade: **0**
O&M Grade: **0**
Clock Start/From: **7**
Clock To: **5**
1st Value:
2nd Value:
Value Percent:
Continuous Index:
Within 8" of Joint: **YES**
Remarks:

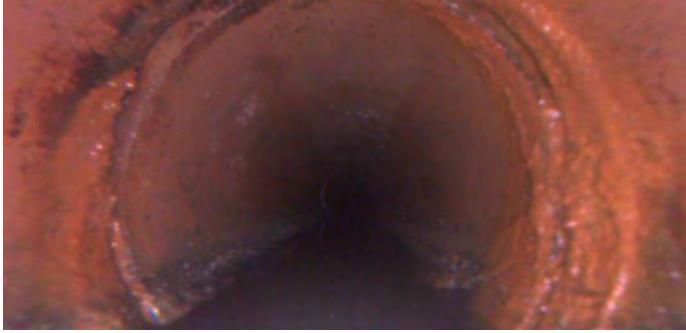
Code: **DAE**
Description: **Deposits Attached Encrustation**

Distance (ft): **181.6**
Structural Grade: **0**
O&M Grade: **2**
Clock Start/From: **8**
Clock To: **5**
1st Value:
2nd Value:
Value Percent: **5.000**
Continuous Index:
Within 8" of Joint: **YES**
Remarks:

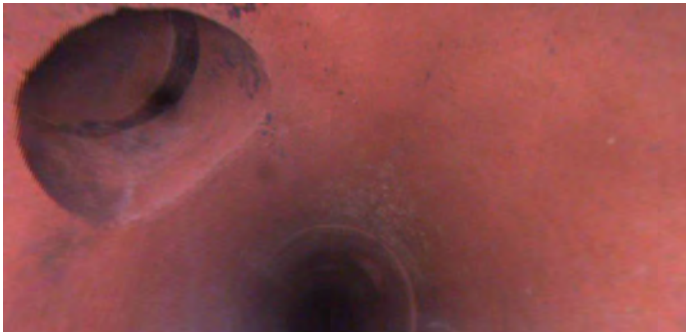
Code: **TF**
Description: **Tap Factory**

Distance (ft): **237.9**
Structural Grade: **0**
O&M Grade: **0**
Clock Start/From: **10**
Clock To:
1st Value: **4.000**
2nd Value:
Value Percent:
Continuous Index:
Within 8" of Joint:
Remarks:

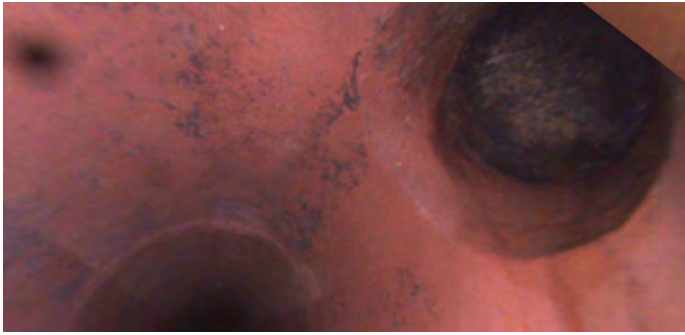
Code: **TFC**
Description: **Tap Factory Capped**

Distance (ft): **240.3**
Structural Grade: **0**
O&M Grade: **0**
Clock Start/From: **2**
Clock To:
1st Value: **4.000**
2nd Value:
Value Percent:
Continuous Index:
Within 8" of Joint:
Remarks:

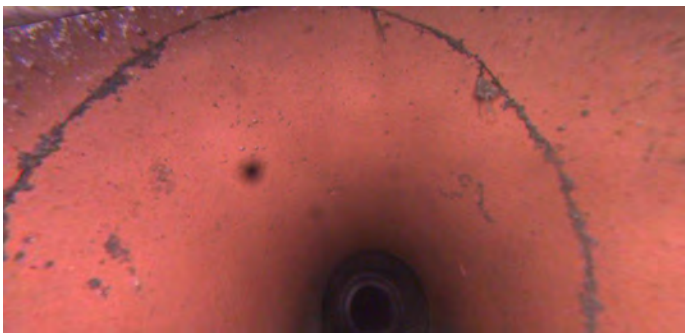
Code: **FS**
Description: **Fracture Spiral**

Distance (ft): **293.3**
Structural Grade: **3**
O&M Grade: **0**
Clock Start/From: **7**
Clock To: **5**
1st Value:
2nd Value:
Value Percent:
Continuous Index:
Within 8" of Joint:
Remarks:

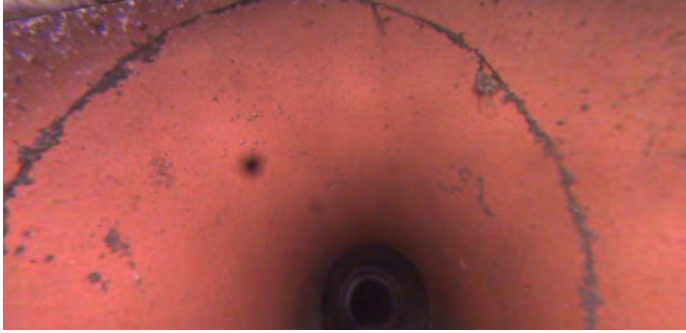
Code: **RFB**
Description: **Roots Fine Barrel**

Distance (ft): **293.3**
Structural Grade: **0**
O&M Grade: **2**
Clock Start/From: **12**
Clock To: **1**
1st Value:
2nd Value:
Value Percent:
Continuous Index:
Within 8" of Joint: **NO**
Remarks:

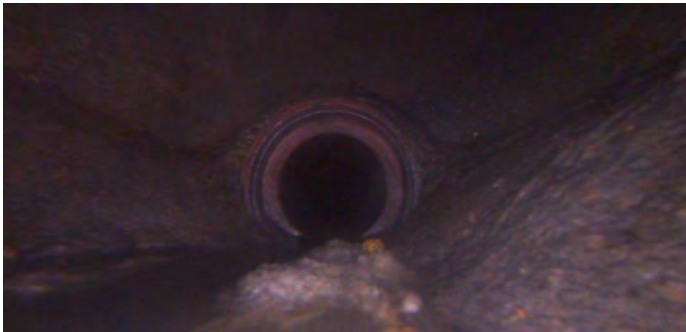
Code: **IW**
Description: **Infil Weeper**

Distance (ft): **296.3**
Structural Grade: **0**
O&M Grade: **2**
Clock Start/From: **7**
Clock To: **5**
1st Value:
2nd Value:
Value Percent:
Continuous Index: **F02**
Within 8" of Joint: **YES**
Remarks: **WANDER**

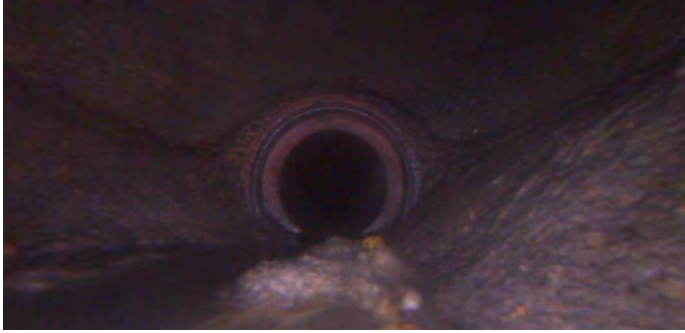
Code: **AMH**
Description: **Manhole**

Distance (ft): **296.3**
Structural Grade: **0**
O&M Grade: **0**
Clock Start/From:
Clock To:
1st Value:
2nd Value:
Value Percent:
Continuous Index:
Within 8" of Joint: **NO**
Remarks: **M-108-029**

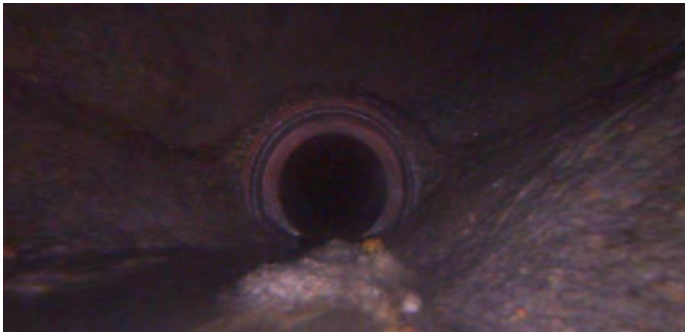
Code: **DAGS**
Description: **Deposits Attached Grease**

Distance (ft): **296.3**
Structural Grade: **0**
O&M Grade: **2**
Clock Start/From: **7**
Clock To: **5**
1st Value:
2nd Value:
Value Percent: **5.000**
Continuous Index: **F01**
Within 8" of Joint: **YES**
Remarks: **WANDER**
