Profile/Photo Observation Report

Date:	03/24/2018	Weather:		Coding:	PACP 6.0
Pipe Length (ft):	299.8	Owner:	NA	Pre Clean:	No Pre-Cleaning
P.O.#:		Surveyor:	Justin Gonzales	PSR:	P-108-027-029
Customer:		Clean Date:	01/01/1900	Shape:	C

Street:	FOXCROFT STREET	Flow Control:	Not Controlled
City:	Hobart, IN	Year Renewed:	
Location:	Light Highway	Tape/Media #:	
Purpose:	Routine Assessment	Dia/Height:	12"
Use:	Sanitary	Material:	VCP
Drain Area:	NA	Lining:	
Category:	NA		
Comment:	Flow direction wrong		
Location Details:		Direction of Survey:	Upstream
US MH:	M-108-029	DS MH:	M-108-027
		Total Length Surveyed (ft):	296.3

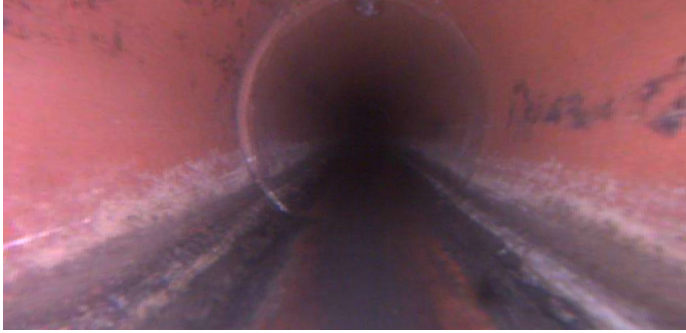
Code: **AMH**
Description: **Manhole**

Distance (ft): **.0**
Structural Grade: **0**
O&M Grade: **0**
Clock Start/From:
Clock To:
1st Value:
2nd Value:
Value Percent:
Continuous Index:
Within 8" of Joint: **NO**
Remarks: **M-108-027**

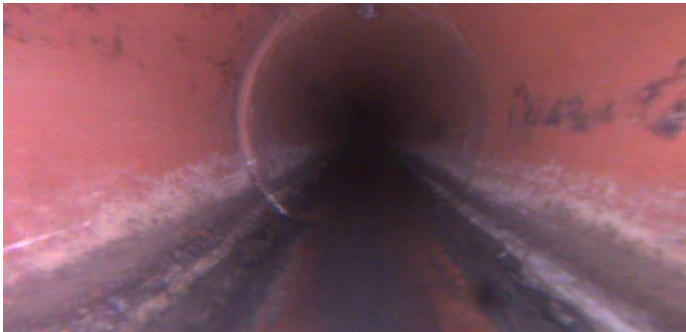
Code: **MWL**
Description: **Water Level**

Distance (ft): **.0**
Structural Grade: **0**
O&M Grade: **0**
Clock Start/From:
Clock To:
1st Value:
2nd Value:
Value Percent: **5.000**
Continuous Index:
Within 8" of Joint: **NO**
Remarks:

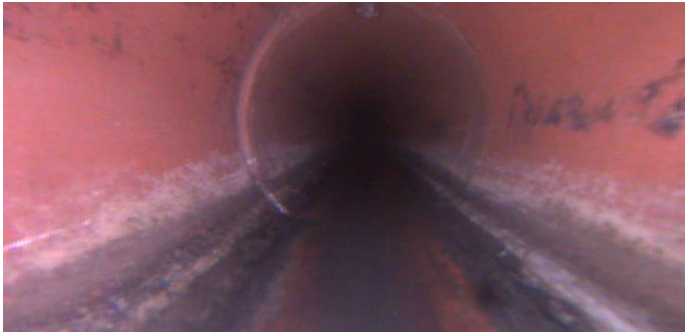
Code: **DAGS**
Description: **Deposits Attached Grease**

Distance (ft): **.0**
Structural Grade: **0**
O&M Grade: **2**
Clock Start/From: **7**
Clock To: **5**
1st Value:
2nd Value:
Value Percent: **5.000**
Continuous Index: **S01**
Within 8" of Joint: **YES**
Remarks: **WANDER**

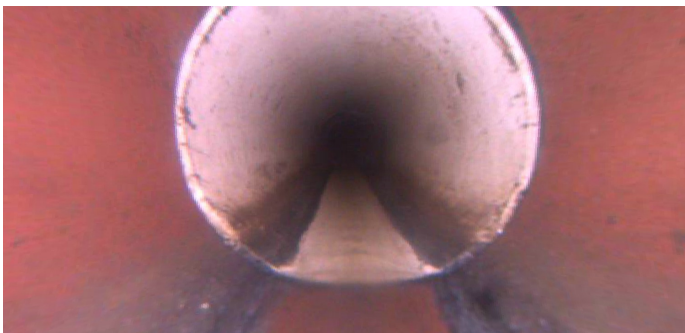
Code: **RPR**
Description: **Repair Point Pipe Replaced**

Distance (ft): **35.9**
Structural Grade: **0**
O&M Grade: **0**
Clock Start/From:
Clock To:
1st Value:
2nd Value:
Value Percent:
Continuous Index:
Within 8" of Joint: **NO**
Remarks: **VCP TO PVC**

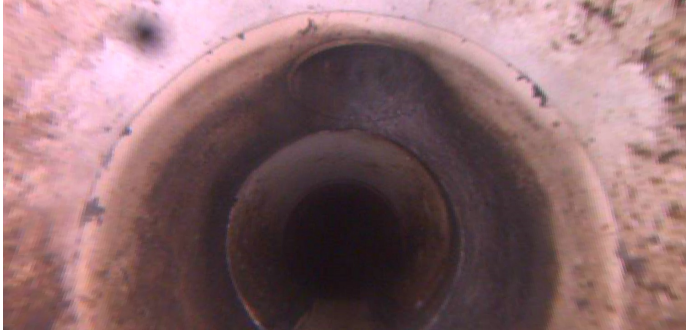
Code: **TF**
Description: **Tap Factory**

Distance (ft): **40.0**
Structural Grade: **0**
O&M Grade: **0**
Clock Start/From: **12**
Clock To:
1st Value: **4.000**
2nd Value:
Value Percent:
Continuous Index:
Within 8" of Joint:
Remarks:

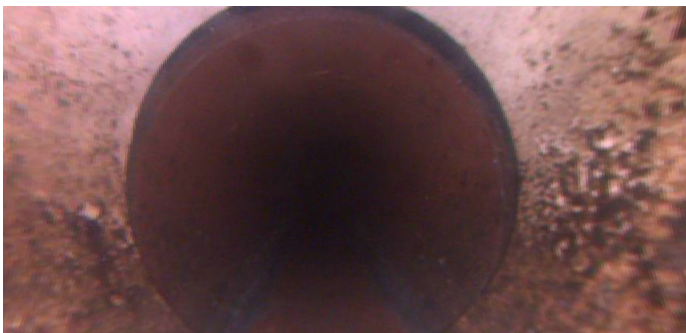
Code: **RPR**
Description: **Repair Point Pipe Replaced**

Distance (ft): **41.6**
Structural Grade: **0**
O&M Grade: **0**
Clock Start/From:
Clock To:
1st Value:
2nd Value:
Value Percent:
Continuous Index:
Within 8" of Joint: **NO**
Remarks: **PVC END**

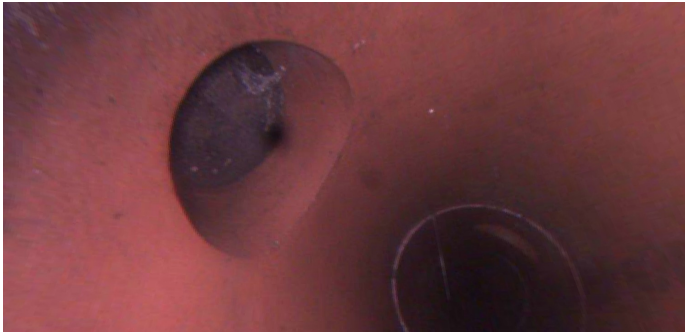
Code: **TFC**
Description: **Tap Factory Capped**

Distance (ft): **72.4**
Structural Grade: **0**
O&M Grade: **0**
Clock Start/From: **10**
Clock To:
1st Value: **4.000**
2nd Value:
Value Percent:
Continuous Index:
Within 8" of Joint:
Remarks:

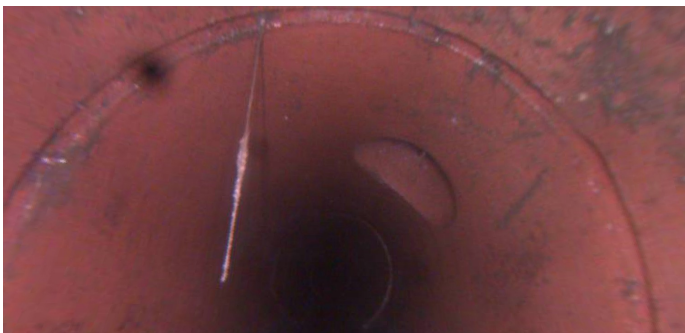
Code: **RFJ**
Description: **Roots Fine Joint**

Distance (ft): **73.9**
Structural Grade: **0**
O&M Grade: **1**
Clock Start/From: **11**
Clock To:
1st Value:
2nd Value:
Value Percent:
Continuous Index:
Within 8" of Joint: **YES**
Remarks:

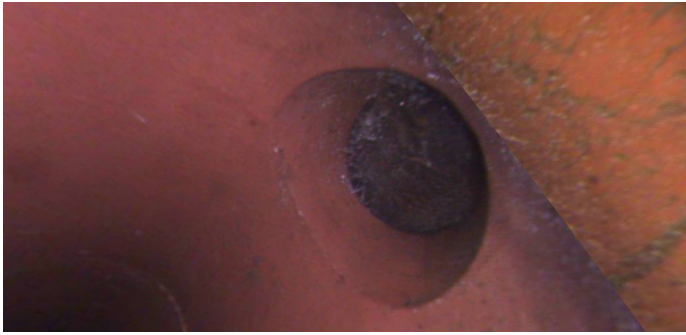
Code: **TFC**
Description: **Tap Factory Capped**

Distance (ft): **74.6**
Structural Grade: **0**
O&M Grade: **0**
Clock Start/From: **2**
Clock To:
1st Value: **4.000**
2nd Value:
Value Percent:
Continuous Index:
Within 8" of Joint:
Remarks:

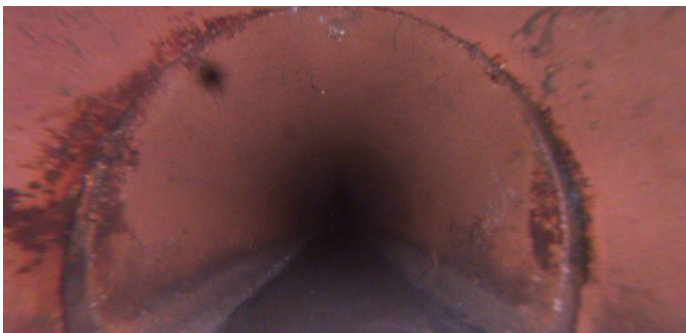
Code: **IS**
Description: **Infil Stain**

Distance (ft): **106.2**
Structural Grade: **0**
O&M Grade: **0**
Clock Start/From: **8**
Clock To: **4**
1st Value:
2nd Value:
Value Percent:
Continuous Index:
Within 8" of Joint: **YES**
Remarks:

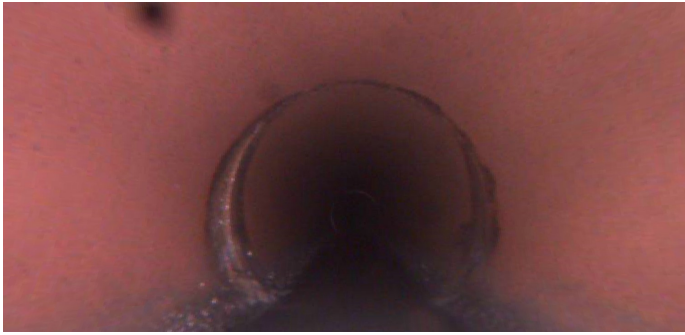
Code: **IS**
Description: **Infil Stain**

Distance (ft): **115.6**
Structural Grade: **0**
O&M Grade: **0**
Clock Start/From: **7**
Clock To: **5**
1st Value:
2nd Value:
Value Percent:
Continuous Index:
Within 8" of Joint: **YES**
Remarks:

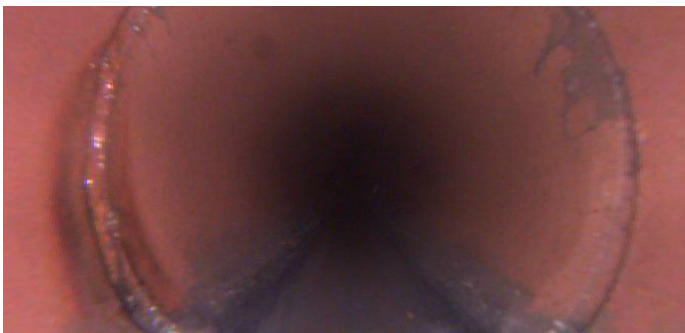
Code: **IS**
Description: **Infil Stain**

Distance (ft): **126.2**
Structural Grade: **0**
O&M Grade: **0**
Clock Start/From: **7**
Clock To: **10**
1st Value:
2nd Value:
Value Percent:
Continuous Index:
Within 8" of Joint: **YES**
Remarks:

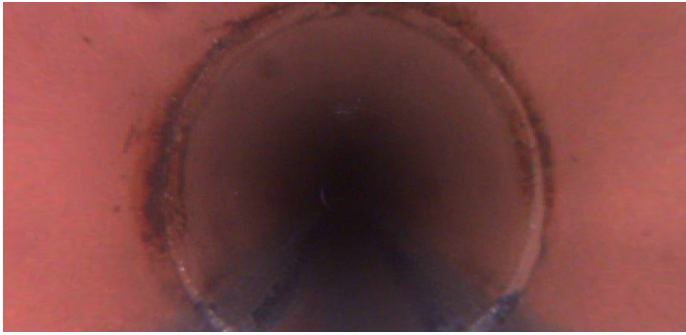
Code: **IS**
Description: **Infil Stain**

Distance (ft): **131.1**
Structural Grade: **0**
O&M Grade: **0**
Clock Start/From: **8**
Clock To: **4**
1st Value:
2nd Value:
Value Percent:
Continuous Index:
Within 8" of Joint: **YES**
Remarks:

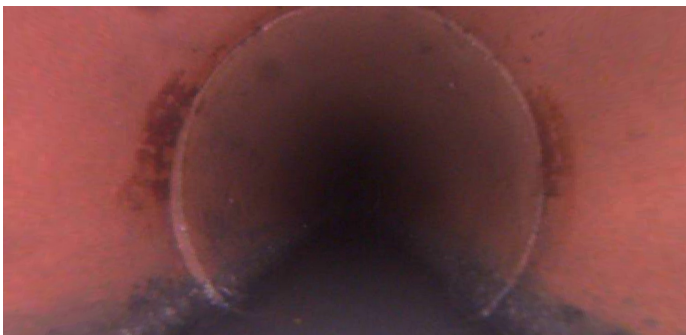
Code: **IS**
Description: **Infil Stain**

Distance (ft): **136.1**
Structural Grade: **0**
O&M Grade: **0**
Clock Start/From: **9**
Clock To: **3**
1st Value:
2nd Value:
Value Percent:
Continuous Index:
Within 8" of Joint: **YES**
Remarks:

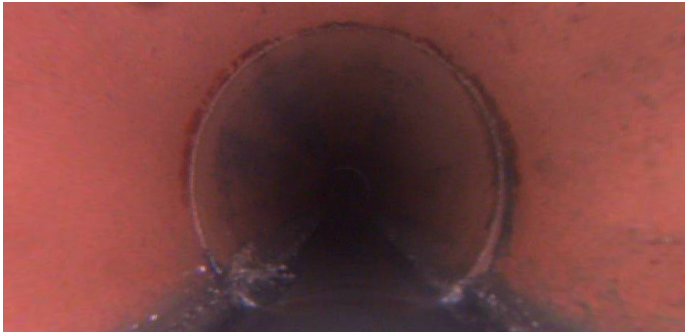
Code: **IW**
Description: **Infil Weeper**

Distance (ft): **141.0**
Structural Grade: **0**
O&M Grade: **2**
Clock Start/From: **7**
Clock To: **5**
1st Value:
2nd Value:
Value Percent:
Continuous Index: **S02**
Within 8" of Joint: **YES**
Remarks: **WANDER**

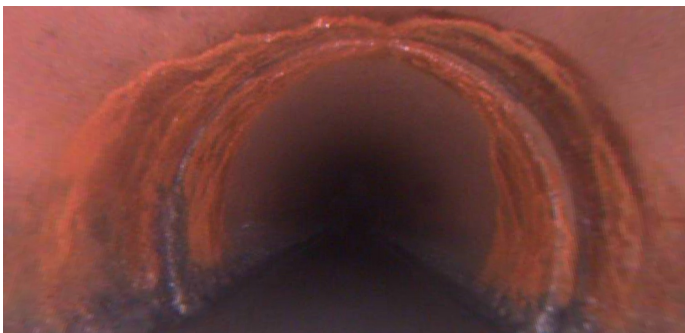
Code: **IS**
Description: **Infil Stain**

Distance (ft): **176.5**
Structural Grade: **0**
O&M Grade: **0**
Clock Start/From: **7**
Clock To: **5**
1st Value:
2nd Value:
Value Percent:
Continuous Index:
Within 8" of Joint: **YES**
Remarks:

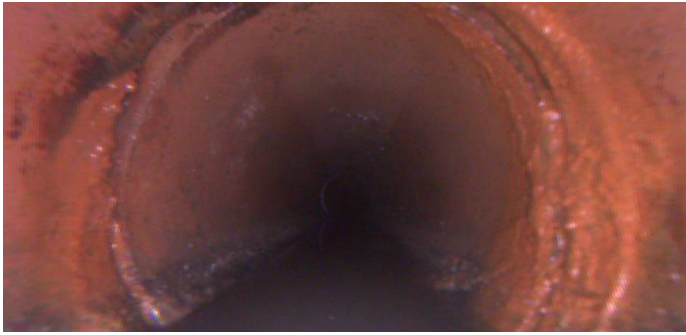
Code: **DAE**
Description: **Deposits Attached Encrustation**

Distance (ft): **181.6**
Structural Grade: **0**
O&M Grade: **2**
Clock Start/From: **8**
Clock To: **5**
1st Value:
2nd Value:
Value Percent: **5.000**
Continuous Index:
Within 8" of Joint: **YES**
Remarks:

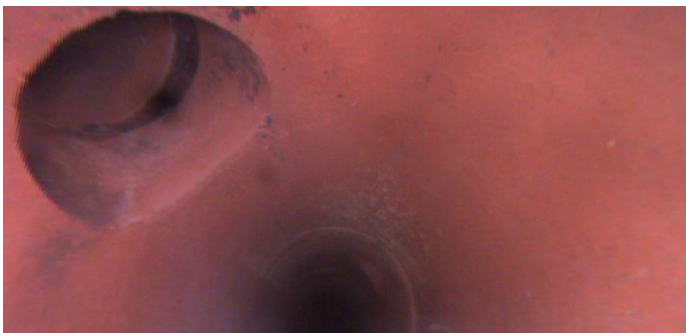
Code: **TF**
Description: **Tap Factory**

Distance (ft): **237.9**
Structural Grade: **0**
O&M Grade: **0**
Clock Start/From: **10**
Clock To:
1st Value: **4.000**
2nd Value:
Value Percent:
Continuous Index:
Within 8" of Joint:
Remarks:

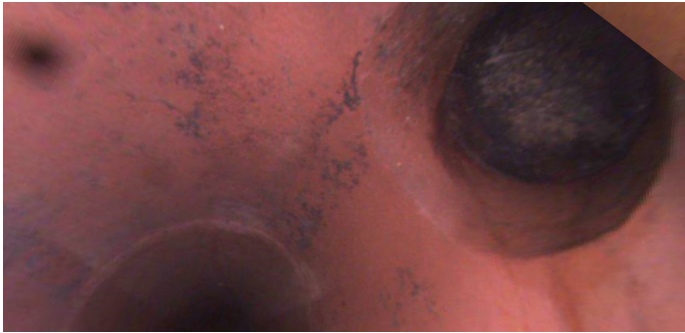
Code: **TFC**
Description: **Tap Factory Capped**

Distance (ft): **240.3**
Structural Grade: **0**
O&M Grade: **0**
Clock Start/From: **2**
Clock To:
1st Value: **4.000**
2nd Value:
Value Percent:
Continuous Index:
Within 8" of Joint:
Remarks:

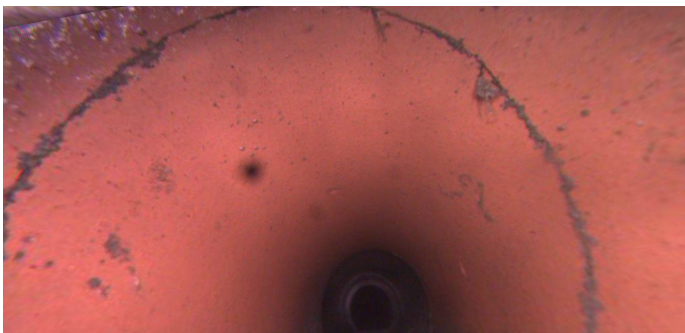
Code: **FS**
Description: **Fracture Spiral**

Distance (ft): **293.3**
Structural Grade: **3**
O&M Grade: **0**
Clock Start/From: **7**
Clock To: **5**
1st Value:
2nd Value:
Value Percent:
Continuous Index:
Within 8" of Joint:
Remarks:

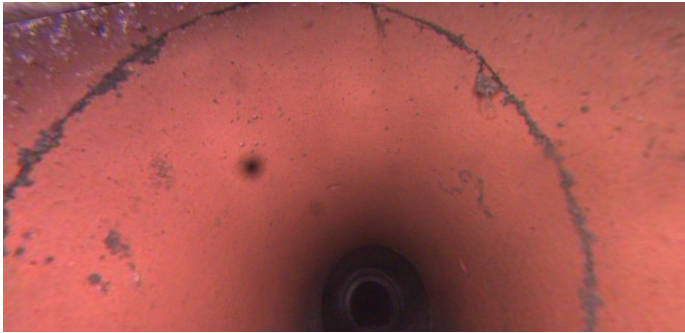
Code: **RFB**
Description: **Roots Fine Barrel**

Distance (ft): **293.3**
Structural Grade: **0**
O&M Grade: **2**
Clock Start/From: **12**
Clock To: **1**
1st Value:
2nd Value:
Value Percent:
Continuous Index:
Within 8" of Joint: **NO**
Remarks:

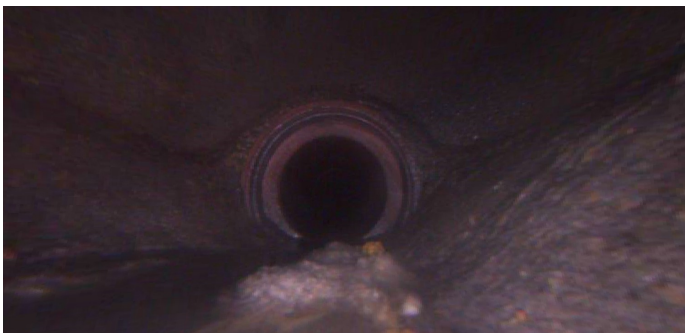
Code: **IW**
Description: **Infil Weeper**

Distance (ft): **296.3**
Structural Grade: **0**
O&M Grade: **2**
Clock Start/From: **7**
Clock To: **5**
1st Value:
2nd Value:
Value Percent:
Continuous Index: **F02**
Within 8" of Joint: **YES**
Remarks: **WANDER**

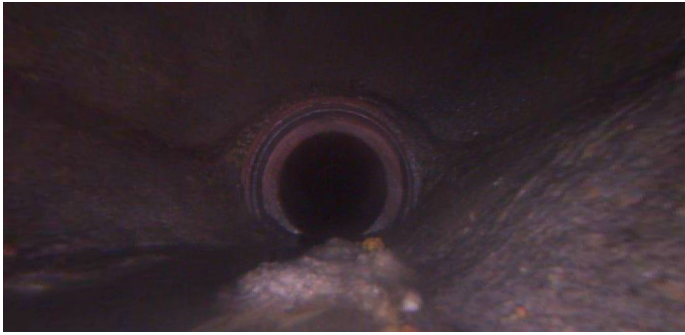
Code: **AMH**
Description: **Manhole**

Distance (ft): **296.3**
Structural Grade: **0**
O&M Grade: **0**
Clock Start/From:
Clock To:
1st Value:
2nd Value:
Value Percent:
Continuous Index:
Within 8" of Joint: **NO**
Remarks: **M-108-029**

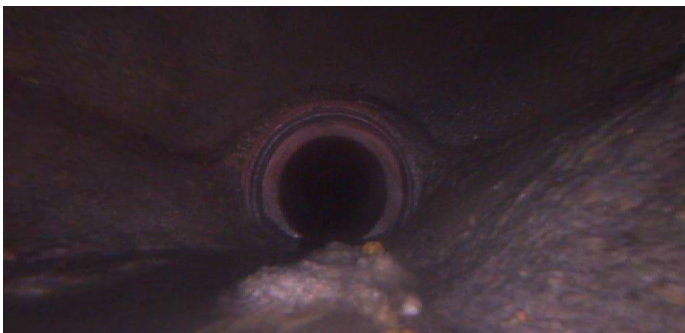
Code: **DAGS**
Description: **Deposits Attached Grease**

Distance (ft): **296.3**
Structural Grade: **0**
O&M Grade: **2**
Clock Start/From: **7**
Clock To: **5**
1st Value:
2nd Value:
Value Percent: **5.000**
Continuous Index: **F01**
Within 8" of Joint: **YES**
Remarks: **WANDER**
