Profile/Photo Observation Report

Profile/Photo Observation Report								
Date: Pipe Length (ft P.O.#: Customer:	989_1	Weather: Owner: Surveyor: Clean Date:	Hobart, M. Piela		Pre Clean: PSR:	PACP 6.0 Not Known P-108-030-029 C		
	Hobart, IN	Clean Date.			Shape:			
Street:	Off Mississippi Lane		Flow Con					
City:	Hobart, IN		Year Rene	ewed:				
Location:	Yard		Tape/Me	dia #:	989			
Purpose:	Routine Assessment		Dia/Heigh	nt:	10"			
Use:	Sanitary		Material:		VCP			
Drain Area:			Lining:					
Category:	NA							
Comment:								
Location Detail	s:		Direction	of Survey:	Upstream			
US MH:	M-108-29	DS MH:	M-108-30		Total Length Surveyed (ft):	217.4		
O&M Index:	1.57	O&M Quick:		3122	O&M Rating:	11.00		
Structural Index:	2.00	Structural Qu		2200	Structural Rating:	4.00		
Overall Index:	1.67	Overall Quicl		3124	Overall Rating:	15.00

Thursday, May 4, 2023

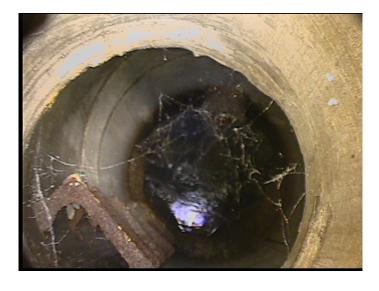
Code:	AMH
Description:	Manhole
Distance (ft):	.0
Structural Grade:	0
O&M Grade:	0
Clock Start/From:	
Clock To:	
1st Value:	
2nd Value:	
Value Percent:	
Continuous Index:	
Within 8" of Joint:	NO
Remarks:	M-108-30

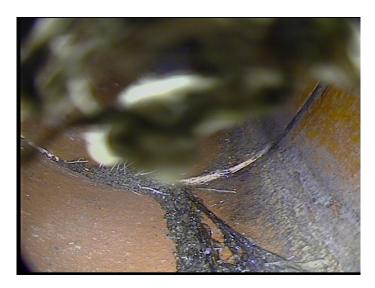
Code: RFJ

Description: Roots Fine Joint

Distance (ft): 3.0
Structural Grade: 0
O&M Grade: 1
Clock Start/From: 7
Clock To:
1st Value:

Within 8" of Joint: YES

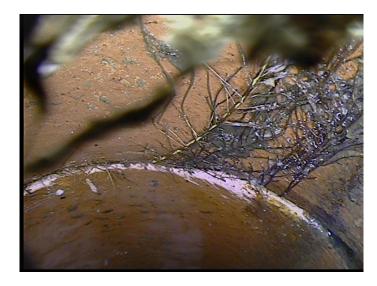
Code: RFJ

Description: Roots Fine Joint

Distance (ft): 13.1
Structural Grade: 0
O&M Grade: 1
Clock Start/From: 4

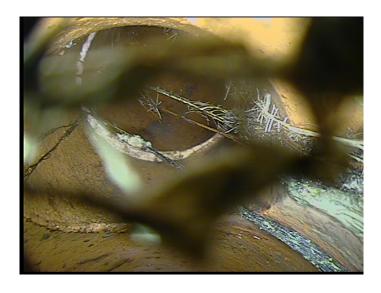
Code: **TFD**

Description: Tap Factory Defective

Distance (ft): 21.5
Structural Grade: 0
O&M Grade: 2
Clock Start/From: 3

1st Value: **4.000**

Within 8" of Joint: NO Remarks: roots

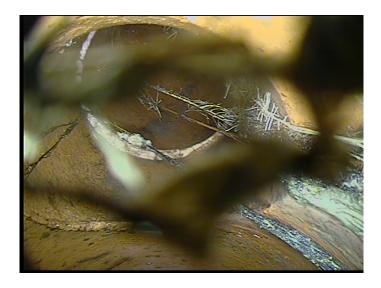
Code: RFL

Description: Roots Fine Lateral

Distance (ft): 21.5
Structural Grade: 0
O&M Grade: 1
Clock Start/From: 4

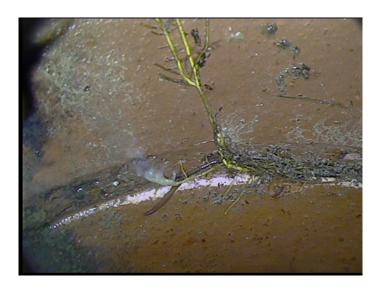
Code: RFJ

Description: Roots Fine Joint

Distance (ft): 71.8
Structural Grade: 0

O&M Grade: 1

Clock Start/From: 9

Within 8" of Joint: YES

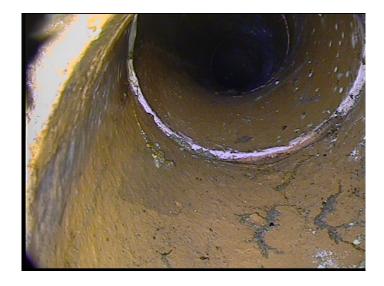
Code: TFA

Description: Tap Factory Active

Distance (ft): 83.6
Structural Grade: 0

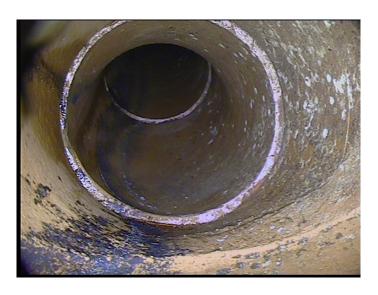
Code: **TF**

Description: Tap Factory

Distance (ft): 84.9
Structural Grade: 0

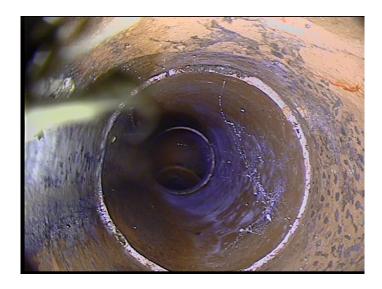
Code: TF

Description: **Tap Factory**

Distance (ft): 145.5 Structural Grade: 0 O&M Grade: 0 Clock Start/From: 3

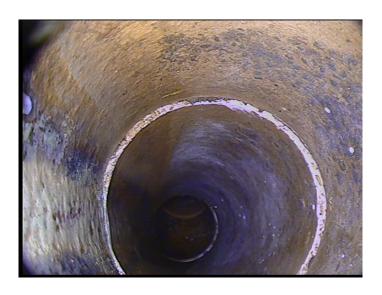
Code: TF

Description: **Tap Factory**

Distance (ft): 147.7 Structural Grade: 0 O&M Grade: 0 Clock Start/From: 9

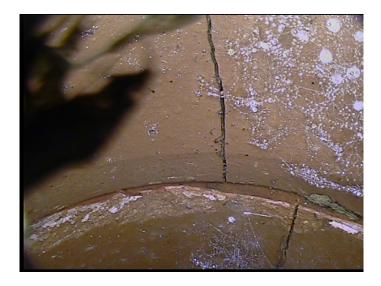
Code: CL

Description: Crack Longitudinal

Distance (ft): 173.2
Structural Grade: 2
O&M Grade: 0
Clock Start/From: 12

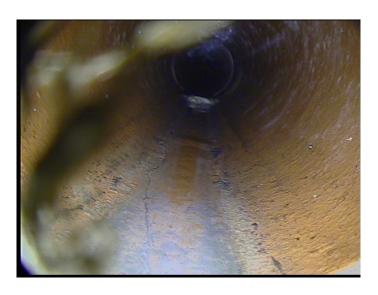
Code: CL

Description: Crack Longitudinal

Distance (ft): 173.2
Structural Grade: 2
O&M Grade: 0
Clock Start/From: 6

Within 8" of Joint: YES

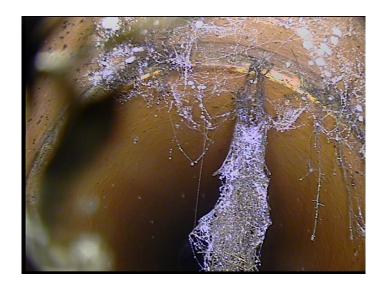
Code: RMJ

Description: Roots Medium Joint

Distance (ft): 194.0
Structural Grade: 0
O&M Grade: 3
Clock Start/From: 7
Clock To: 5

Value Percent: 5.000

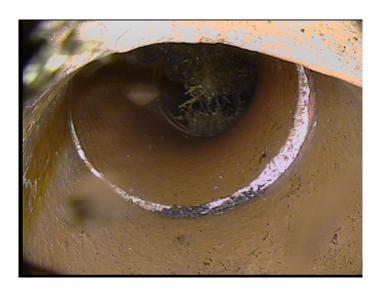
Code: **TFD**

Description: Tap Factory Defective

Distance (ft): 214.4
Structural Grade: 0
O&M Grade: 2
Clock Start/From: 3

Within 8" of Joint: NO Remarks: roots

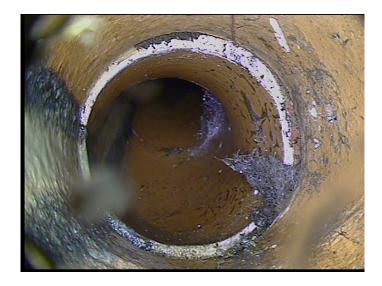
Code: **TF**

Description: Tap Factory

Distance (ft): 216.4
Structural Grade: 0
O&M Grade: 0
Clock Start/From: 10

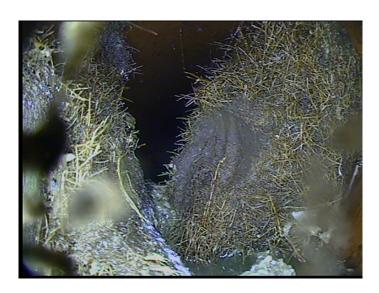
Code: MSA

Description: Abandoned Survey

Distance (ft): 217.4
Structural Grade: 0

Remarks: large roots
