Profile/Photo Observation Report

Date:	03/24/2018	Weather:		Coding:	PACP 6.0
Pipe Length (ft):	116.8	Owner:	NA	Pre Clean:	No Pre-Cleaning
P.O.#:		Surveyor:	Justin Gonzales	PSR:	P-108-029-034
Customer:		Clean Date:	01/01/1900	Shape:	C

Street:	MISSISSIPPI PL	Flow Control:	Not Controlled
City:	Hobart, IN	Year Renewed:	
Location:	Light Highway	Tape/Media #:	
Purpose:	Routine Assessment	Dia/Height:	12"
Use:	Sanitary	Material:	VCP
Drain Area:	NA	Lining:	
Category:	NA		
Comment:	Flow direction wrong		
Location Details:		Direction of Survey:	Upstream
US MH:	M-108-034	DS MH:	M-108-029
		Total Length Surveyed (ft):	112.4

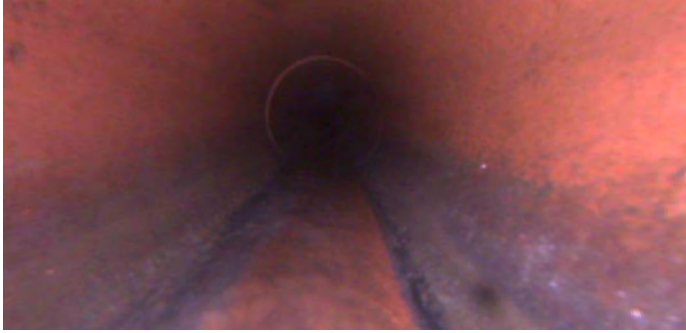
Code: **AMH**
Description: **Manhole**

Distance (ft): **.0**
Structural Grade: **0**
O&M Grade: **0**
Clock Start/From:
Clock To:
1st Value:
2nd Value:
Value Percent:
Continuous Index:
Within 8" of Joint: **NO**
Remarks: **M-108-029**

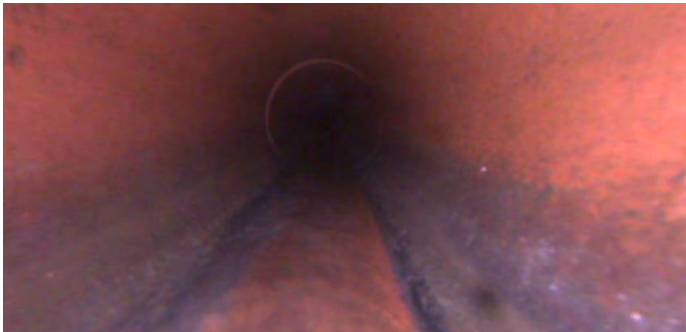
Code: **MWL**
Description: **Water Level**

Distance (ft): **.0**
Structural Grade: **0**
O&M Grade: **0**
Clock Start/From:
Clock To:
1st Value:
2nd Value:
Value Percent: **5.000**
Continuous Index:
Within 8" of Joint: **NO**
Remarks:

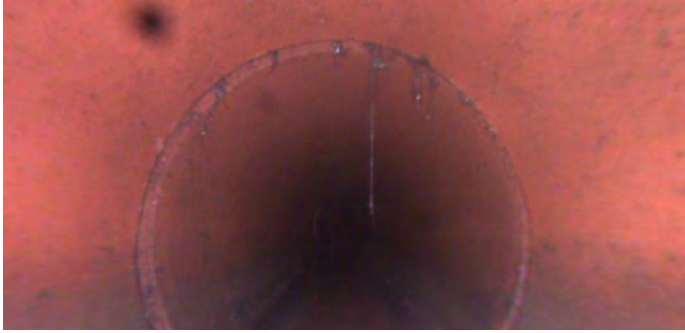
Code: **RFJ**
Description: **Roots Fine Joint**

Distance (ft): **6.5**
Structural Grade: **0**
O&M Grade: **1**
Clock Start/From: **10**
Clock To: **2**
1st Value:
2nd Value:
Value Percent:
Continuous Index:
Within 8" of Joint: **YES**
Remarks:

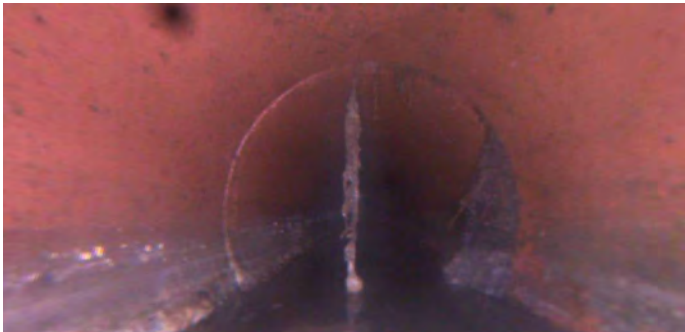
Code: **RMJ**
Description: **Roots Medium Joint**

Distance (ft): **45.6**
Structural Grade: **0**
O&M Grade: **3**
Clock Start/From: **12**
Clock To: **5**
1st Value:
2nd Value:
Value Percent: **5.000**
Continuous Index:
Within 8" of Joint: **YES**
Remarks:

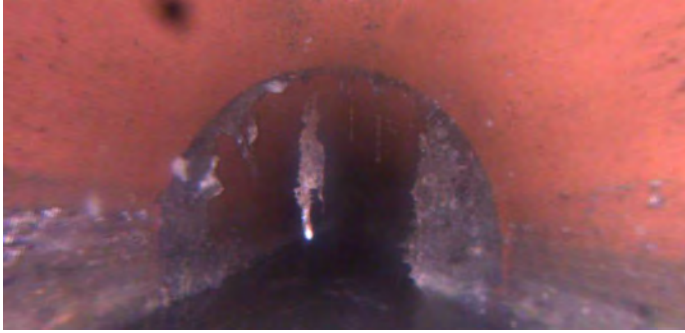
Code: **RMJ**
Description: **Roots Medium Joint**

Distance (ft): **49.7**
Structural Grade: **0**
O&M Grade: **3**
Clock Start/From: **7**
Clock To: **5**
1st Value:
2nd Value:
Value Percent: **15.000**
Continuous Index:
Within 8" of Joint: **YES**
Remarks:

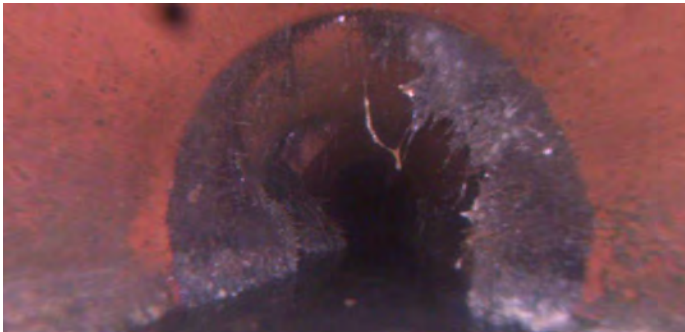
Code: **RMJ**
Description: **Roots Medium Joint**

Distance (ft): **53.7**
Structural Grade: **0**
O&M Grade: **3**
Clock Start/From: **7**
Clock To: **5**
1st Value:
2nd Value:
Value Percent: **35.000**
Continuous Index:
Within 8" of Joint: **YES**
Remarks:

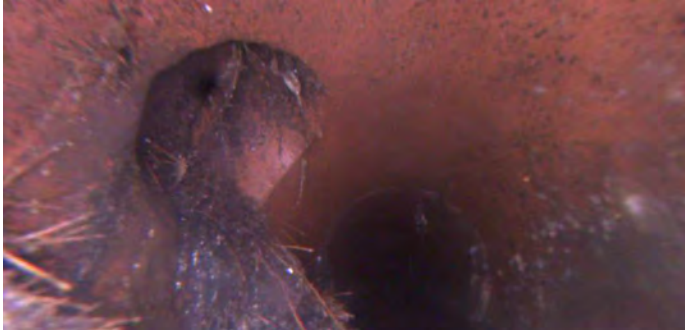
Code: **RML**
Description: **Roots Medium Lateral**

Distance (ft): **54.6**
Structural Grade: **0**
O&M Grade: **3**
Clock Start/From: **6**
Clock To: **11**
1st Value:
2nd Value:
Value Percent: **20.000**
Continuous Index:
Within 8" of Joint: **NO**
Remarks:

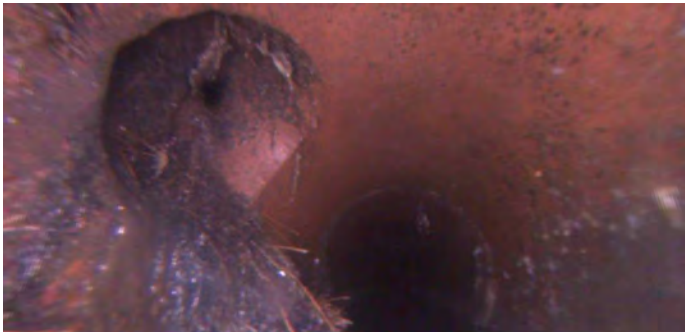
Code: **TFD**
Description: **Tap Factory Defective**

Distance (ft): **54.6**
Structural Grade: **0**
O&M Grade: **2**
Clock Start/From: **10**
Clock To:
1st Value: **4.000**
2nd Value:
Value Percent:
Continuous Index:
Within 8" of Joint:
Remarks: **ROOTS COMING FROM MOUTH OF TAP**

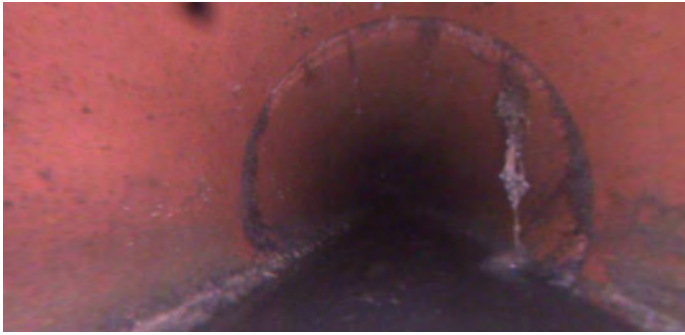
Code: **RFJ**
Description: **Roots Fine Joint**

Distance (ft): **59.5**
Structural Grade: **0**
O&M Grade: **1**
Clock Start/From: **7**
Clock To: **5**
1st Value:
2nd Value:
Value Percent:
Continuous Index: **S01**
Within 8" of Joint: **YES**
Remarks: **WANDER**

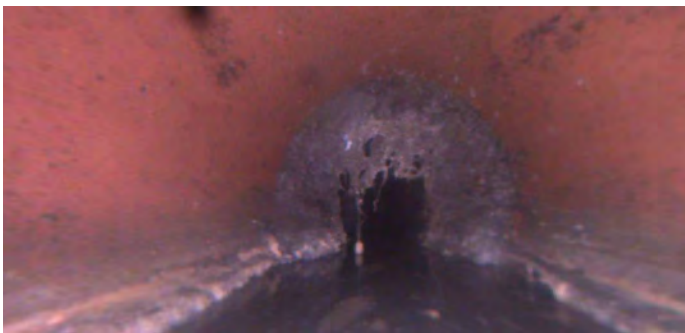
Code: **RMJ**
Description: **Roots Medium Joint**

Distance (ft): **67.0**
Structural Grade: **0**
O&M Grade: **3**
Clock Start/From: **7**
Clock To: **5**
1st Value:
2nd Value:
Value Percent: **35.000**
Continuous Index:
Within 8" of Joint: **YES**
Remarks:

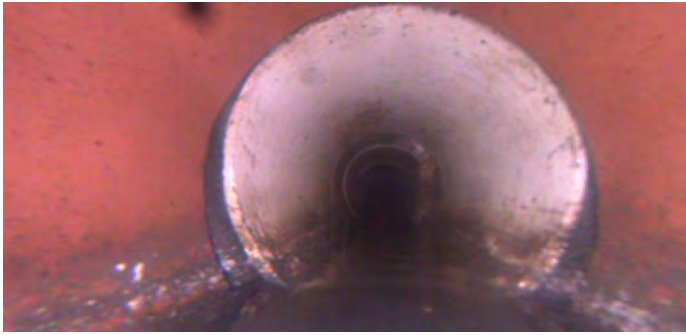
Code: **RPR**
Description: **Repair Point Pipe Replaced**

Distance (ft): **70.2**
Structural Grade: **0**
O&M Grade: **0**
Clock Start/From:
Clock To:
1st Value:
2nd Value:
Value Percent:
Continuous Index:
Within 8" of Joint: **NO**
Remarks: **PVC**

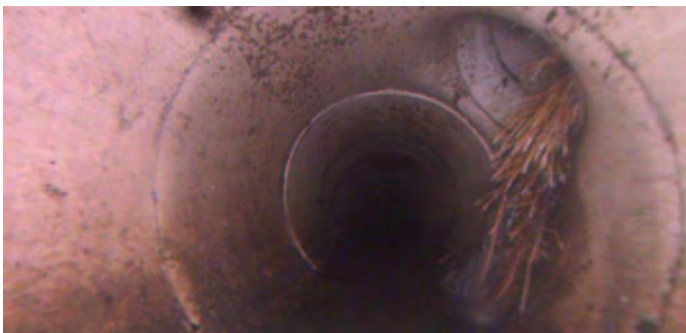
Code: **RML**
Description: **Roots Medium Lateral**

Distance (ft): **72.2**
Structural Grade: **0**
O&M Grade: **3**
Clock Start/From: **2**
Clock To:
1st Value:
2nd Value:
Value Percent: **5.000**
Continuous Index:
Within 8" of Joint: **NO**
Remarks:

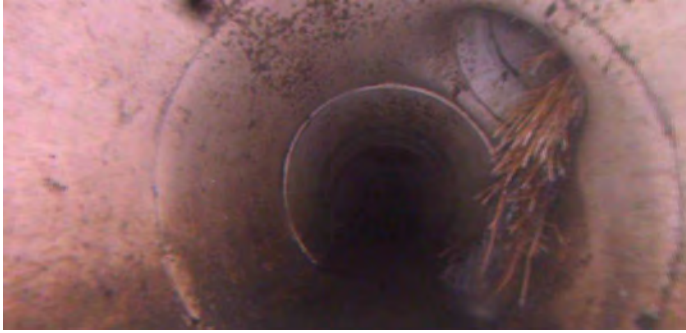
Code: **TFD**
Description: **Tap Factory Defective**

Distance (ft): **72.2**
Structural Grade: **0**
O&M Grade: **2**
Clock Start/From: **2**
Clock To:
1st Value: **4.000**
2nd Value:
Value Percent:
Continuous Index:
Within 8" of Joint: **NO**
Remarks: **ROOTS COMING FROM TAP**

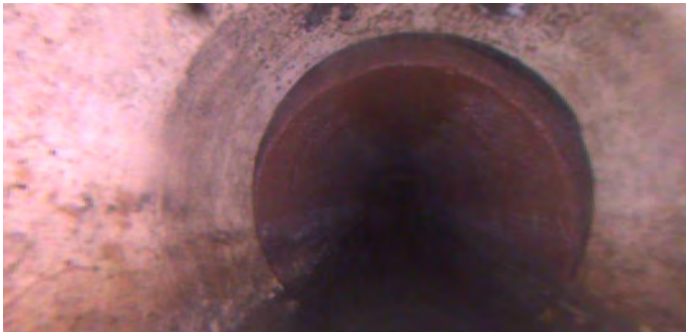
Code: **RPR**
Description: **Repair Point Pipe Replaced**

Distance (ft): **73.7**
Structural Grade: **0**
O&M Grade: **0**
Clock Start/From:
Clock To:
1st Value:
2nd Value:
Value Percent:
Continuous Index:
Within 8" of Joint: **NO**
Remarks: **PVC END**

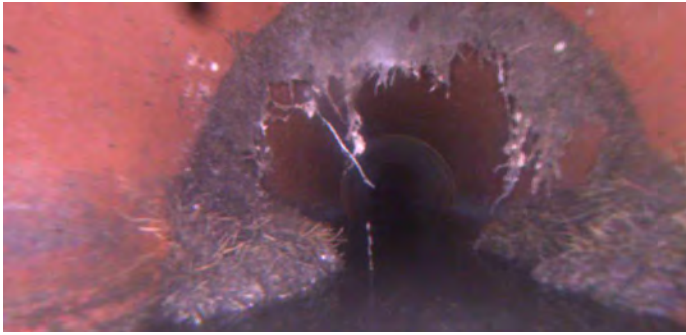
Code: **RMJ**
Description: **Roots Medium Joint**

Distance (ft): **77.4**
Structural Grade: **0**
O&M Grade: **3**
Clock Start/From: **7**
Clock To: **5**
1st Value:
2nd Value:
Value Percent: **35.000**
Continuous Index:
Within 8" of Joint: **YES**
Remarks:

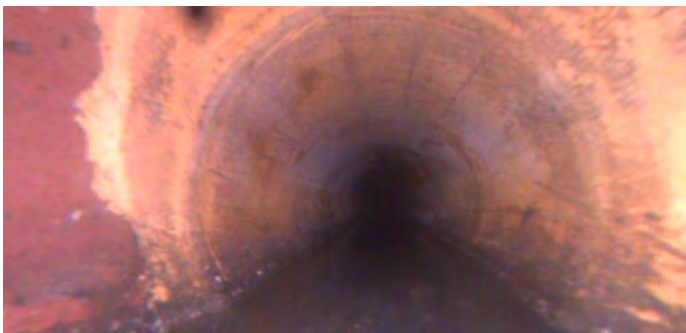
Code: **RPR**
Description: **Repair Point Pipe Replaced**

Distance (ft): **79.5**
Structural Grade: **0**
O&M Grade: **0**
Clock Start/From:
Clock To:
1st Value:
2nd Value:
Value Percent:
Continuous Index:
Within 8" of Joint: **NO**
Remarks: **CIP LINER**

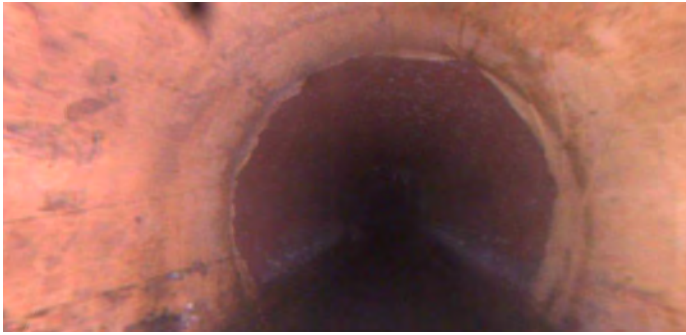
Code: **RPR**
Description: **Repair Point Pipe Replaced**

Distance (ft): **82.8**
Structural Grade: **0**
O&M Grade: **0**
Clock Start/From:
Clock To:
1st Value:
2nd Value:
Value Percent:
Continuous Index:
Within 8" of Joint: **NO**
Remarks: **CIP LINER END**

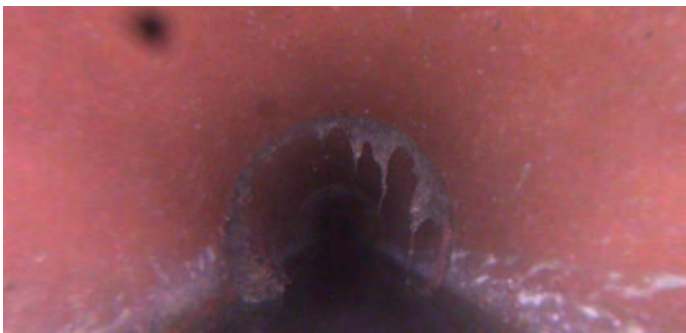
Code: **RMJ**
Description: **Roots Medium Joint**

Distance (ft): **84.6**
Structural Grade: **0**
O&M Grade: **3**
Clock Start/From: **8**
Clock To: **4**
1st Value:
2nd Value:
Value Percent: **10.000**
Continuous Index:
Within 8" of Joint: **YES**
Remarks:

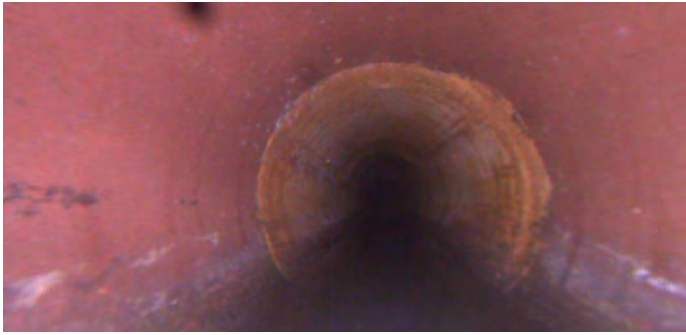
Code: **RPR**
Description: **Repair Point Pipe Replaced**

Distance (ft): **86.8**
Structural Grade: **0**
O&M Grade: **0**
Clock Start/From:
Clock To:
1st Value:
2nd Value:
Value Percent:
Continuous Index:
Within 8" of Joint: **NO**
Remarks: **CIP LINER**

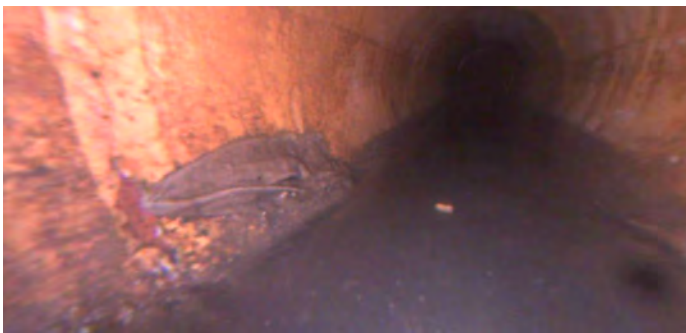
Code: **DAR**
Description: **Deposits Attached Ragging**

Distance (ft): **91.6**
Structural Grade: **0**
O&M Grade: **2**
Clock Start/From: **8**
Clock To:
1st Value:
2nd Value:
Value Percent: **5.000**
Continuous Index:
Within 8" of Joint: **NO**
Remarks:

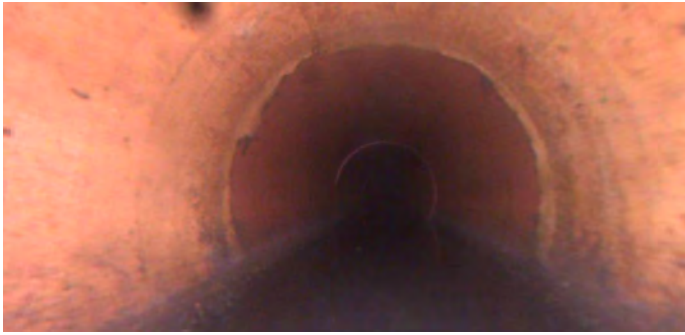
Code: **RPR**
Description: **Repair Point Pipe Replaced**

Distance (ft): **95.0**
Structural Grade: **0**
O&M Grade: **0**
Clock Start/From:
Clock To:
1st Value:
2nd Value:
Value Percent:
Continuous Index:
Within 8" of Joint: **NO**
Remarks: **CIP LINER END**

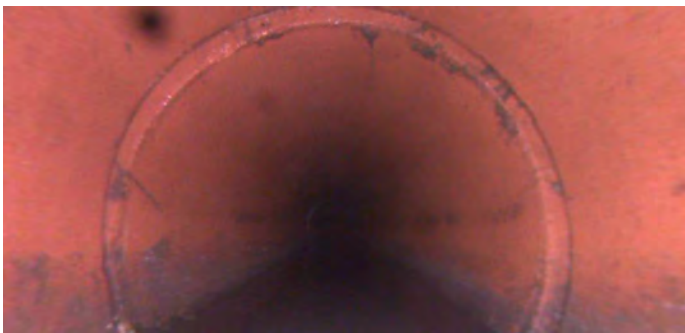
Code: **RFJ**
Description: **Roots Fine Joint**

Distance (ft): **97.1**
Structural Grade: **0**
O&M Grade: **1**
Clock Start/From: **9**
Clock To:
1st Value:
2nd Value:
Value Percent:
Continuous Index:
Within 8" of Joint: **YES**
Remarks:

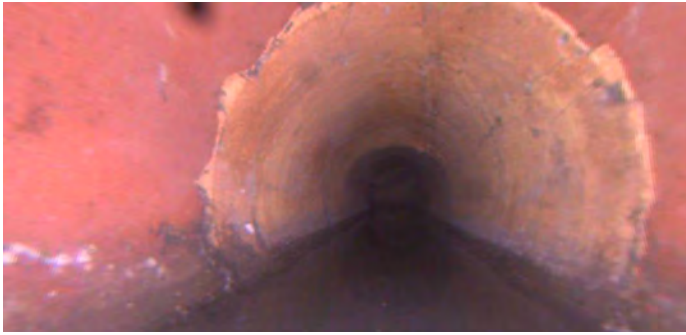
Code: **RPR**
Description: **Repair Point Pipe Replaced**

Distance (ft): **107.1**
Structural Grade: **0**
O&M Grade: **0**
Clock Start/From:
Clock To:
1st Value:
2nd Value:
Value Percent:
Continuous Index:
Within 8" of Joint: **NO**
Remarks: **CIP LINER**

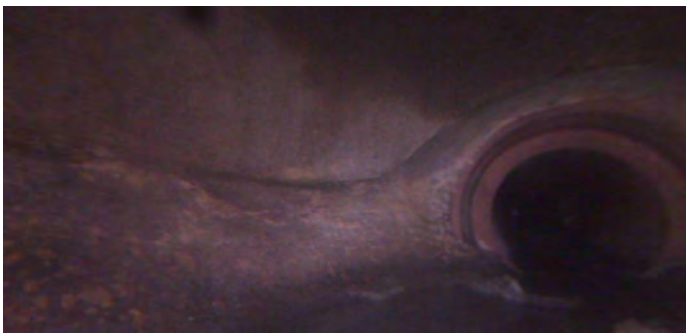
Code: **RPR**
Description: **Repair Point Pipe Replaced**

Distance (ft): **112.4**
Structural Grade: **0**
O&M Grade: **0**
Clock Start/From:
Clock To:
1st Value:
2nd Value:
Value Percent:
Continuous Index:
Within 8" of Joint: **NO**
Remarks: **CIP LINER END**

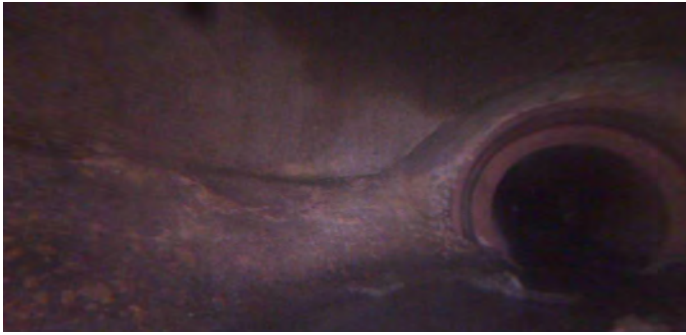
Code: **RFJ**
Description: **Roots Fine Joint**

Distance (ft): **112.4**
Structural Grade: **0**
O&M Grade: **1**
Clock Start/From: **7**
Clock To: **5**
1st Value:
2nd Value:
Value Percent:
Continuous Index: **F01**
Within 8" of Joint: **YES**
Remarks: **WANDER**

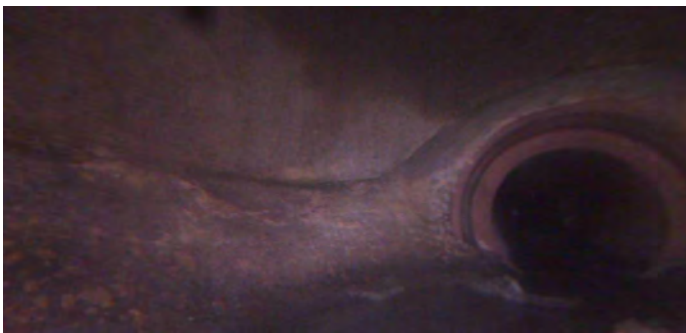
Code: **AMH**
Description: **Manhole**

Distance (ft): **112.4**
Structural Grade: **0**
O&M Grade: **0**
Clock Start/From:
Clock To:
1st Value:
2nd Value:
Value Percent:
Continuous Index:
Within 8" of Joint: **NO**
Remarks: **M-108-034**
