Profile/Photo Observation Report

Date:	03/24/2018	Weather:		Coding:	PACP 6.0
Pipe Length (ft):	116.8	Owner:	NA	Pre Clean:	No Pre-Cleaning
P.O.#:		Surveyor:	Justin Gonzales	PSR:	P-108-029-034
Customer:		Clean Date:	01/01/1900	Shape:	C

Street:	FOXCROFT STREET	Flow Control:	Not Controlled
City:	Hobart, IN	Year Renewed:	
Location:	Light Highway	Tape/Media #:	
Purpose:	Routine Assessment	Dia/Height:	12"
Use:	Sanitary	Material:	VCP
Drain Area:	NA	Lining:	
Category:	NA		
Comment:	Flow direction wrong		
Location Details:		Direction of Survey:	Upstream
US MH:	M-108-034	DS MH:	M-108-029
		Total Length Surveyed (ft):	112.4

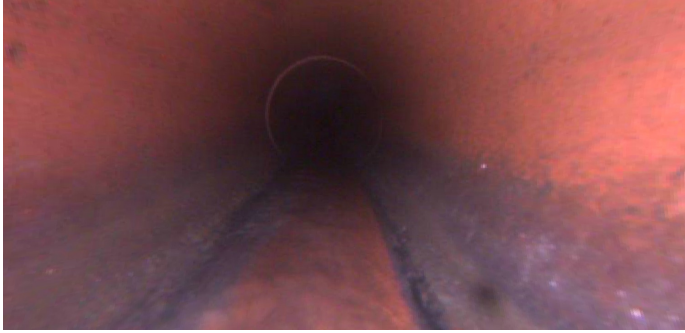
Code: **AMH**
Description: **Manhole**

Distance (ft): **.0**
Structural Grade: **0**
O&M Grade: **0**
Clock Start/From:
Clock To:
1st Value:
2nd Value:
Value Percent:
Continuous Index:
Within 8" of Joint: **NO**
Remarks: **M-108-029**

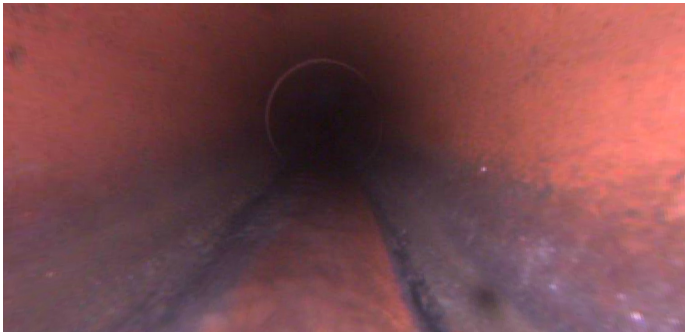
Code: **MWL**
Description: **Water Level**

Distance (ft): **.0**
Structural Grade: **0**
O&M Grade: **0**
Clock Start/From:
Clock To:
1st Value:
2nd Value:
Value Percent: **5.000**
Continuous Index:
Within 8" of Joint: **NO**
Remarks:

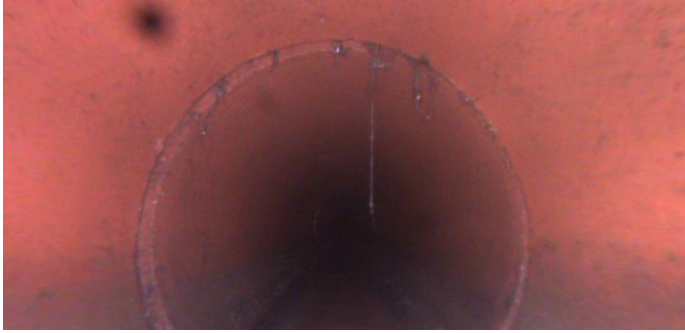
Code: **RFJ**
Description: **Roots Fine Joint**

Distance (ft): **6.5**
Structural Grade: **0**
O&M Grade: **1**
Clock Start/From: **10**
Clock To: **2**
1st Value:
2nd Value:
Value Percent:
Continuous Index:
Within 8" of Joint: **YES**
Remarks:

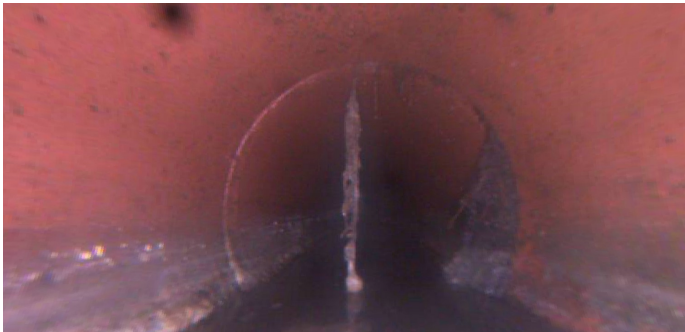
Code: **RMJ**
Description: **Roots Medium Joint**

Distance (ft): **45.6**
Structural Grade: **0**
O&M Grade: **3**
Clock Start/From: **12**
Clock To: **5**
1st Value:
2nd Value:
Value Percent: **5.000**
Continuous Index:
Within 8" of Joint: **YES**
Remarks:

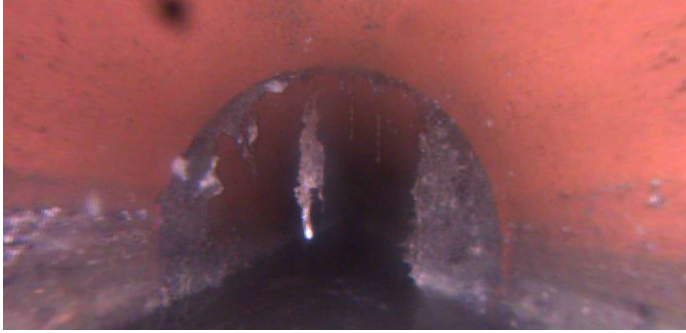
Code: **RMJ**
Description: **Roots Medium Joint**

Distance (ft): **49.7**
Structural Grade: **0**
O&M Grade: **3**
Clock Start/From: **7**
Clock To: **5**
1st Value:
2nd Value:
Value Percent: **15.000**
Continuous Index:
Within 8" of Joint: **YES**
Remarks:

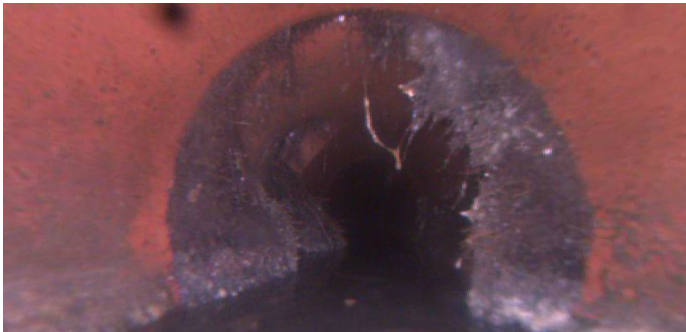
Code: **RMJ**
Description: **Roots Medium Joint**

Distance (ft): **53.7**
Structural Grade: **0**
O&M Grade: **3**
Clock Start/From: **7**
Clock To: **5**
1st Value:
2nd Value:
Value Percent: **35.000**
Continuous Index:
Within 8" of Joint: **YES**
Remarks:

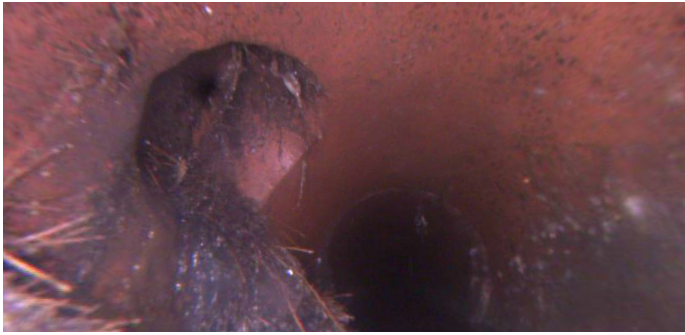
Code: **RML**
Description: **Roots Medium Lateral**

Distance (ft): **54.6**
Structural Grade: **0**
O&M Grade: **3**
Clock Start/From: **6**
Clock To: **11**
1st Value:
2nd Value:
Value Percent: **20.000**
Continuous Index:
Within 8" of Joint: **NO**
Remarks:

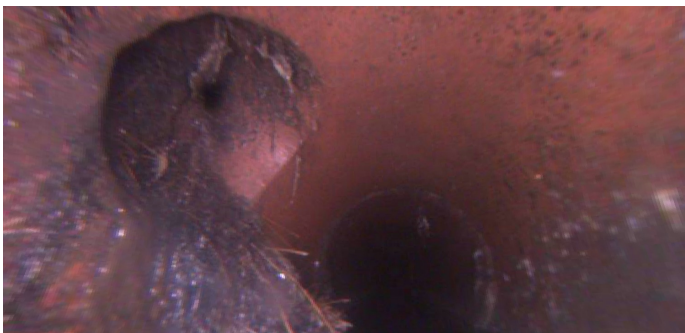
Code: **TFD**
Description: **Tap Factory Defective**

Distance (ft): **54.6**
Structural Grade: **0**
O&M Grade: **2**
Clock Start/From: **10**
Clock To:
1st Value: **4.000**
2nd Value:
Value Percent:
Continuous Index:
Within 8" of Joint:
Remarks: **ROOTS COMING FROM MOUTH OF TAP**

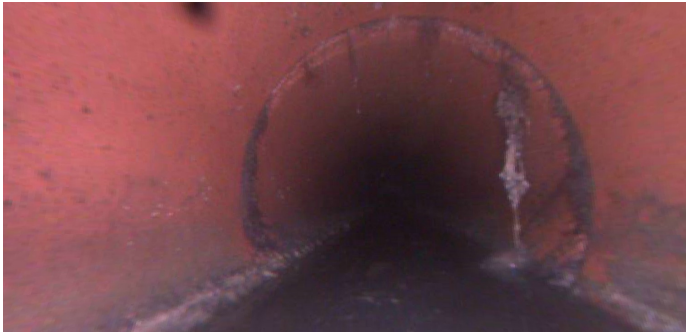
Code: **RFJ**
Description: **Roots Fine Joint**

Distance (ft): **59.5**
Structural Grade: **0**
O&M Grade: **1**
Clock Start/From: **7**
Clock To: **5**
1st Value:
2nd Value:
Value Percent:
Continuous Index: **S01**
Within 8" of Joint: **YES**
Remarks: **WANDER**

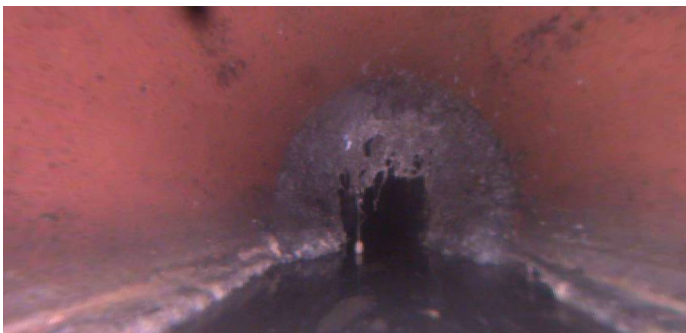
Code: **RMJ**
Description: **Roots Medium Joint**

Distance (ft): **67.0**
Structural Grade: **0**
O&M Grade: **3**
Clock Start/From: **7**
Clock To: **5**
1st Value:
2nd Value:
Value Percent: **35.000**
Continuous Index:
Within 8" of Joint: **YES**
Remarks:

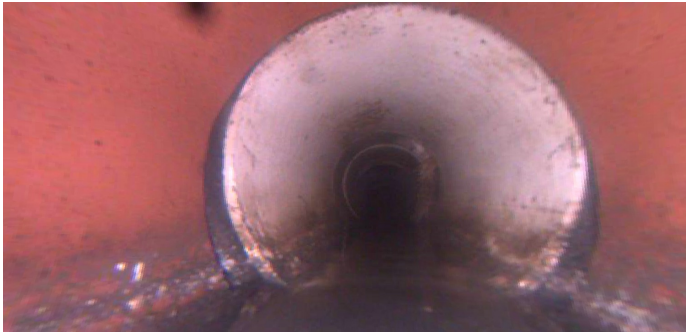
Code: **RPR**
Description: **Repair Point Pipe Replaced**

Distance (ft): **70.2**
Structural Grade: **0**
O&M Grade: **0**
Clock Start/From:
Clock To:
1st Value:
2nd Value:
Value Percent:
Continuous Index:
Within 8" of Joint: **NO**
Remarks: **PVC**

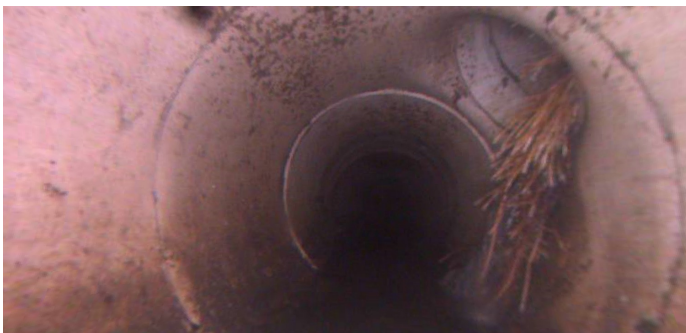
Code: **RML**
Description: **Roots Medium Lateral**

Distance (ft): **72.2**
Structural Grade: **0**
O&M Grade: **3**
Clock Start/From: **2**
Clock To:
1st Value:
2nd Value:
Value Percent: **5.000**
Continuous Index:
Within 8" of Joint: **NO**
Remarks:

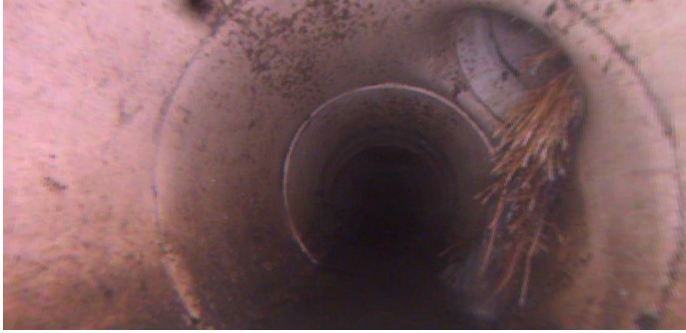
Code: **TFD**
Description: **Tap Factory Defective**

Distance (ft): **72.2**
Structural Grade: **0**
O&M Grade: **2**
Clock Start/From: **2**
Clock To:
1st Value: **4.000**
2nd Value:
Value Percent:
Continuous Index:
Within 8" of Joint: **NO**
Remarks: **ROOTS COMING FROM TAP**

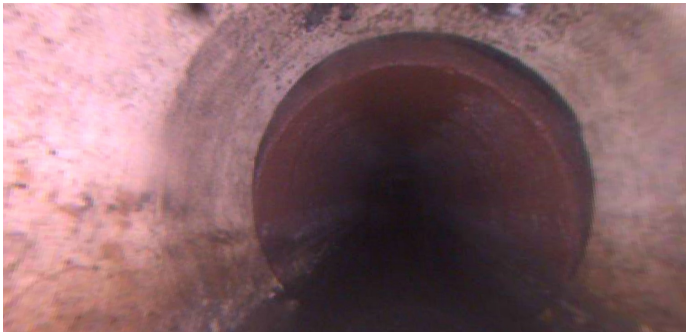
Code: **RPR**
Description: **Repair Point Pipe Replaced**

Distance (ft): **73.7**
Structural Grade: **0**
O&M Grade: **0**
Clock Start/From:
Clock To:
1st Value:
2nd Value:
Value Percent:
Continuous Index:
Within 8" of Joint: **NO**
Remarks: **PVC END**

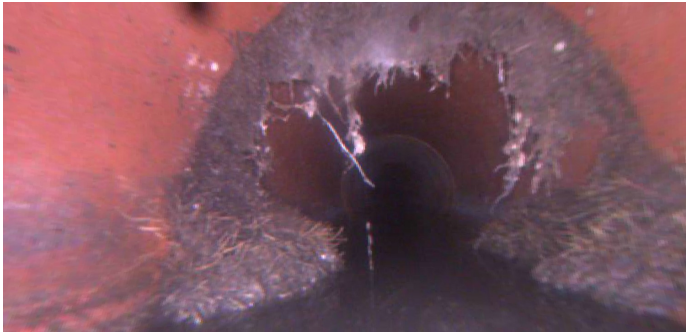
Code: **RMJ**
Description: **Roots Medium Joint**

Distance (ft): **77.4**
Structural Grade: **0**
O&M Grade: **3**
Clock Start/From: **7**
Clock To: **5**
1st Value:
2nd Value:
Value Percent: **35.000**
Continuous Index:
Within 8" of Joint: **YES**
Remarks:

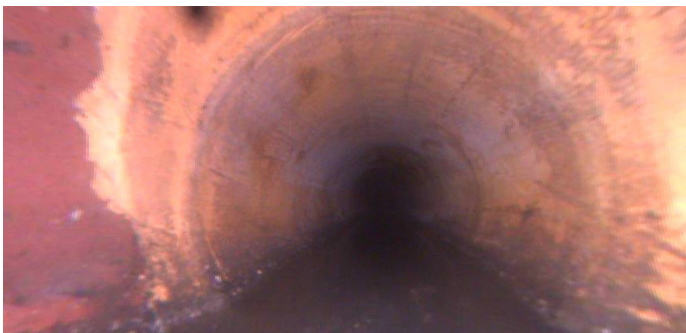
Code: **RPR**
Description: **Repair Point Pipe Replaced**

Distance (ft): **79.5**
Structural Grade: **0**
O&M Grade: **0**
Clock Start/From:
Clock To:
1st Value:
2nd Value:
Value Percent:
Continuous Index:
Within 8" of Joint: **NO**
Remarks: **CIP LINER**

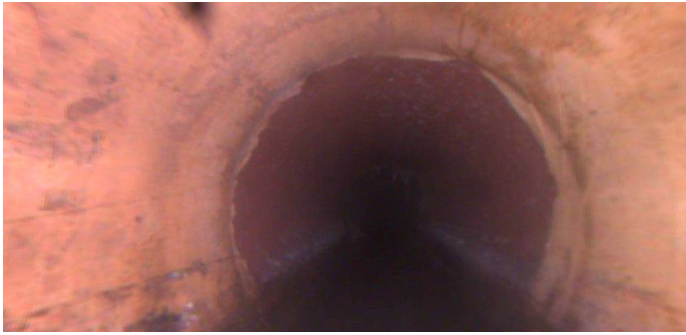
Code: **RPR**
Description: **Repair Point Pipe Replaced**

Distance (ft): **82.8**
Structural Grade: **0**
O&M Grade: **0**
Clock Start/From:
Clock To:
1st Value:
2nd Value:
Value Percent:
Continuous Index:
Within 8" of Joint: **NO**
Remarks: **CIP LINER END**

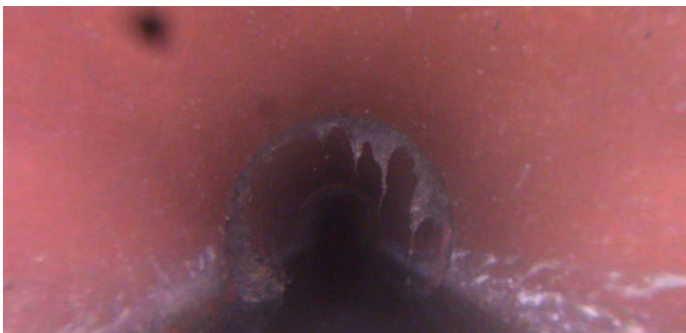
Code: **RMJ**
Description: **Roots Medium Joint**

Distance (ft): **84.6**
Structural Grade: **0**
O&M Grade: **3**
Clock Start/From: **8**
Clock To: **4**
1st Value:
2nd Value:
Value Percent: **10.000**
Continuous Index:
Within 8" of Joint: **YES**
Remarks:

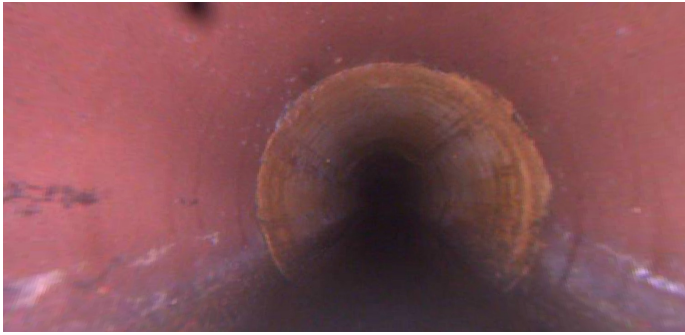
Code: **RPR**
Description: **Repair Point Pipe Replaced**

Distance (ft): **86.8**
Structural Grade: **0**
O&M Grade: **0**
Clock Start/From:
Clock To:
1st Value:
2nd Value:
Value Percent:
Continuous Index:
Within 8" of Joint: **NO**
Remarks: **CIP LINER**

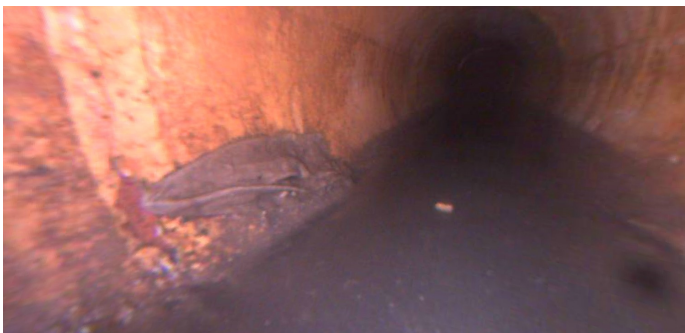
Code: **DAR**
Description: **Deposits Attached Ragging**

Distance (ft): **91.6**
Structural Grade: **0**
O&M Grade: **2**
Clock Start/From: **8**
Clock To:
1st Value:
2nd Value:
Value Percent: **5.000**
Continuous Index:
Within 8" of Joint: **NO**
Remarks:

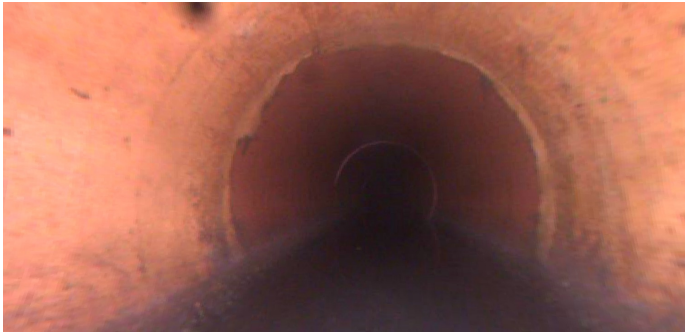
Code: **RPR**
Description: **Repair Point Pipe Replaced**

Distance (ft): **95.0**
Structural Grade: **0**
O&M Grade: **0**
Clock Start/From:
Clock To:
1st Value:
2nd Value:
Value Percent:
Continuous Index:
Within 8" of Joint: **NO**
Remarks: **CIP LINER END**

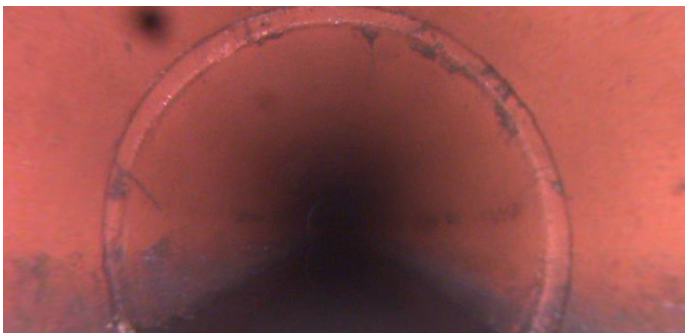
Code: **RFJ**
Description: **Roots Fine Joint**

Distance (ft): **97.1**
Structural Grade: **0**
O&M Grade: **1**
Clock Start/From: **9**
Clock To:
1st Value:
2nd Value:
Value Percent:
Continuous Index:
Within 8" of Joint: **YES**
Remarks:

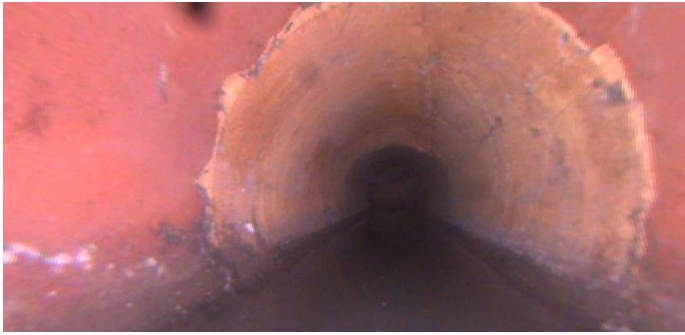
Code: **RPR**
Description: **Repair Point Pipe Replaced**

Distance (ft): **107.1**
Structural Grade: **0**
O&M Grade: **0**
Clock Start/From:
Clock To:
1st Value:
2nd Value:
Value Percent:
Continuous Index:
Within 8" of Joint: **NO**
Remarks: **CIP LINER**

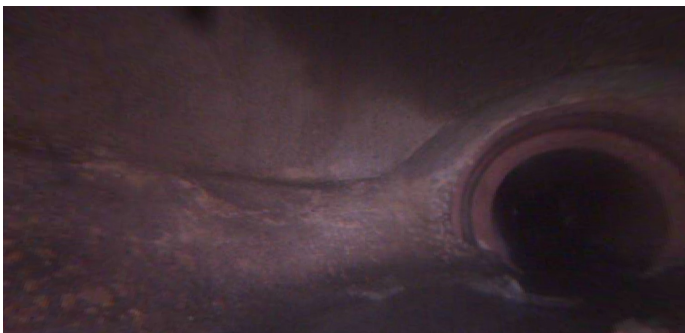
Code: **RPR**
Description: **Repair Point Pipe Replaced**

Distance (ft): **112.4**
Structural Grade: **0**
O&M Grade: **0**
Clock Start/From:
Clock To:
1st Value:
2nd Value:
Value Percent:
Continuous Index:
Within 8" of Joint: **NO**
Remarks: **CIP LINER END**

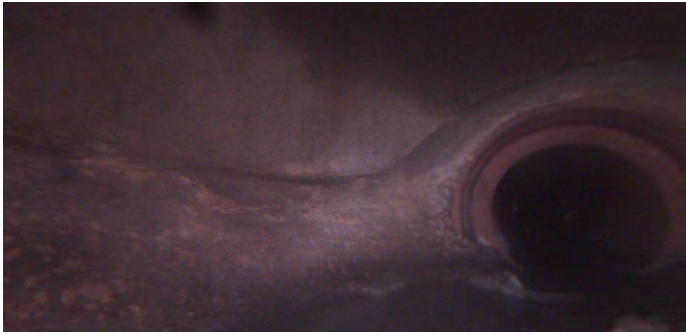
Code: **RFJ**
Description: **Roots Fine Joint**

Distance (ft): **112.4**
Structural Grade: **0**
O&M Grade: **1**
Clock Start/From: **7**
Clock To: **5**
1st Value:
2nd Value:
Value Percent:
Continuous Index: **F01**
Within 8" of Joint: **YES**
Remarks: **WANDER**

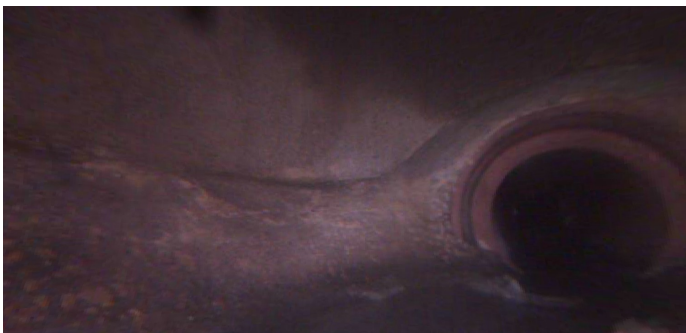
Code: **AMH**
Description: **Manhole**

Distance (ft): **112.4**
Structural Grade: **0**
O&M Grade: **0**
Clock Start/From:
Clock To:
1st Value:
2nd Value:
Value Percent:
Continuous Index:
Within 8" of Joint: **NO**
Remarks: **M-108-034**
