Profile/Photo Observation Report

Date:	03/24/2018	Weather:		Coding:	PACP 6.0
Pipe Length (ft):	67.9	Owner:	NA	Pre Clean:	No Pre-Cleaning
P.O.#:		Surveyor:	Byrd Fitzgerald	PSR:	P-108-034-035
Customer:		Clean Date:	01/01/1900	Shape:	C

Street:	MISSISSIPPI PL	Flow Control:	Not Controlled
City:	Hobart, IN	Year Renewed:	
Location:	Light Highway	Tape/Media #:	
Purpose:	Routine Assessment	Dia/Height:	12"
Use:	Sanitary	Material:	VCP
Drain Area:	NA	Lining:	
Category:	NA		
Comment:			
Location Details:		Direction of Survey:	Downstream
US MH:	M-108-035	DS MH:	M-108-034
		Total Length Surveyed (ft):	67.6

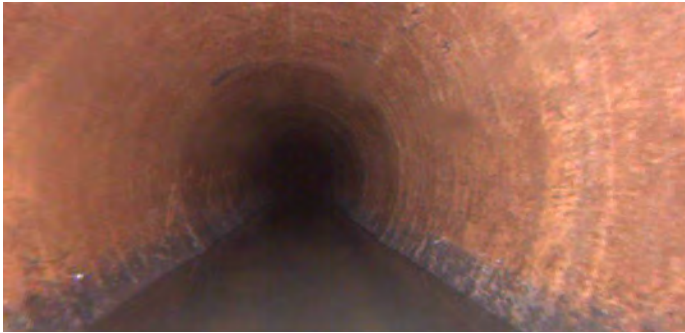
Code:	MWL
Description:	Water Level

Distance (ft):	.0
Structural Grade:	0
O&M Grade:	0
Clock Start/From:	
Clock To:	
1st Value:	
2nd Value:	
Value Percent:	5.000
Continuous Index:	
Within 8" of Joint:	NO
Remarks:

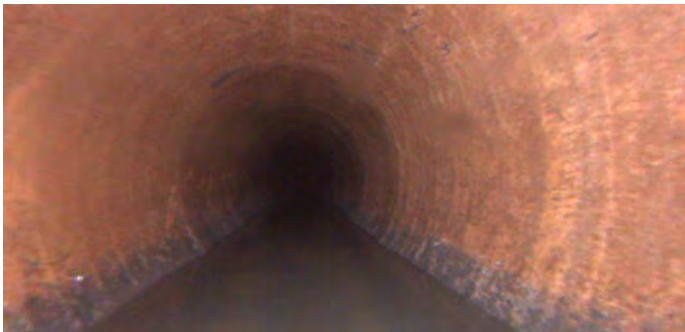
Code:	RPL
Description:	Repair Localized Liner

Distance (ft):	.0
Structural Grade:	0
O&M Grade:	0
Clock Start/From:	7
Clock To:	5
1st Value:	
2nd Value:	
Value Percent:	
Continuous Index:	S01
Within 8" of Joint:	NO
Remarks:	lining

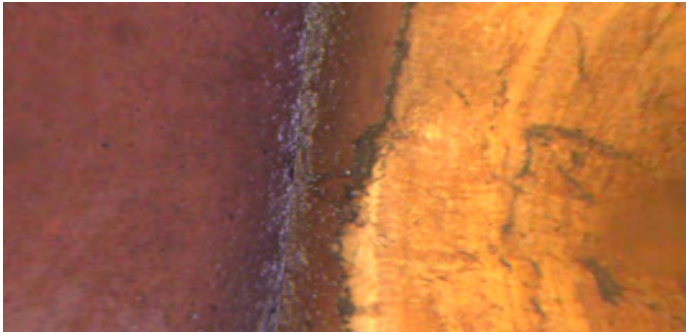
Code: **RPL**
Description: **Repair Localized Liner**

Distance (ft): **5.1**
Structural Grade: **0**
O&M Grade: **0**
Clock Start/From: **7**
Clock To: **5**
1st Value:
2nd Value:
Value Percent:
Continuous Index: **F01**
Within 8" of Joint: **NO**
Remarks: **lining**

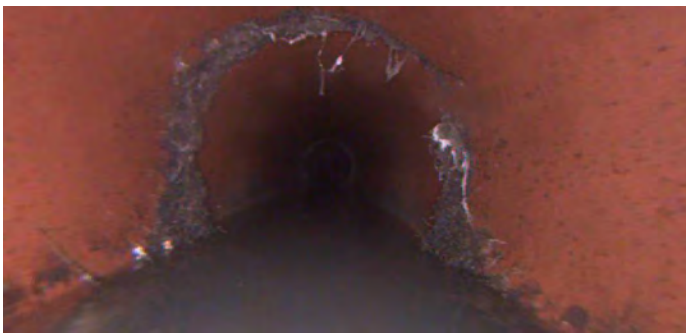
Code: **RFJ**
Description: **Roots Fine Joint**

Distance (ft): **10.1**
Structural Grade: **0**
O&M Grade: **1**
Clock Start/From: **7**
Clock To: **5**
1st Value:
2nd Value:
Value Percent:
Continuous Index: **S02**
Within 8" of Joint: **YES**
Remarks: **wandering**

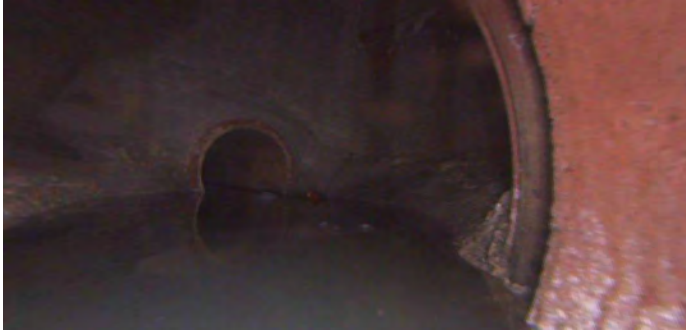
Code: **RFJ**
Description: **Roots Fine Joint**

Distance (ft): **66.2**
Structural Grade: **0**
O&M Grade: **1**
Clock Start/From: **7**
Clock To: **5**
1st Value:
2nd Value:
Value Percent:
Continuous Index: **F02**
Within 8" of Joint: **YES**
Remarks: **wandering**

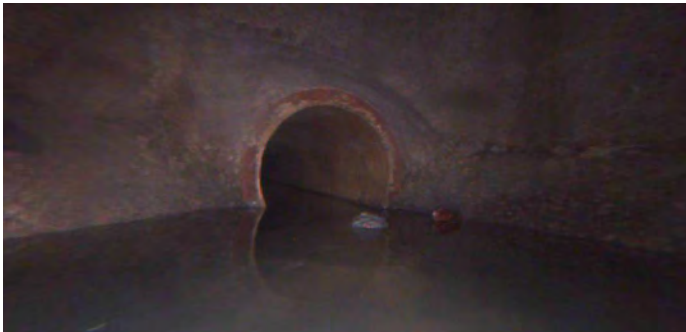
Code: **AMH**
Description: **Manhole**

Distance (ft): **67.6**
Structural Grade: **0**
O&M Grade: **0**
Clock Start/From:
Clock To:
1st Value:
2nd Value:
Value Percent:
Continuous Index:
Within 8" of Joint: **NO**
Remarks: **M-108-034**
