Profile/Photo Observation Report

Date:	03/24/2018	Weather:		Coding:	PACP 6.0
Pipe Length (ft):	67.9	Owner:	NA	Pre Clean:	No Pre-Cleaning
P.O.#:		Surveyor:	Byrd Fitzgerald	PSR:	P-108-034-035
Customer:		Clean Date:	01/01/1900	Shape:	C

Street:	FOXCROFT STREET	Flow Control:	Not Controlled
City:	Hobart, IN	Year Renewed:	
Location:	Light Highway	Tape/Media #:	
Purpose:	Routine Assessment	Dia/Height:	12"
Use:	Sanitary	Material:	VCP
Drain Area:	NA	Lining:	
Category:	NA		
Comment:			
Location Details:		Direction of Survey:	Downstream
US MH:	M-108-035	DS MH:	M-108-034
		Total Length Surveyed (ft):	67.6

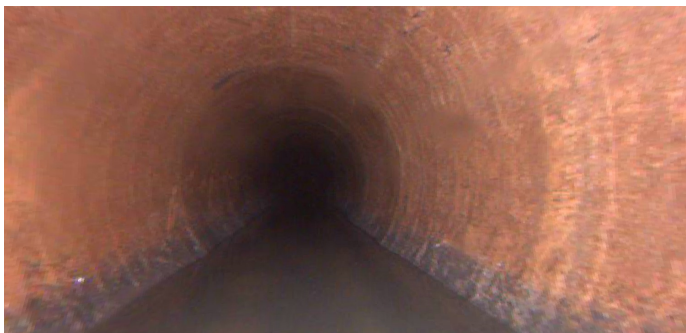
Code: **AMH**
Description: **Manhole**

Distance (ft): **.0**
Structural Grade: **0**
O&M Grade: **0**
Clock Start/From:
Clock To:
1st Value:
2nd Value:
Value Percent:
Continuous Index:
Within 8" of Joint: **NO**
Remarks: **M-108-035**

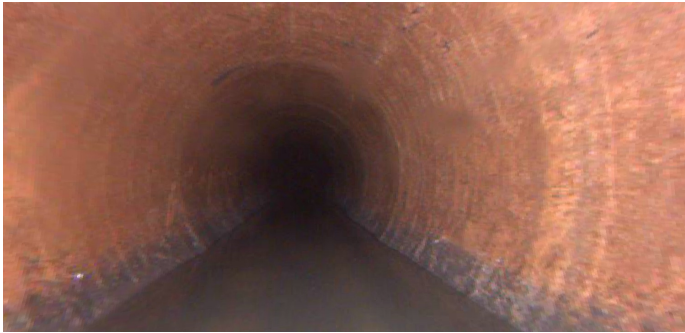
Code:	MWL
Description:	Water Level

Distance (ft):	.0
Structural Grade:	0
O&M Grade:	0
Clock Start/From:	
Clock To:	
1st Value:	
2nd Value:	
Value Percent:	5.000
Continuous Index:	
Within 8" of Joint:	NO
Remarks:

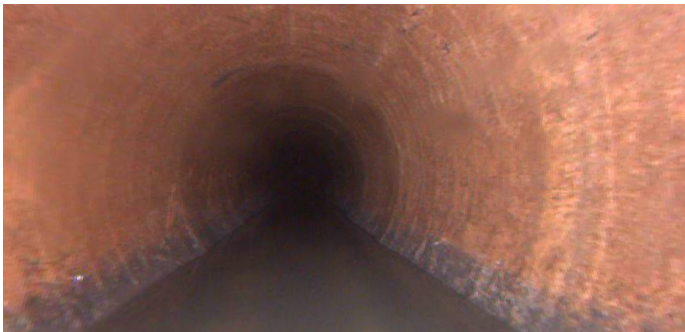
Code:	RPL
Description:	Repair Localized Liner

Distance (ft):	.0
Structural Grade:	0
O&M Grade:	0
Clock Start/From:	7
Clock To:	5
1st Value:	
2nd Value:	
Value Percent:	
Continuous Index:	S01
Within 8" of Joint:	NO
Remarks:	lining

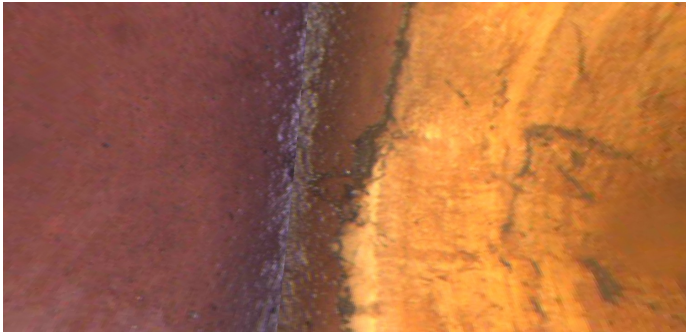
Code: **RPL**
Description: **Repair Localized Liner**

Distance (ft): **5.1**
Structural Grade: **0**
O&M Grade: **0**
Clock Start/From: **7**
Clock To: **5**
1st Value:
2nd Value:
Value Percent:
Continuous Index: **F01**
Within 8" of Joint: **NO**
Remarks: **lining**

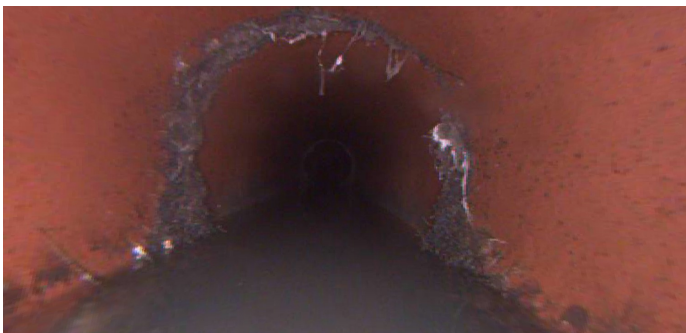
Code: **RFJ**
Description: **Roots Fine Joint**

Distance (ft): **10.1**
Structural Grade: **0**
O&M Grade: **1**
Clock Start/From: **7**
Clock To: **5**
1st Value:
2nd Value:
Value Percent:
Continuous Index: **S02**
Within 8" of Joint: **YES**
Remarks: **wandering**

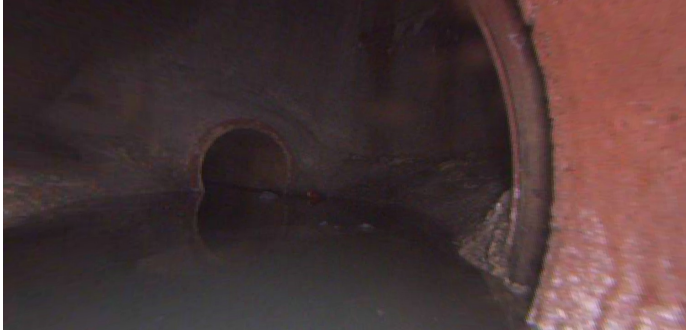
Code: **RFJ**
Description: **Roots Fine Joint**

Distance (ft): **66.2**
Structural Grade: **0**
O&M Grade: **1**
Clock Start/From: **7**
Clock To: **5**
1st Value:
2nd Value:
Value Percent:
Continuous Index: **F02**
Within 8" of Joint: **YES**
Remarks: **wandering**

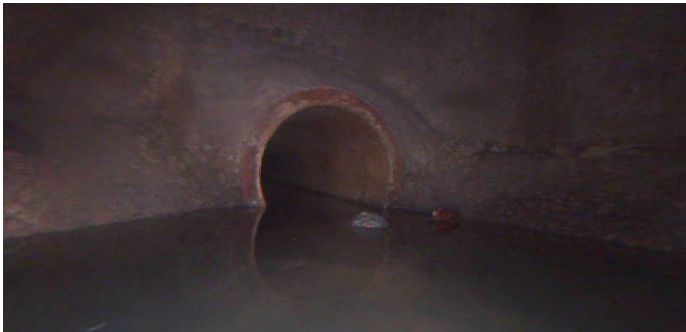
Code: **AMH**
Description: **Manhole**

Distance (ft): **67.6**
Structural Grade: **0**
O&M Grade: **0**
Clock Start/From:
Clock To:
1st Value:
2nd Value:
Value Percent:
Continuous Index:
Within 8" of Joint: **NO**
Remarks: **M-108-034**
