Profile/Photo Observation Report

Date:	03/25/2018	Weather:		Coding:	PACP 6.0
Pipe Length (ft):	41.1	Owner:	NA	Pre Clean:	No Pre-Cleaning
P.O.#:		Surveyor:	Jen Costello	PSR:	P-108-036-037
Customer:		Clean Date:	01/01/1900	Shape:	C

Street:	OFF 15TH PL	Flow Control:	Not Controlled
City:	Hobart, IN	Year Renewed:	
Location:	Light Highway	Tape/Media #:	
Purpose:	Routine Assessment	Dia/Height:	10"
Use:	Sanitary	Material:	VCP
Drain Area:	NA	Lining:	
Category:	NA		
Comment:			
Location Details:		Direction of Survey:	Downstream
US MH:	M-108-037	DS MH:	M-108-036
		Total Length Surveyed (ft):	3.6

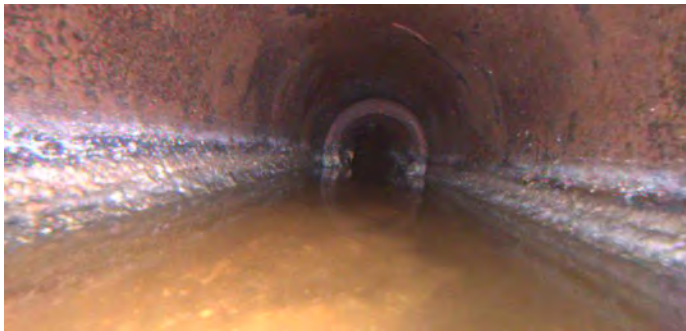
Code: **AMH**
Description: **Manhole**

Distance (ft): **.0**
Structural Grade: **0**
O&M Grade: **0**
Clock Start/From:
Clock To:
1st Value:
2nd Value:
Value Percent:
Continuous Index:
Within 8" of Joint: **NO**
Remarks: **M-108-037**

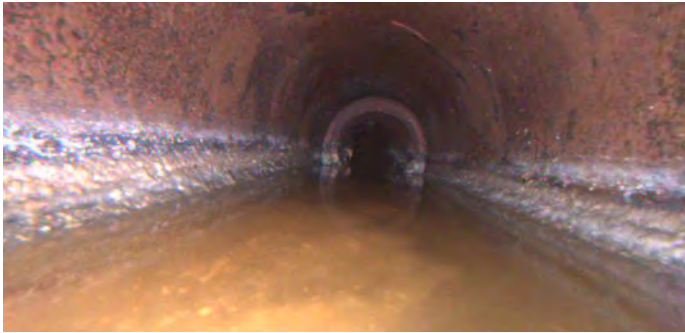
Code:	MWL
Description:	Water Level

Distance (ft):	.0
Structural Grade:	0
O&M Grade:	0
Clock Start/From:	
Clock To:	
1st Value:	
2nd Value:	
Value Percent:	40.000
Continuous Index:	
Within 8" of Joint:	NO
Remarks:

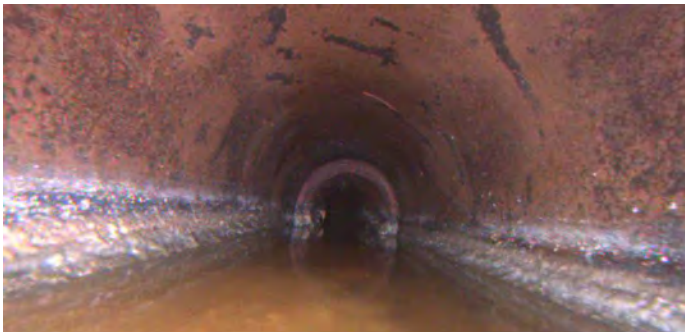
Code:	DAGS
Description:	Deposits Attached Grease

Distance (ft):	.0
Structural Grade:	0
O&M Grade:	2
Clock Start/From:	8
Clock To:	4
1st Value:	
2nd Value:	
Value Percent:	5.000
Continuous Index:	S01
Within 8" of Joint:	NO
Remarks:

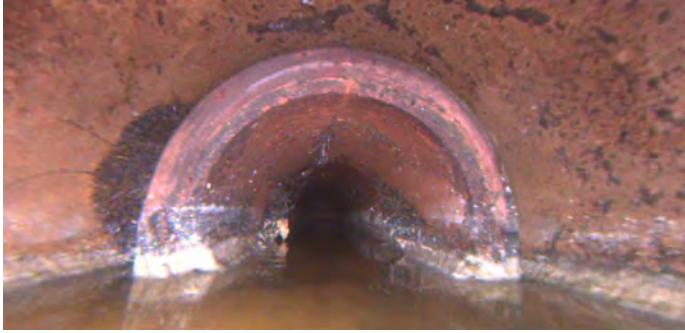
Code: **RMJ**
Description: **Roots Medium Joint**

Distance (ft): **2.4**
Structural Grade: **0**
O&M Grade: **3**
Clock Start/From: **8**
Clock To: **9**
1st Value:
2nd Value:
Value Percent: **5.000**
Continuous Index:
Within 8" of Joint: **YES**
Remarks:

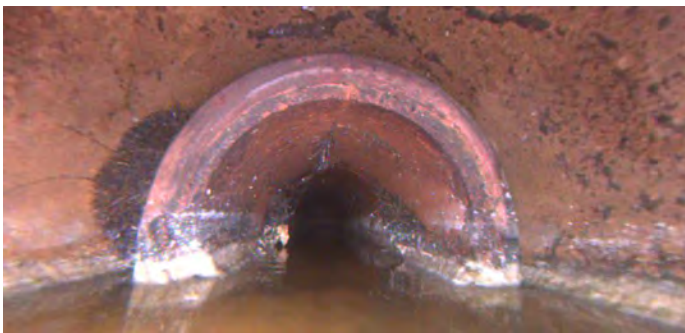
Code: **MSC**
Description: **Shape or Size Change**

Distance (ft): **2.4**
Structural Grade: **0**
O&M Grade: **0**
Clock Start/From:
Clock To:
1st Value: **6.000**
2nd Value:
Value Percent:
Continuous Index:
Within 8" of Joint: **NO**
Remarks:

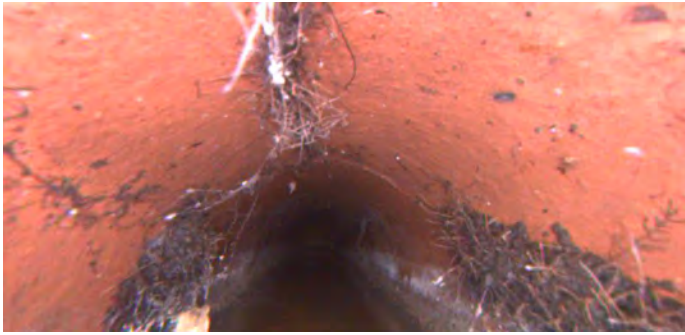
Code: **FM**
Description: **Fracture Multiple**

Distance (ft): **3.1**
Structural Grade: **4**
O&M Grade: **0**
Clock Start/From: **8**
Clock To: **4**
1st Value:
2nd Value:
Value Percent:
Continuous Index:
Within 8" of Joint:
Remarks:

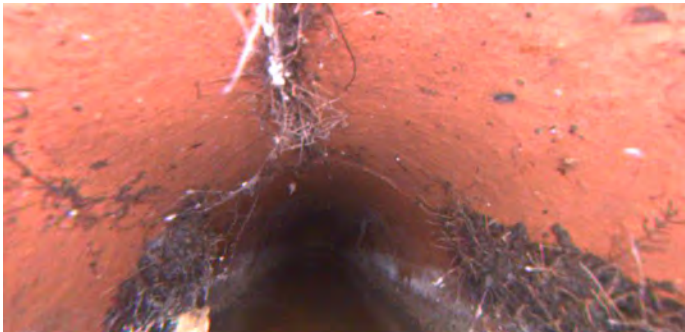
Code: **RMJ**
Description: **Roots Medium Joint**

Distance (ft): **3.1**
Structural Grade: **0**
O&M Grade: **3**
Clock Start/From: **8**
Clock To: **4**
1st Value:
2nd Value:
Value Percent: **10.000**
Continuous Index:
Within 8" of Joint: **YES**
Remarks:

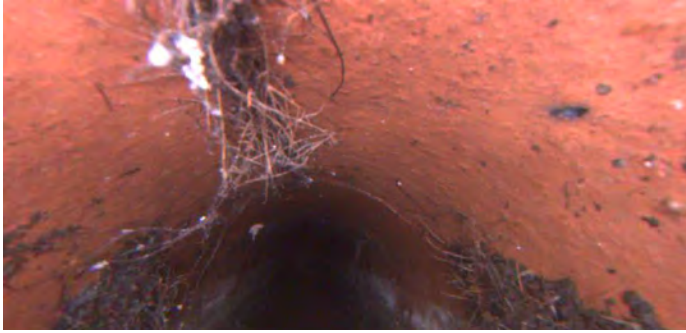
Code: **MSA**
Description: **Abandoned Survey**

Distance (ft): **3.6**
Structural Grade: **0**
O&M Grade: **0**
Clock Start/From:
Clock To:
1st Value:
2nd Value:
Value Percent:
Continuous Index:
Within 8" of Joint: **NO**
Remarks: **ROOTS**

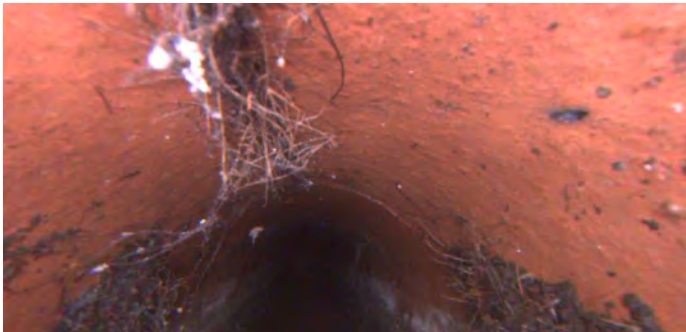
Code: **DAGS**
Description: **Deposits Attached Grease**

Distance (ft): **3.6**
Structural Grade: **0**
O&M Grade: **2**
Clock Start/From: **8**
Clock To: **4**
1st Value:
2nd Value:
Value Percent: **5.000**
Continuous Index: **F01**
Within 8" of Joint: **NO**
Remarks:
