Profile/Photo Observation Report

Street:	FOXCROFT STREET	Flow Control:	Not Controlled
City:	Hobart, IN	Year Renewed:	
Location:	Light Highway	Tape/Media #:	
Purpose:	Routine Assessment	Dia/Height:	10"
Use:	Sanitary	Material:	VCP
Drain Area:	NA	Lining:	
Category:	NA		
Comment:

Location Details:		Direction of Survey:	Downstream
US MH:	M-108-037	DS MH:	M-108-036
		Total Length Surveyed (ft):	3.6

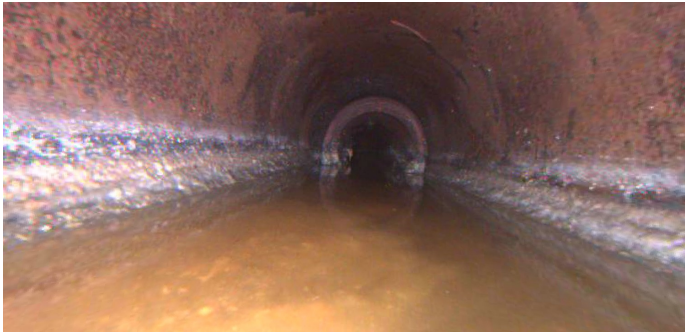
Code:	MWL
Description:	Water Level

Distance (ft):	.0
Structural Grade:	0
O&M Grade:	0
Clock Start/From:	
Clock To:	
1st Value:	
2nd Value:	
Value Percent:	40.000
Continuous Index:	
Within 8" of Joint:	NO
Remarks:

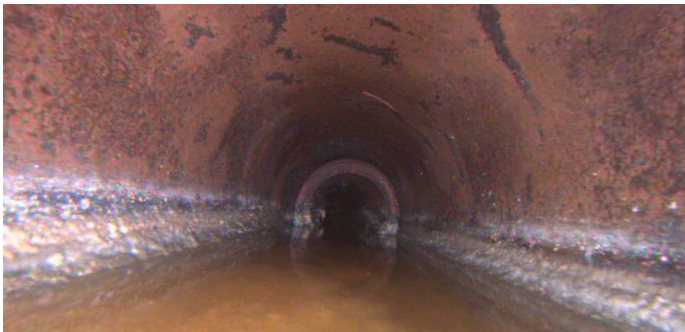
Code:	DAGS
Description:	Deposits Attached Grease

Distance (ft):	.0
Structural Grade:	0
O&M Grade:	2
Clock Start/From:	8
Clock To:	4
1st Value:	
2nd Value:	
Value Percent:	5.000
Continuous Index:	S01
Within 8" of Joint:	NO
Remarks:

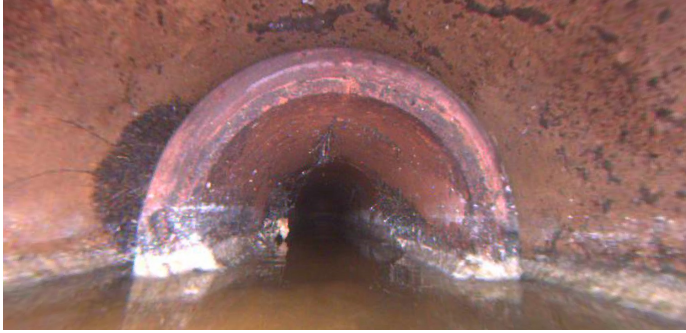
Code: **RMJ**
Description: **Roots Medium Joint**

Distance (ft): **2.4**
Structural Grade: **0**
O&M Grade: **3**
Clock Start/From: **8**
Clock To: **9**
1st Value:
2nd Value:
Value Percent: **5.000**
Continuous Index:
Within 8" of Joint: **YES**
Remarks:

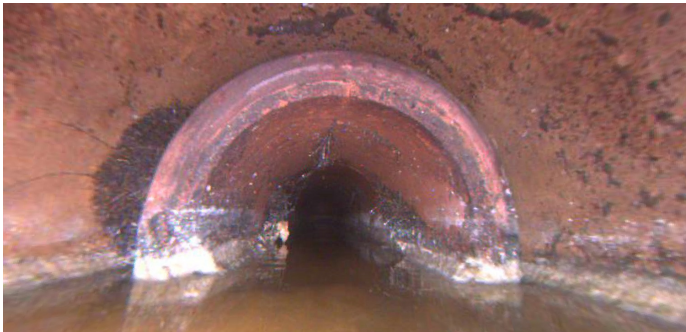
Code: **MSC**
Description: **Shape or Size Change**

Distance (ft): **2.4**
Structural Grade: **0**
O&M Grade: **0**
Clock Start/From:
Clock To:
1st Value: **6.000**
2nd Value:
Value Percent:
Continuous Index:
Within 8" of Joint: **NO**
Remarks:

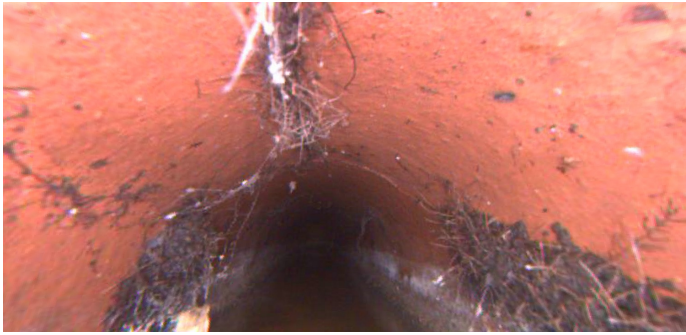
Code: **FM**
Description: **Fracture Multiple**

Distance (ft): **3.1**
Structural Grade: **4**
O&M Grade: **0**
Clock Start/From: **8**
Clock To: **4**
1st Value:
2nd Value:
Value Percent:
Continuous Index:
Within 8" of Joint:
Remarks:

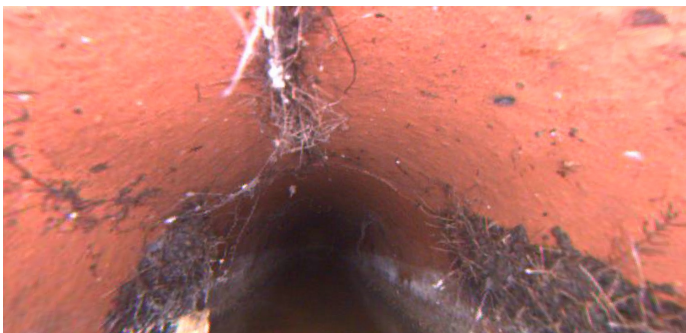
Code: **RMJ**
Description: **Roots Medium Joint**

Distance (ft): **3.1**
Structural Grade: **0**
O&M Grade: **3**
Clock Start/From: **8**
Clock To: **4**
1st Value:
2nd Value:
Value Percent: **10.000**
Continuous Index:
Within 8" of Joint: **YES**
Remarks:

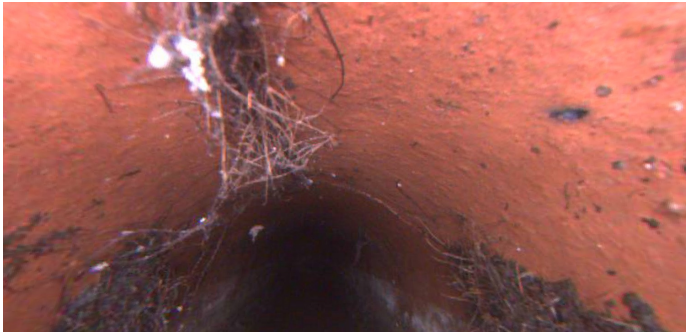
Code: **MSA**
Description: **Abandoned Survey**

Distance (ft): **3.6**
Structural Grade: **0**
O&M Grade: **0**
Clock Start/From:
Clock To:
1st Value:
2nd Value:
Value Percent:
Continuous Index:
Within 8" of Joint: **NO**
Remarks: **ROOTS**

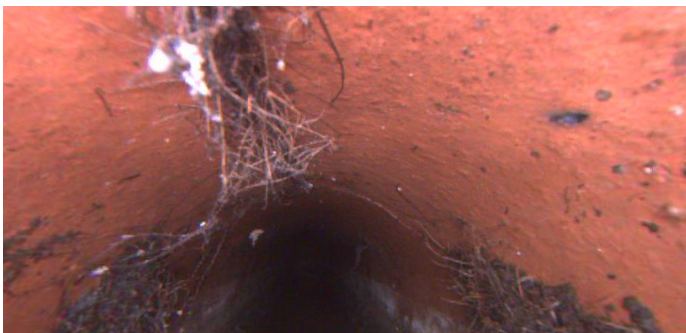
Code: **DAGS**
Description: **Deposits Attached Grease**

Distance (ft): **3.6**
Structural Grade: **0**
O&M Grade: **2**
Clock Start/From: **8**
Clock To: **4**
1st Value:
2nd Value:
Value Percent: **5.000**
Continuous Index: **F01**
Within 8" of Joint: **NO**
Remarks:
