## Profile/Photo Observation Report

Date:	<b>03/25/2018</b>	Weather:		Coding:	<b>PACP 6.0</b>
Pipe Length (ft):	<b>282.5</b>	Owner:	<b>NA</b>	Pre Clean:	<b>No Pre-Cleaning</b>
P.O.#:		Surveyor:	<b>Byrd Fitzgerald</b>	PSR:	<b>P-108-037-038</b>
Customer:		Clean Date:	<b>01/01/1900</b>	Shape:	<b>C</b>

Street:	<b>OFF 15TH PL</b>	Flow Control:	<b>Not Controlled</b>
City:	<b>Hobart, IN</b>	Year Renewed:	
Location:	<b>Light Highway</b>	Tape/Media #:	
Purpose:	<b>Routine Assessment</b>	Dia/Height:	<b>10"</b>
Use:	<b>Sanitary</b>	Material:	<b>VCP</b>
Drain Area:	<b>NA</b>	Lining:	
Category:	<b>NA</b>		
Comment:	<b>Flow direction wrong</b>		
Location Details:		Direction of Survey:	<b>Upstream</b>
US MH:	<b>M-108-038</b>	DS MH:	<b>M-108-037</b>
		Total Length Surveyed (ft):	<b>272.1</b>

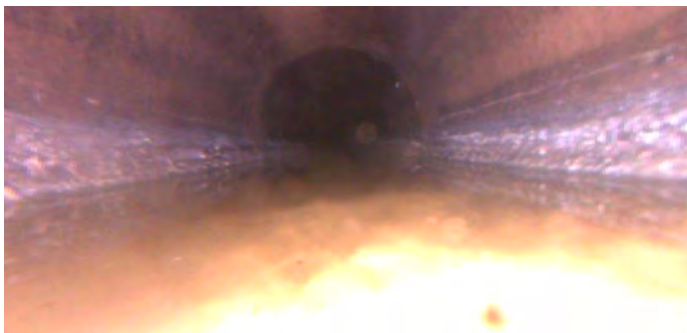
Code: **AMH**  
 Description: **Manhole**  
 Distance (ft): **.0**  
 Structural Grade: **0**  
 O&M Grade: **0**  
 Clock Start/From:  
 Clock To:  
 1st Value:  
 2nd Value:  
 Value Percent:  
 Continuous Index:  
 Within 8" of Joint: **NO**  
 Remarks: **M-108-037**

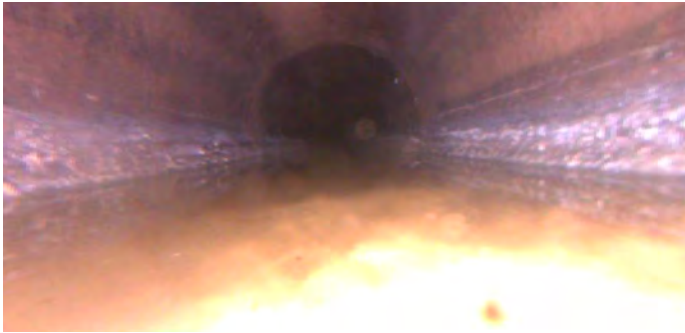
Code:	<b>MWL</b>
Description:	<b>Water Level</b>

Distance (ft):	<b>.0</b>
Structural Grade:	<b>0</b>
O&M Grade:	<b>0</b>
Clock Start/From:	
Clock To:	
1st Value:	
2nd Value:	
Value Percent:	<b>20.000</b>
Continuous Index:	
Within 8" of Joint:	<b>NO</b>
Remarks:

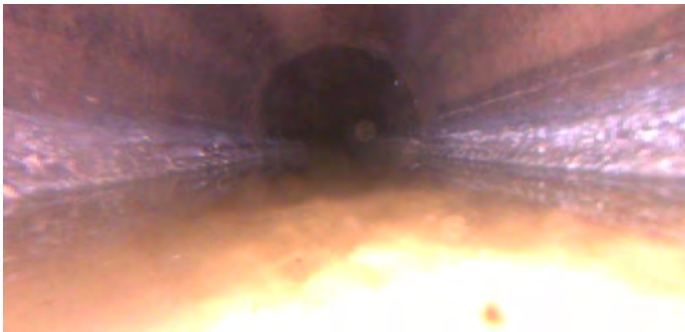
Code:	<b>DAGS</b>
Description:	<b>Deposits Attached Grease</b>

Distance (ft):	<b>.0</b>
Structural Grade:	<b>0</b>
O&M Grade:	<b>2</b>
Clock Start/From:	<b>7</b>
Clock To:	<b>5</b>
1st Value:	
2nd Value:	
Value Percent:	<b>5.000</b>
Continuous Index:	<b>S01</b>
Within 8" of Joint:	<b>NO</b>
Remarks:	<b>wandering</b>

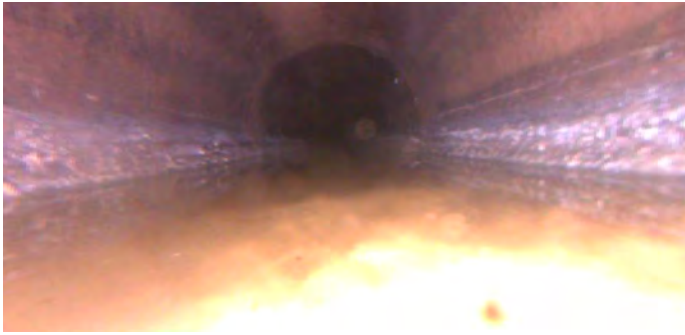
Code: **DSZ**  
Description: **Deposits Settled Other**

Distance (ft): **.0**  
Structural Grade: **0**  
O&M Grade: **2**  
Clock Start/From: **6**  
Clock To:  
1st Value:  
2nd Value:  
Value Percent: **10.000**  
Continuous Index: **S02**  
Within 8" of Joint: **NO**  
Remarks: **tissue/debris**

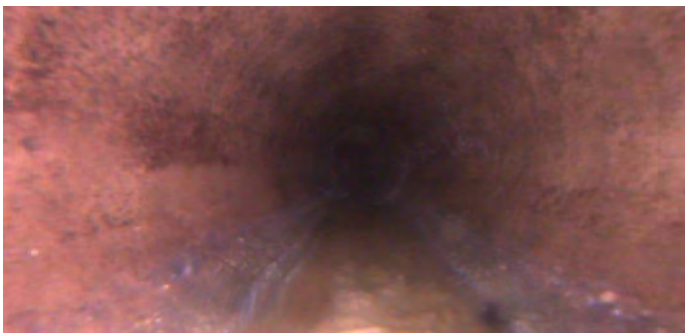
Code: **MWL**  
Description: **Water Level**

Distance (ft): **9.2**  
Structural Grade: **0**  
O&M Grade: **0**  
Clock Start/From:  
Clock To:  
1st Value:  
2nd Value:  
Value Percent: **5.000**  
Continuous Index:  
Within 8" of Joint: **NO**  
Remarks:

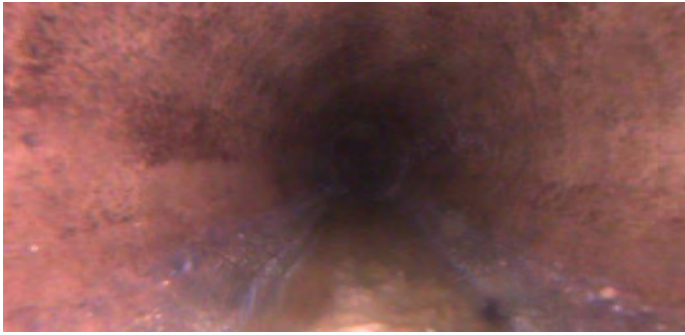
Code: **DAGS**  
Description: **Deposits Attached Grease**

Distance (ft): **9.2**  
Structural Grade: **0**  
O&M Grade: **2**  
Clock Start/From: **7**  
Clock To: **5**  
1st Value:  
2nd Value:  
Value Percent: **5.000**  
Continuous Index: **F01**  
Within 8" of Joint: **NO**  
Remarks: **wandering**

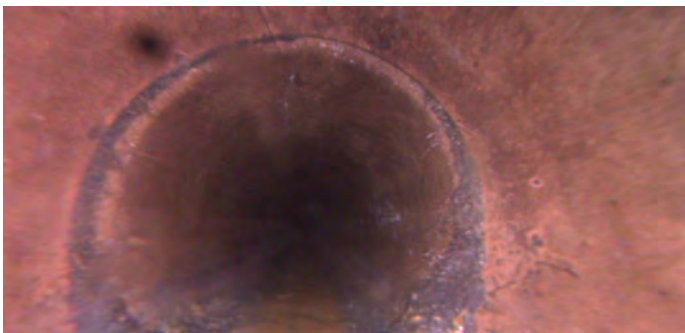
Code: **RFJ**  
Description: **Roots Fine Joint**

Distance (ft): **11.7**  
Structural Grade: **0**  
O&M Grade: **1**  
Clock Start/From: **7**  
Clock To: **5**  
1st Value:  
2nd Value:  
Value Percent:  
Continuous Index: **S03**  
Within 8" of Joint: **YES**  
Remarks: **wandering**

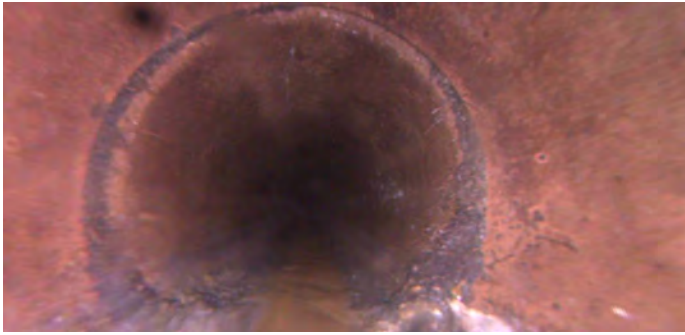
Code: **DSZ**  
Description: **Deposits Settled Other**

Distance (ft): **11.7**  
Structural Grade: **0**  
O&M Grade: **2**  
Clock Start/From: **6**  
Clock To:  
1st Value:  
2nd Value:  
Value Percent: **10.000**  
Continuous Index: **F02**  
Within 8" of Joint: **NO**  
Remarks: **tissue/debris**

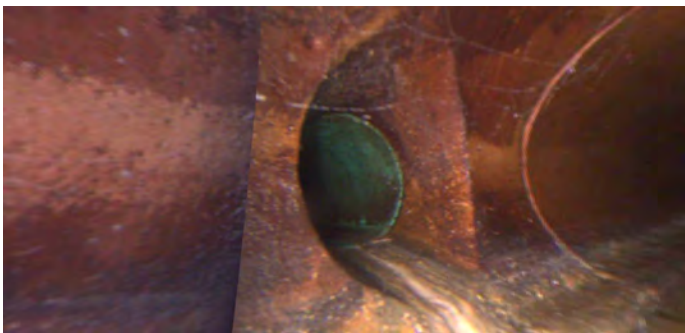
Code: **TF**  
Description: **Tap Factory**

Distance (ft): **48.2**  
Structural Grade: **0**  
O&M Grade: **0**  
Clock Start/From: **3**  
Clock To:  
1st Value: **4.000**  
2nd Value:  
Value Percent:  
Continuous Index:  
Within 8" of Joint: **YES**  
Remarks:

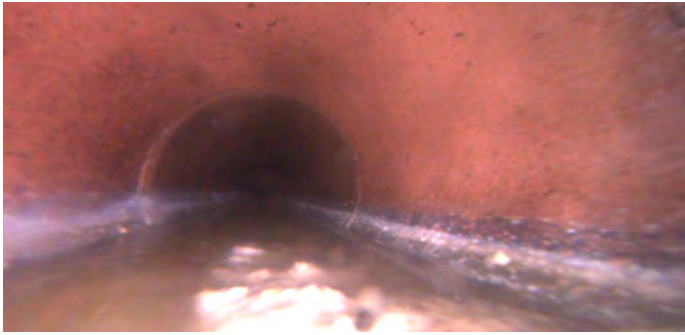
Code: **DSZ**  
Description: **Deposits Settled Other**

Distance (ft): **73.5**  
Structural Grade: **0**  
O&M Grade: **2**  
Clock Start/From: **6**  
Clock To:  
1st Value:  
2nd Value:  
Value Percent: **10.000**  
Continuous Index:  
Within 8" of Joint: **NO**  
Remarks: **tissue/debris**

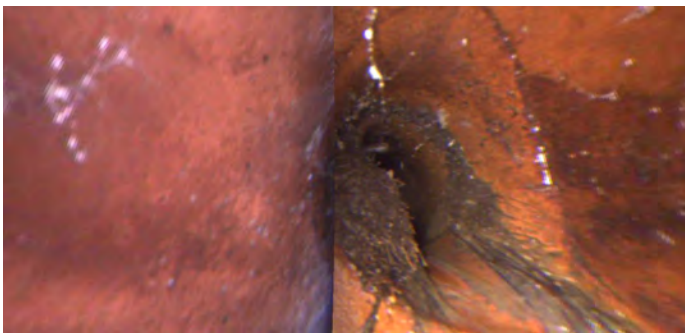
Code: **TFD**  
Description: **Tap Factory Defective**

Distance (ft): **120.9**  
Structural Grade: **0**  
O&M Grade: **2**  
Clock Start/From: **3**  
Clock To:  
1st Value: **4.000**  
2nd Value:  
Value Percent:  
Continuous Index:  
Within 8" of Joint:  
Remarks: **roots**

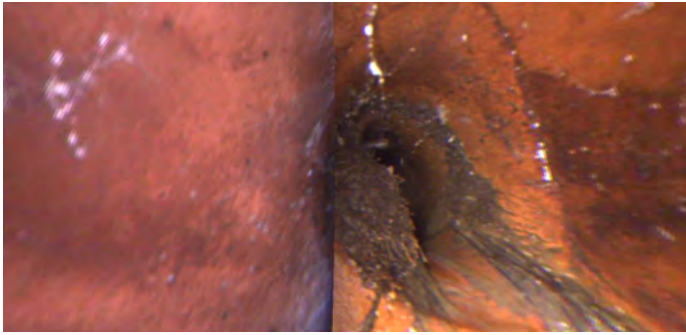
Code: **RML**  
Description: **Roots Medium Lateral**

Distance (ft): **120.9**  
Structural Grade: **0**  
O&M Grade: **3**  
Clock Start/From: **7**  
Clock To: **5**  
1st Value:  
2nd Value:  
Value Percent: **5.000**  
Continuous Index:  
Within 8" of Joint: **NO**  
Remarks:

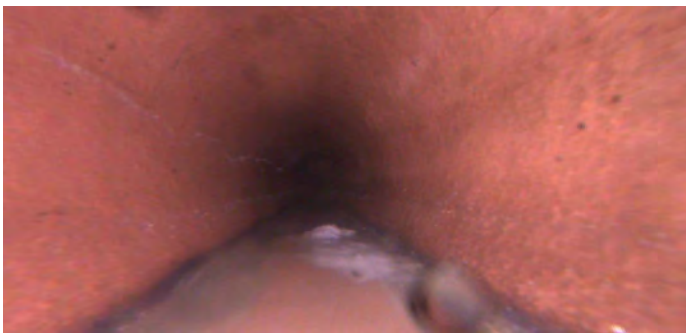
Code: **DSZ**  
Description: **Deposits Settled Other**

Distance (ft): **154.4**  
Structural Grade: **0**  
O&M Grade: **2**  
Clock Start/From: **6**  
Clock To:  
1st Value:  
2nd Value:  
Value Percent: **5.000**  
Continuous Index:  
Within 8" of Joint: **NO**  
Remarks: **tissue**

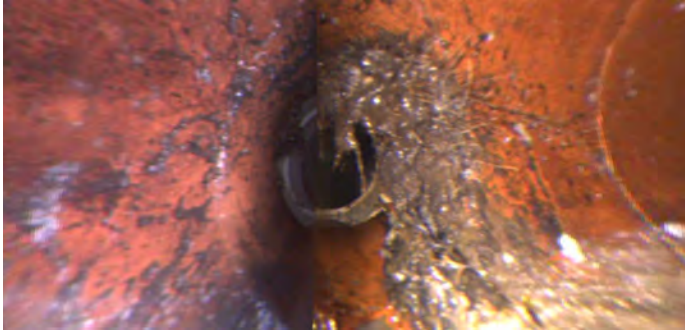
Code: **TFD**  
Description: **Tap Factory Defective**

Distance (ft): **188.9**  
Structural Grade: **0**  
O&M Grade: **2**  
Clock Start/From: **3**  
Clock To:  
1st Value: **4.000**  
2nd Value:  
Value Percent:  
Continuous Index:  
Within 8" of Joint:  
Remarks: **offset**

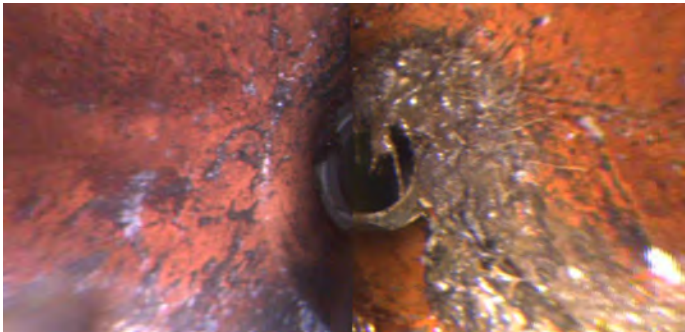
Code: **RMC**  
Description: **Roots Medium Connection**

Distance (ft): **188.9**  
Structural Grade: **0**  
O&M Grade: **3**  
Clock Start/From: **12**  
Clock To: **5**  
1st Value:  
2nd Value:  
Value Percent: **10.000**  
Continuous Index:  
Within 8" of Joint: **NO**  
Remarks:

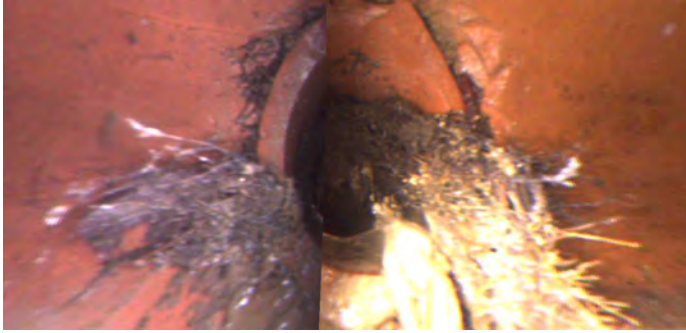
Code: **TFD**  
Description: **Tap Factory Defective**

Distance (ft): **238.8**  
Structural Grade: **0**  
O&M Grade: **2**  
Clock Start/From: **3**  
Clock To:  
1st Value: **4.000**  
2nd Value:  
Value Percent:  
Continuous Index:  
Within 8" of Joint:  
Remarks: **roots**

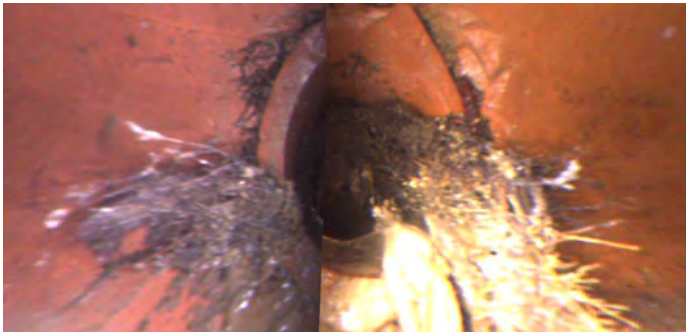
Code: **RML**  
Description: **Roots Medium Lateral**

Distance (ft): **238.8**  
Structural Grade: **0**  
O&M Grade: **3**  
Clock Start/From: **12**  
Clock To: **5**  
1st Value:  
2nd Value:  
Value Percent: **5.000**  
Continuous Index:  
Within 8" of Joint: **NO**  
Remarks: **into pipe**

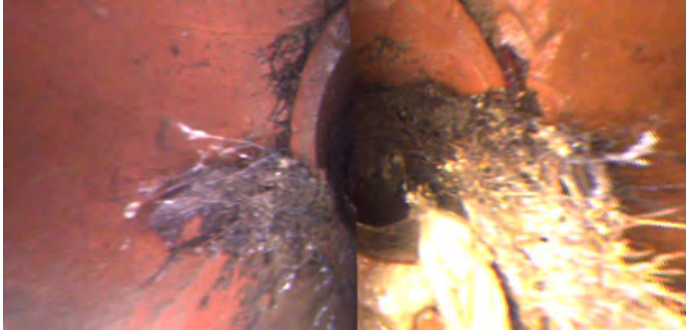
Code: **RMC**  
Description: **Roots Medium Connection**

Distance (ft): **238.8**  
Structural Grade: **0**  
O&M Grade: **3**  
Clock Start/From: **7**  
Clock To:  
1st Value:  
2nd Value:  
Value Percent: **5.000**  
Continuous Index:  
Within 8" of Joint: **NO**  
Remarks:

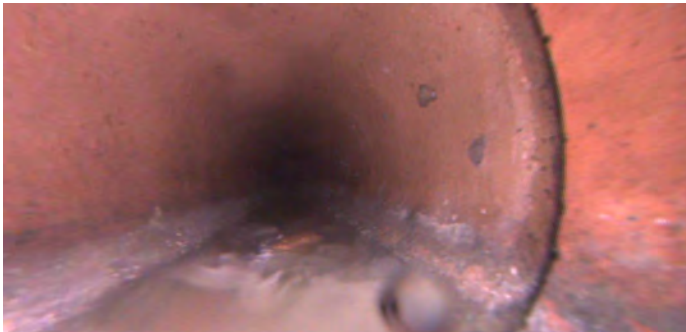
Code: **DSZ**  
Description: **Deposits Settled Other**

Distance (ft): **240.6**  
Structural Grade: **0**  
O&M Grade: **2**  
Clock Start/From: **6**  
Clock To:  
1st Value:  
2nd Value:  
Value Percent: **5.000**  
Continuous Index:  
Within 8" of Joint: **NO**  
Remarks: **tissue**

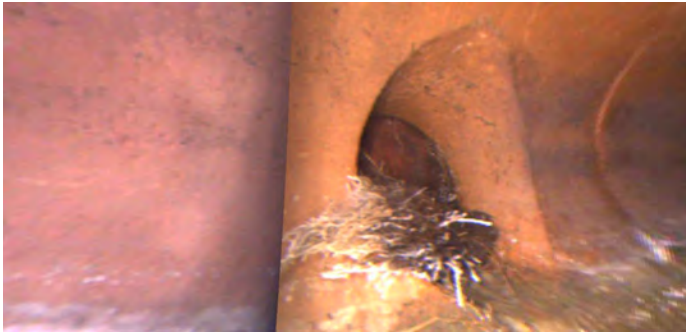
Code: **TFD**  
Description: **Tap Factory Defective**

Distance (ft): **257.4**  
Structural Grade: **0**  
O&M Grade: **2**  
Clock Start/From: **3**  
Clock To:  
1st Value: **4.000**  
2nd Value:  
Value Percent:  
Continuous Index:  
Within 8" of Joint: **YES**  
Remarks: **roots**

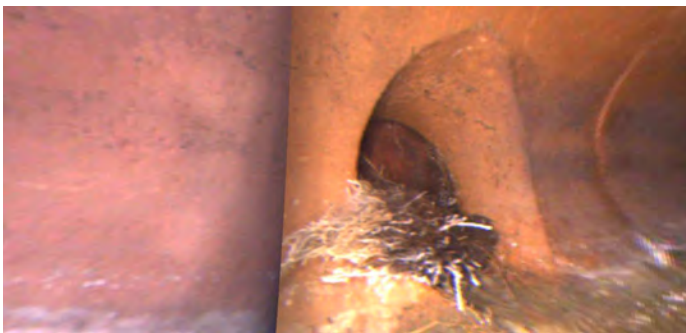
Code: **RML**  
Description: **Roots Medium Lateral**

Distance (ft): **257.4**  
Structural Grade: **0**  
O&M Grade: **3**  
Clock Start/From: **6**  
Clock To: **9**  
1st Value:  
2nd Value:  
Value Percent: **5.000**  
Continuous Index:  
Within 8" of Joint: **NO**  
Remarks:

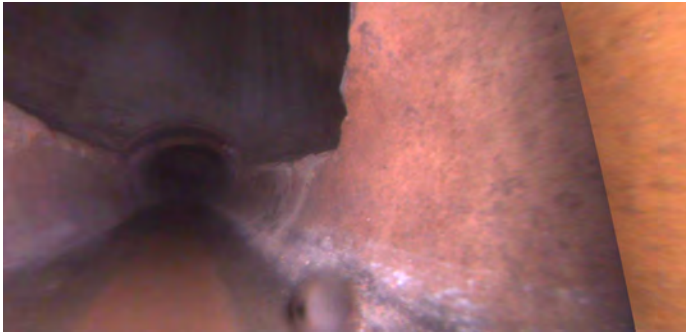
Code: **RFJ**  
Description: **Roots Fine Joint**

Distance (ft): **270.2**  
Structural Grade: **0**  
O&M Grade: **1**  
Clock Start/From: **7**  
Clock To: **5**  
1st Value:  
2nd Value:  
Value Percent:  
Continuous Index: **F03**  
Within 8" of Joint: **YES**  
Remarks: **wandering**

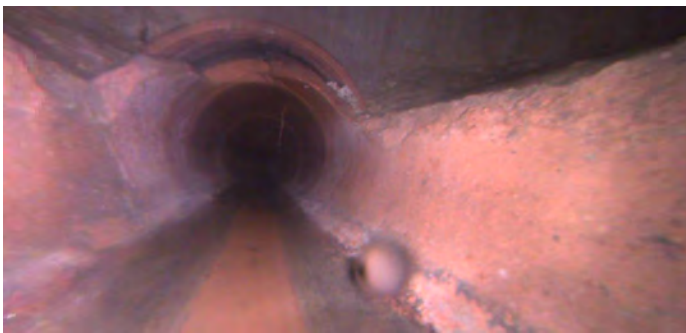
Code: **AMH**  
Description: **Manhole**

Distance (ft): **272.1**  
Structural Grade: **0**  
O&M Grade: **0**  
Clock Start/From:  
Clock To:  
1st Value:  
2nd Value:  
Value Percent:  
Continuous Index:  
Within 8" of Joint: **NO**  
Remarks: **M-108-038**
