Profile/Photo Observation Report

Street:	FOXCROFT STREET	Flow Control:	Not Controlled
City:	Hobart, IN	Year Renewed:	
Location:	Light Highway	Tape/Media #:	
Purpose:	Routine Assessment	Dia/Height:	10"
Use:	Sanitary	Material:	VCP
Drain Area:	NA	Lining:	
Category:	NA		
Comment:	Flow direction wrong

Location Details:		Direction of Survey:	Upstream
US MH:	M-108-038	DS MH:	M-108-037
		Total Length Surveyed (ft):	272.1

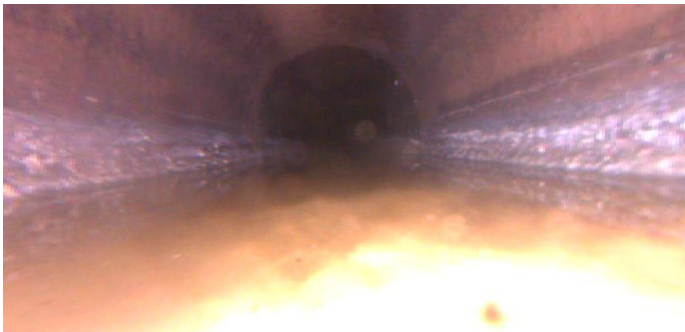
Code:	DAGS
Description:	Deposits Attached Grease

Distance (ft):	.0
Structural Grade:	0
O&M Grade:	2
Clock Start/From:	7
Clock To:	5
1st Value:	
2nd Value:	
Value Percent:	5.000
Continuous Index:	S01
Within 8" of Joint:	NO
Remarks:	wandering

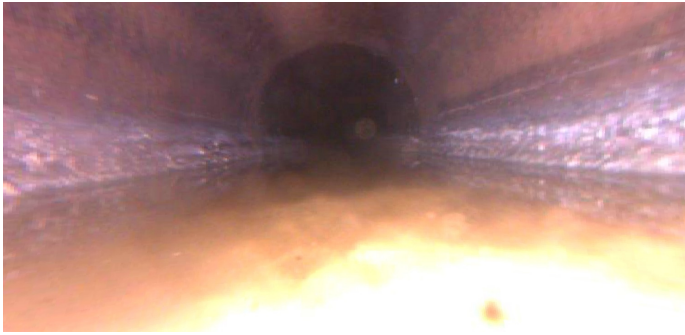
Code: **DSZ**
Description: **Deposits Settled Other**

Distance (ft): **.0**
Structural Grade: **0**
O&M Grade: **2**
Clock Start/From: **6**
Clock To:
1st Value:
2nd Value:
Value Percent: **10.000**
Continuous Index: **S02**
Within 8" of Joint: **NO**
Remarks: **tissue/debris**

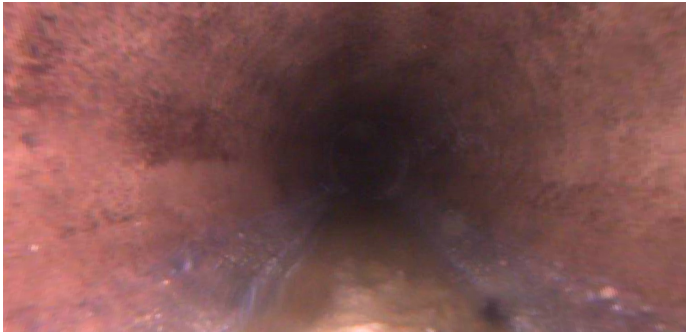
Code: **DAGS**
Description: **Deposits Attached Grease**

Distance (ft): **9.2**
Structural Grade: **0**
O&M Grade: **2**
Clock Start/From: **7**
Clock To: **5**
1st Value:
2nd Value:
Value Percent: **5.000**
Continuous Index: **F01**
Within 8" of Joint: **NO**
Remarks: **wandering**

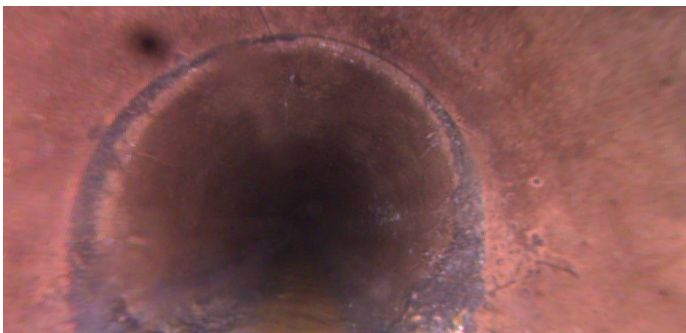
Code: **RFJ**
Description: **Roots Fine Joint**

Distance (ft): **11.7**
Structural Grade: **0**
O&M Grade: **1**
Clock Start/From: **7**
Clock To: **5**
1st Value:
2nd Value:
Value Percent:
Continuous Index: **S03**
Within 8" of Joint: **YES**
Remarks: **wandering**

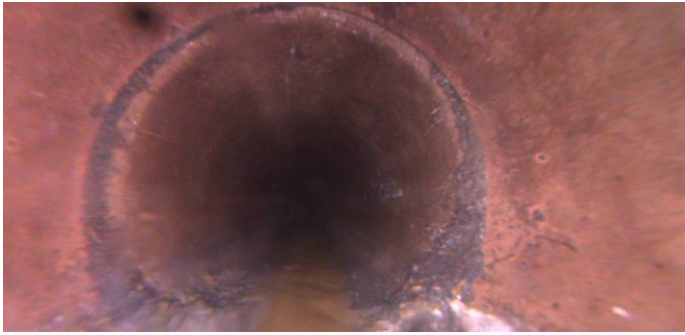
Code: **DSZ**
Description: **Deposits Settled Other**

Distance (ft): **11.7**
Structural Grade: **0**
O&M Grade: **2**
Clock Start/From: **6**
Clock To:
1st Value:
2nd Value:
Value Percent: **10.000**
Continuous Index: **F02**
Within 8" of Joint: **NO**
Remarks: **tissue/debris**

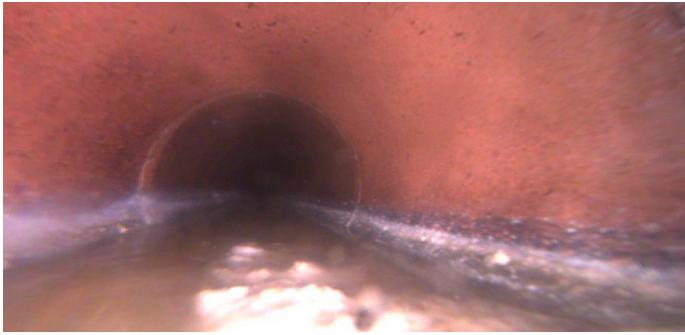
Code: **DSZ**
Description: **Deposits Settled Other**

Distance (ft): **73.5**
Structural Grade: **0**
O&M Grade: **2**
Clock Start/From: **6**
Clock To:
1st Value:
2nd Value:
Value Percent: **10.000**
Continuous Index:
Within 8" of Joint: **NO**
Remarks: **tissue/debris**

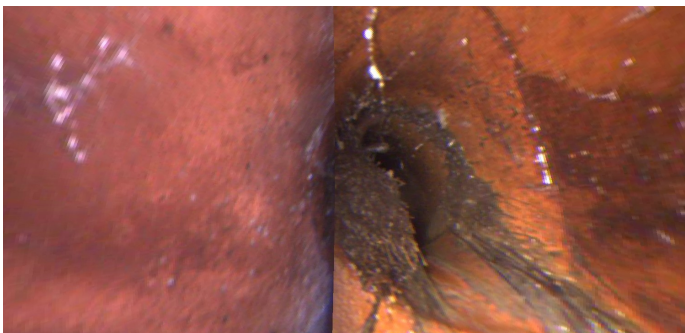
Code: **TFD**
Description: **Tap Factory Defective**

Distance (ft): **120.9**
Structural Grade: **0**
O&M Grade: **2**
Clock Start/From: **3**
Clock To:
1st Value: **4.000**
2nd Value:
Value Percent:
Continuous Index:
Within 8" of Joint:
Remarks: **roots**

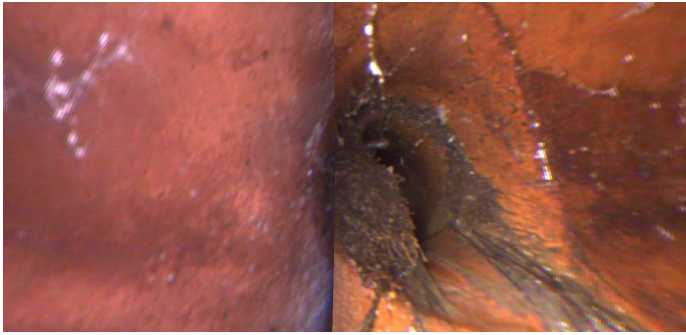
Code: **RML**
Description: **Roots Medium Lateral**

Distance (ft): **120.9**
Structural Grade: **0**
O&M Grade: **3**
Clock Start/From: **7**
Clock To: **5**
1st Value:
2nd Value:
Value Percent: **5.000**
Continuous Index:
Within 8" of Joint: **NO**
Remarks:

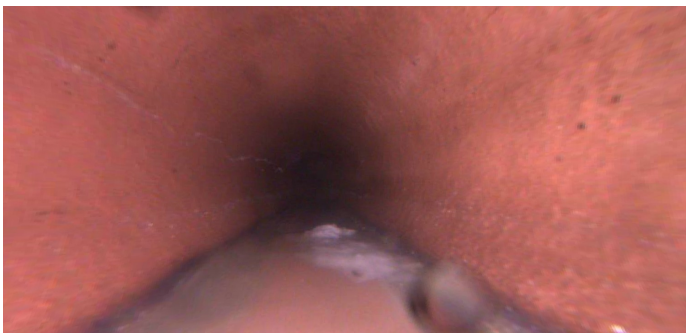
Code: **DSZ**
Description: **Deposits Settled Other**

Distance (ft): **154.4**
Structural Grade: **0**
O&M Grade: **2**
Clock Start/From: **6**
Clock To:
1st Value:
2nd Value:
Value Percent: **5.000**
Continuous Index:
Within 8" of Joint: **NO**
Remarks: **tissue**

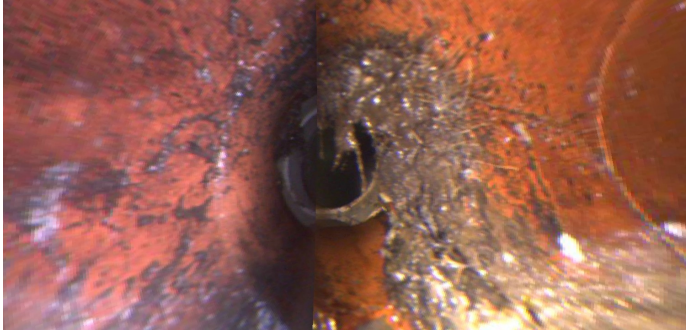
Code: **TFD**
Description: **Tap Factory Defective**

Distance (ft): **188.9**
Structural Grade: **0**
O&M Grade: **2**
Clock Start/From: **3**
Clock To:
1st Value: **4.000**
2nd Value:
Value Percent:
Continuous Index:
Within 8" of Joint:
Remarks: **offset**

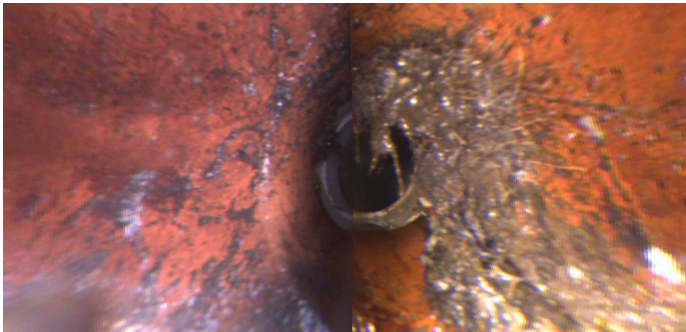
Code: **RMC**
Description: **Roots Medium Connection**

Distance (ft): **188.9**
Structural Grade: **0**
O&M Grade: **3**
Clock Start/From: **12**
Clock To: **5**
1st Value:
2nd Value:
Value Percent: **10.000**
Continuous Index:
Within 8" of Joint: **NO**
Remarks:

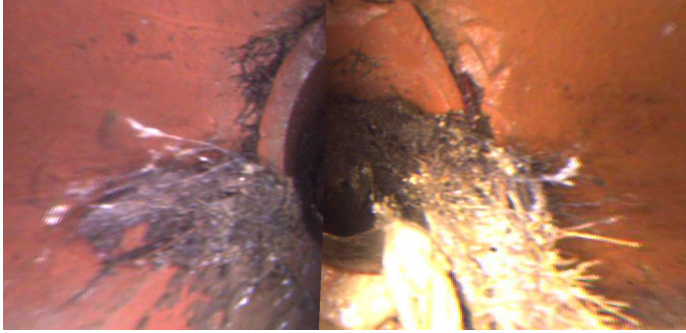
Code: **TFD**
Description: **Tap Factory Defective**

Distance (ft): **238.8**
Structural Grade: **0**
O&M Grade: **2**
Clock Start/From: **3**
Clock To:
1st Value: **4.000**
2nd Value:
Value Percent:
Continuous Index:
Within 8" of Joint:
Remarks: **roots**

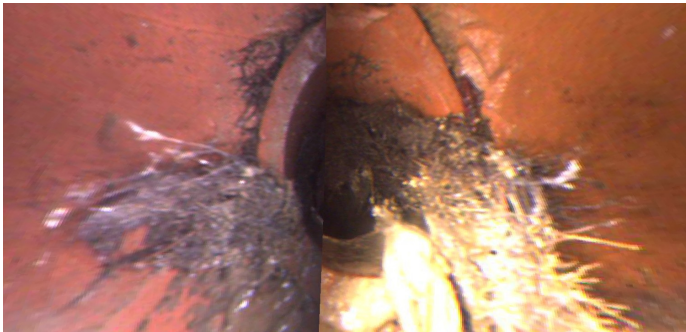
Code: **RML**
Description: **Roots Medium Lateral**

Distance (ft): **238.8**
Structural Grade: **0**
O&M Grade: **3**
Clock Start/From: **12**
Clock To: **5**
1st Value:
2nd Value:
Value Percent: **5.000**
Continuous Index:
Within 8" of Joint: **NO**
Remarks: **into pipe**

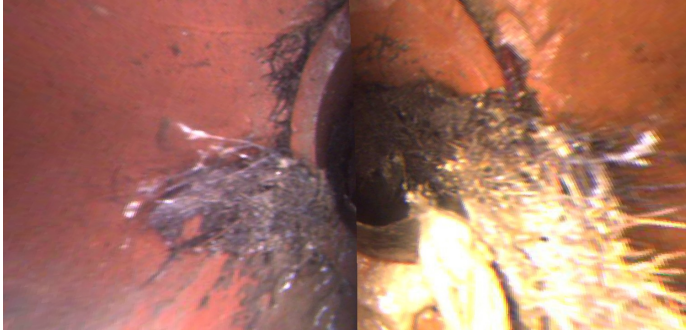
Code: **RMC**
Description: **Roots Medium Connection**

Distance (ft): **238.8**
Structural Grade: **0**
O&M Grade: **3**
Clock Start/From: **7**
Clock To:
1st Value:
2nd Value:
Value Percent: **5.000**
Continuous Index:
Within 8" of Joint: **NO**
Remarks:

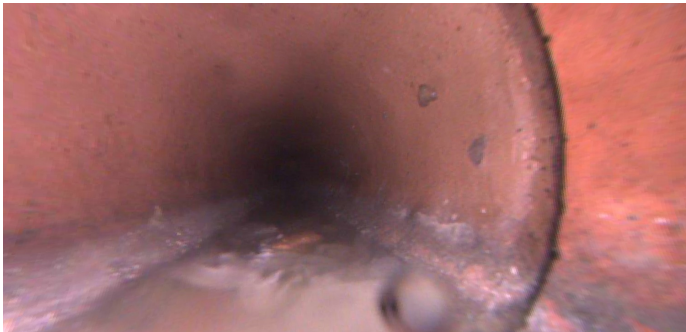
Code: **DSZ**
Description: **Deposits Settled Other**

Distance (ft): **240.6**
Structural Grade: **0**
O&M Grade: **2**
Clock Start/From: **6**
Clock To:
1st Value:
2nd Value:
Value Percent: **5.000**
Continuous Index:
Within 8" of Joint: **NO**
Remarks: **tissue**

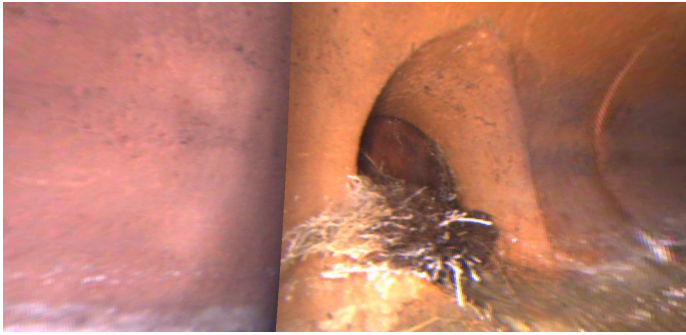
Code: **TFD**
Description: **Tap Factory Defective**

Distance (ft): **257.4**
Structural Grade: **0**
O&M Grade: **2**
Clock Start/From: **3**
Clock To:
1st Value: **4.000**
2nd Value:
Value Percent:
Continuous Index:
Within 8" of Joint: **YES**
Remarks: **roots**

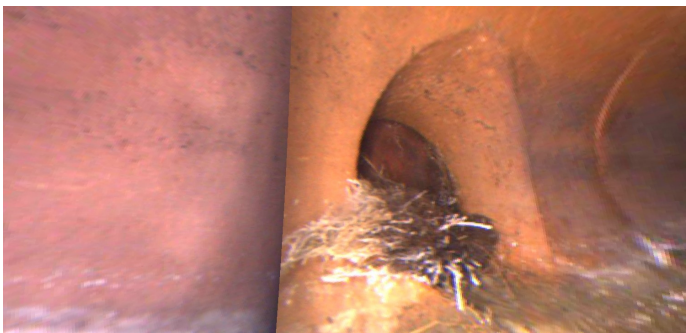
Code: **RML**
Description: **Roots Medium Lateral**

Distance (ft): **257.4**
Structural Grade: **0**
O&M Grade: **3**
Clock Start/From: **6**
Clock To: **9**
1st Value:
2nd Value:
Value Percent: **5.000**
Continuous Index:
Within 8" of Joint: **NO**
Remarks:

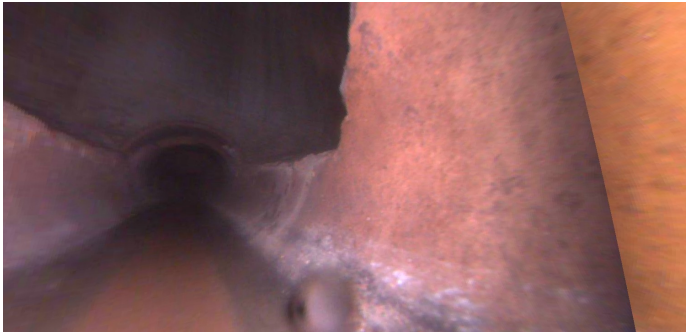
Code: **RFJ**
Description: **Roots Fine Joint**

Distance (ft): **270.2**
Structural Grade: **0**
O&M Grade: **1**
Clock Start/From: **7**
Clock To: **5**
1st Value:
2nd Value:
Value Percent:
Continuous Index: **F03**
Within 8" of Joint: **YES**
Remarks: **wandering**
