Profile/Photo Observation Report

Street:	S COLORADO ST & W 7TH PL	Flow Control:	Not Controlled
City:	Hobart, IN	Year Renewed:	
Location:	Yard	Tape/Media #:	
Purpose:	Routine Assessment	Dia/Height:	10"
Use:	Sanitary	Material:	VCP
Drain Area:	NA	Lining:	
Category:	NA		
Comment:	P_C debris, flow direction is marked wrong.		
Location Details:		Direction of Survey:	Upstream
US MH:	M-506-011	DS MH:	M-506-026
		Total Length Surveyed (ft):	37.7

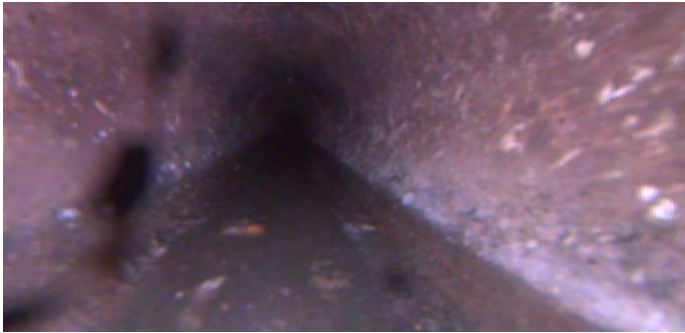
Code:	MWL
Description:	Water Level

Distance (ft):	.0
Structural Grade:	0
O&M Grade:	0
Clock Start/From:	
Clock To:	
1st Value:	
2nd Value:	
Value Percent:	5.000
Continuous Index:	
Within 8" of Joint:	NO
Remarks:

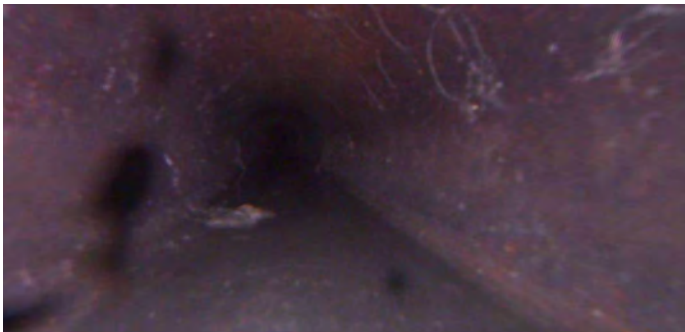
Code:	DSZ
Description:	Deposits Settled Other

Distance (ft):	13.2
Structural Grade:	0
O&M Grade:	2
Clock Start/From:	6
Clock To:	
1st Value:	
2nd Value:	
Value Percent:	5.000
Continuous Index:	S01
Within 8" of Joint:	NO
Remarks:	tissue/debris

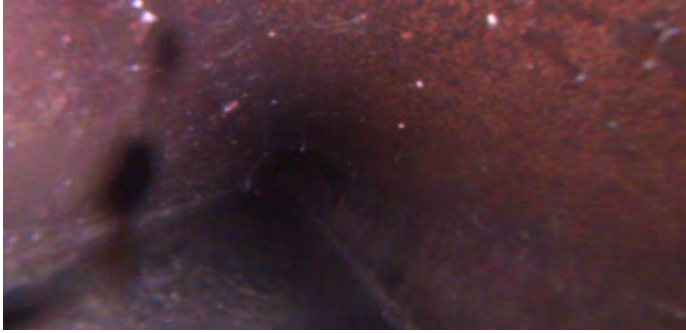
Code: **MSA**
Description: **Abandoned Survey**

Distance (ft): **37.7**
Structural Grade: **0**
O&M Grade: **0**
Clock Start/From:
Clock To:
1st Value:
2nd Value:
Value Percent:
Continuous Index:
Within 8" of Joint: **NO**
Remarks: **camera flipped**

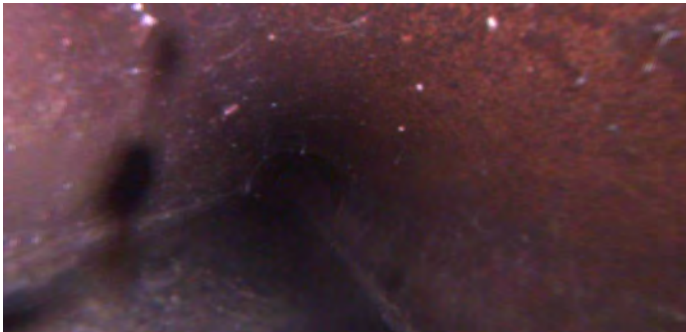
Code: **DSZ**
Description: **Deposits Settled Other**

Distance (ft): **37.7**
Structural Grade: **0**
O&M Grade: **2**
Clock Start/From: **6**
Clock To:
1st Value:
2nd Value:
Value Percent: **5.000**
Continuous Index: **F01**
Within 8" of Joint: **NO**
Remarks: **tissue/debris**
