Profile/Photo Observation Report

Street:	S COLORADO ST & W 7TH PL	Flow Control:	Not Controlled
City:	Hobart, IN	Year Renewed:	
Location:	Yard	Tape/Media #:	
Purpose:	Routine Assessment	Dia/Height:	10"
Use:	Sanitary	Material:	VCP
Drain Area:	NA	Lining:	
Category:	NA		
Comment:	F_S_P_C debris, flow direction is marked wrong.		
Location Details:		Direction of Survey:	Downstream
US MH:	M-506-011	DS MH:	M-506-026
		Total Length Surveyed (ft):	13.2

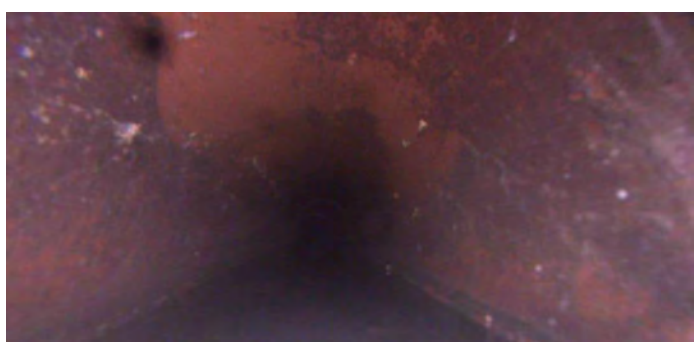
Code: **AMH**
Description: **Manhole**

Distance (ft): **.0**
Structural Grade: **0**
O&M Grade: **0**
Clock Start/From:
Clock To:
1st Value:
2nd Value:
Value Percent:
Continuous Index:
Within 8" of Joint: **NO**
Remarks: **M-506-011**

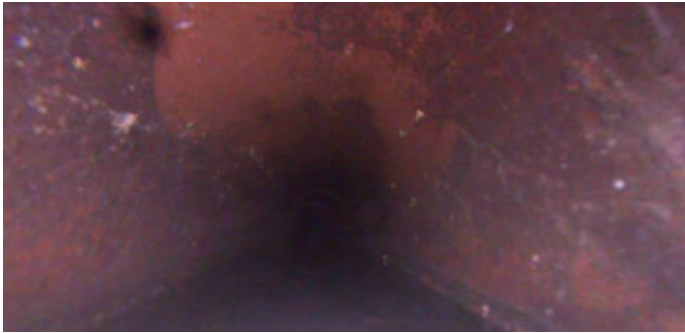
Code:	MWL
Description:	Water Level

Distance (ft):	.0
Structural Grade:	0
O&M Grade:	0
Clock Start/From:	
Clock To:	
1st Value:	
2nd Value:	
Value Percent:	10.000
Continuous Index:	
Within 8" of Joint:	NO
Remarks:

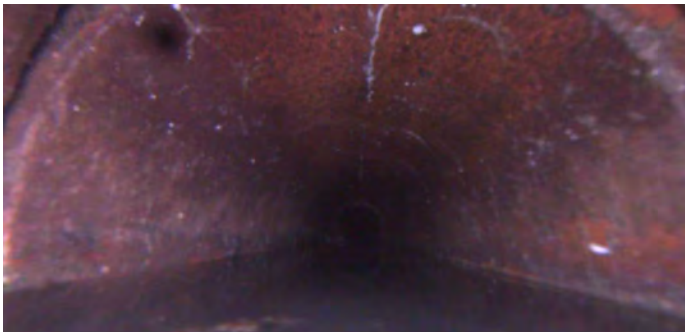
Code:	MSA
Description:	Abandoned Survey

Distance (ft):	13.2
Structural Grade:	0
O&M Grade:	0
Clock Start/From:	
Clock To:	
1st Value:	
2nd Value:	
Value Percent:	
Continuous Index:	
Within 8" of Joint:	NO
Remarks:	debris under water
