Profile/Photo Observation Report

Street:	OFF 15TH PL	Flow Control:	Not Controlled
City:	Hobart, IN	Year Renewed:	
Location:	Light Highway	Tape/Media #:	
Purpose:	Routine Assessment	Dia/Height:	10"
Use:	Sanitary	Material:	VCP
Drain Area:	NA	Lining:	
Category:	NA		
Comment:	Flow direction wrong

Location Details:		Direction of Survey:	Downstream
US MH:	M-108-039	DS MH:	M-108-038
		Total Length Surveyed (ft):	203.6

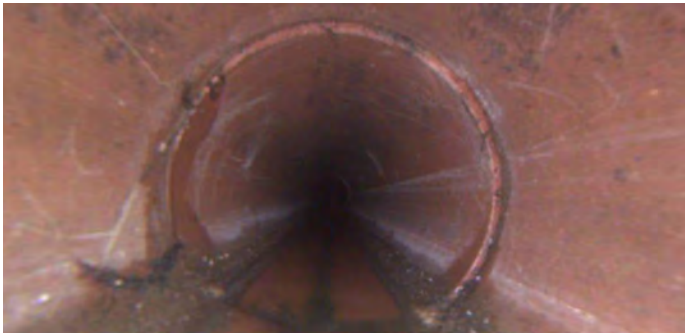
Code:	RFJ
Description:	Roots Fine Joint

Distance (ft):	6.0
Structural Grade:	0
O&M Grade:	1
Clock Start/From:	8
Clock To:	4
1st Value:	
2nd Value:	
Value Percent:	
Continuous Index:	S02
Within 8" of Joint:	YES
Remarks:

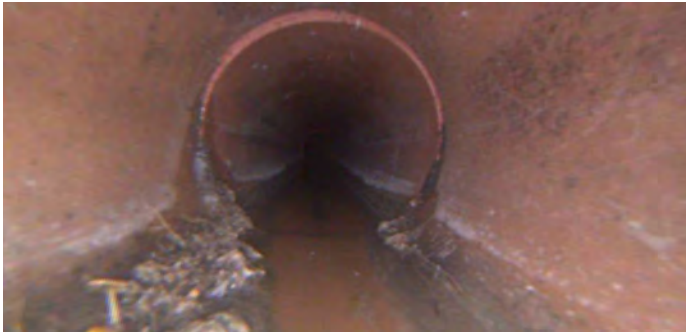
Code: **RMJ**
Description: **Roots Medium Joint**

Distance (ft): **26.3**
Structural Grade: **0**
O&M Grade: **3**
Clock Start/From: **7**
Clock To:
1st Value:
2nd Value:
Value Percent: **5.000**
Continuous Index:
Within 8" of Joint: **YES**
Remarks: **into barrel**

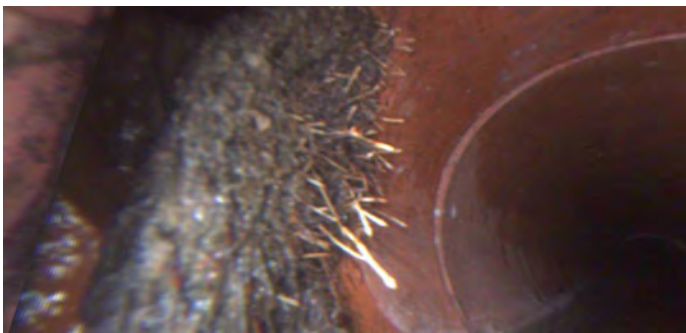
Code: **TFD**
Description: **Tap Factory Defective**

Distance (ft): **49.5**
Structural Grade: **0**
O&M Grade: **2**
Clock Start/From: **10**
Clock To:
1st Value: **4.000**
2nd Value:
Value Percent:
Continuous Index:
Within 8" of Joint:
Remarks: **blocked by roots**

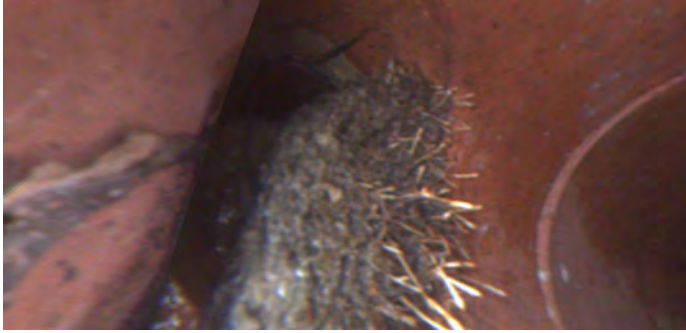
Code: **RML**
Description: **Roots Medium Lateral**

Distance (ft): **49.5**
Structural Grade: **0**
O&M Grade: **3**
Clock Start/From: **1**
Clock To: **6**
1st Value:
2nd Value:
Value Percent: **40.000**
Continuous Index:
Within 8" of Joint: **NO**
Remarks: **around tap**

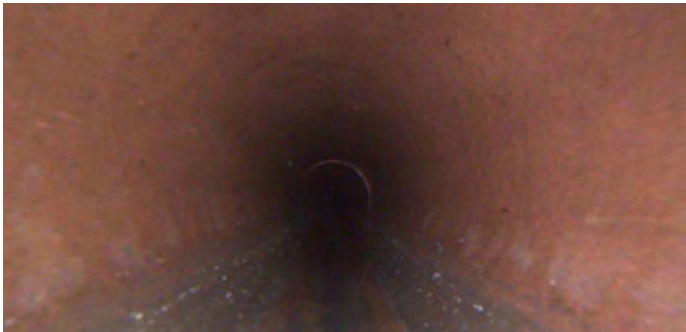
Code: **RFJ**
Description: **Roots Fine Joint**

Distance (ft): **52.2**
Structural Grade: **0**
O&M Grade: **1**
Clock Start/From: **8**
Clock To: **4**
1st Value:
2nd Value:
Value Percent:
Continuous Index: **F02**
Within 8" of Joint: **YES**
Remarks:

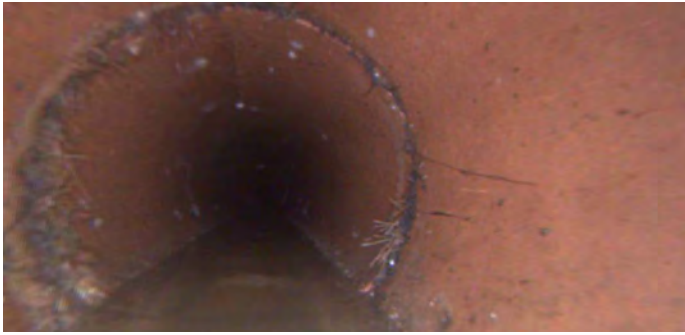
Code: **RFJ**
Description: **Roots Fine Joint**

Distance (ft): **97.5**
Structural Grade: **0**
O&M Grade: **1**
Clock Start/From: **7**
Clock To: **5**
1st Value:
2nd Value:
Value Percent:
Continuous Index:
Within 8" of Joint: **YES**
Remarks:

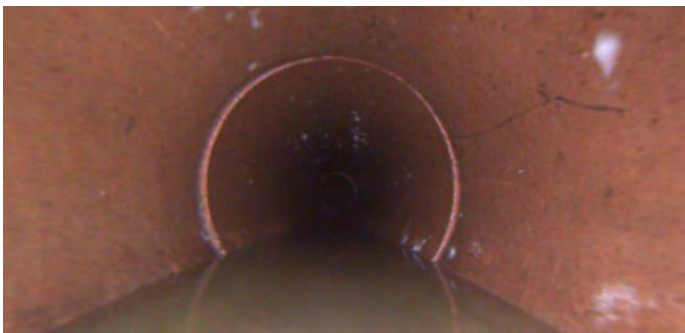
Code: **RFJ**
Description: **Roots Fine Joint**

Distance (ft): **113.1**
Structural Grade: **0**
O&M Grade: **1**
Clock Start/From: **2**
Clock To:
1st Value:
2nd Value:
Value Percent:
Continuous Index:
Within 8" of Joint: **YES**
Remarks:

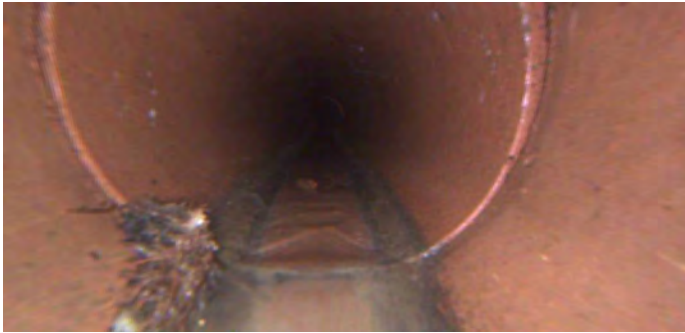
Code: **RFJ**
Description: **Roots Fine Joint**

Distance (ft): **118.9**
Structural Grade: **0**
O&M Grade: **1**
Clock Start/From: **7**
Clock To:
1st Value:
2nd Value:
Value Percent:
Continuous Index: **S01**
Within 8" of Joint: **YES**
Remarks: **wandering**

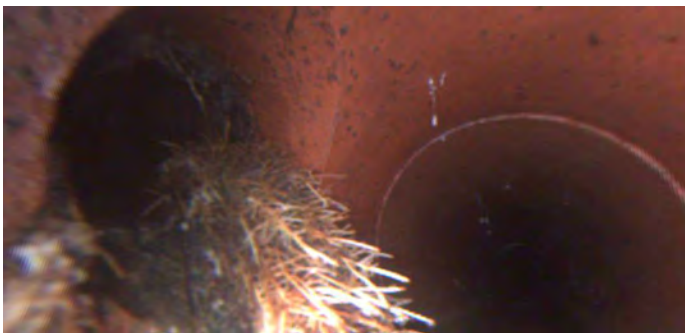
Code: **RML**
Description: **Roots Medium Lateral**

Distance (ft): **141.8**
Structural Grade: **0**
O&M Grade: **3**
Clock Start/From: **3**
Clock To: **5**
1st Value:
2nd Value:
Value Percent: **5.000**
Continuous Index:
Within 8" of Joint: **NO**
Remarks: **around tap**

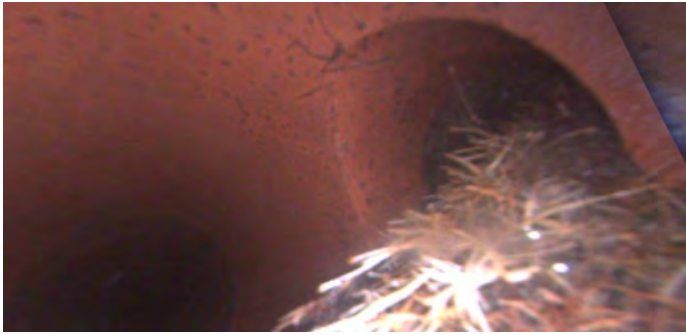
Code: **TFD**
Description: **Tap Factory Defective**

Distance (ft): **142.5**
Structural Grade: **0**
O&M Grade: **2**
Clock Start/From: **10**
Clock To:
1st Value: **4.000**
2nd Value:
Value Percent:
Continuous Index:
Within 8" of Joint:
Remarks: **roots**

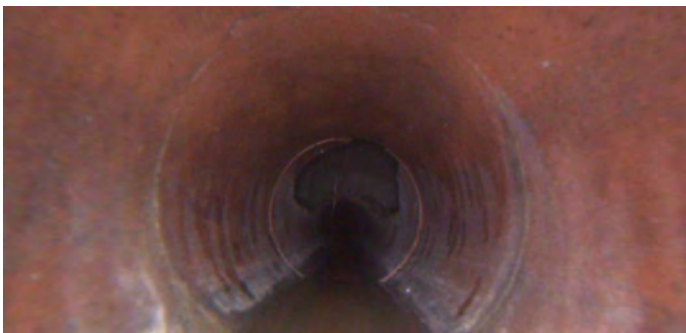
Code: **FC**
Description: **Fracture Circumferential**

Distance (ft): **200.0**
Structural Grade: **2**
O&M Grade: **0**
Clock Start/From: **8**
Clock To: **4**
1st Value:
2nd Value:
Value Percent:
Continuous Index:
Within 8" of Joint:
Remarks:

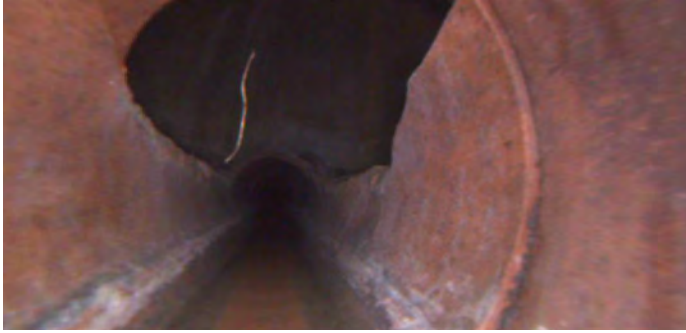
Code: **RFJ**
Description: **Roots Fine Joint**

Distance (ft): **201.3**
Structural Grade: **0**
O&M Grade: **1**
Clock Start/From: **7**
Clock To:
1st Value:
2nd Value:
Value Percent:
Continuous Index: **F01**
Within 8" of Joint: **YES**
Remarks: **wandering**
