Profile/Photo Observation Report

Street:	FOXCROFT STREET	Flow Control:	Not Controlled
City:	Hobart, IN	Year Renewed:	
Location:	Light Highway	Tape/Media #:	
Purpose:	Routine Assessment	Dia/Height:	10"
Use:	Sanitary	Material:	VCP
Drain Area:	NA	Lining:	
Category:	NA		
Comment:	Flow direction wrong

Location Details:		Direction of Survey:	Downstream
US MH:	M-108-039	DS MH:	M-108-038
		Total Length Surveyed (ft):	203.6

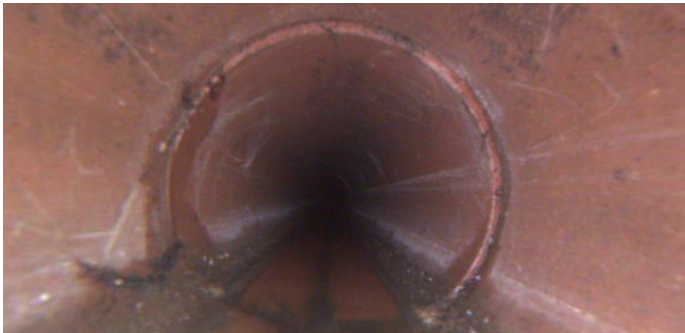
Code:	RFJ
Description:	Roots Fine Joint

Distance (ft):	6.0
Structural Grade:	0
O&M Grade:	1
Clock Start/From:	8
Clock To:	4
1st Value:	
2nd Value:	
Value Percent:	
Continuous Index:	S02
Within 8" of Joint:	YES
Remarks:

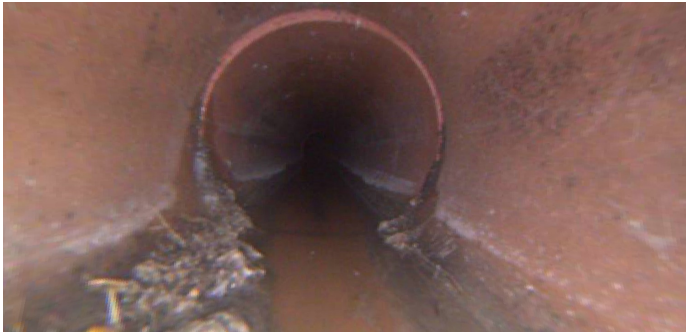
Code: **RMJ**
Description: **Roots Medium Joint**

Distance (ft): **26.3**
Structural Grade: **0**
O&M Grade: **3**
Clock Start/From: **7**
Clock To:
1st Value:
2nd Value:
Value Percent: **5.000**
Continuous Index:
Within 8" of Joint: **YES**
Remarks: **into barrel**

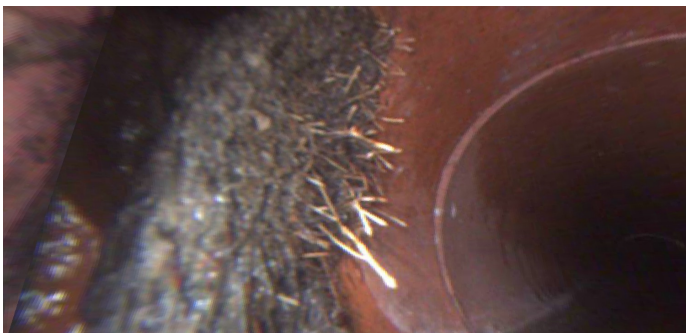
Code: **TFD**
Description: **Tap Factory Defective**

Distance (ft): **49.5**
Structural Grade: **0**
O&M Grade: **2**
Clock Start/From: **10**
Clock To:
1st Value: **4.000**
2nd Value:
Value Percent:
Continuous Index:
Within 8" of Joint:
Remarks: **blocked by roots**

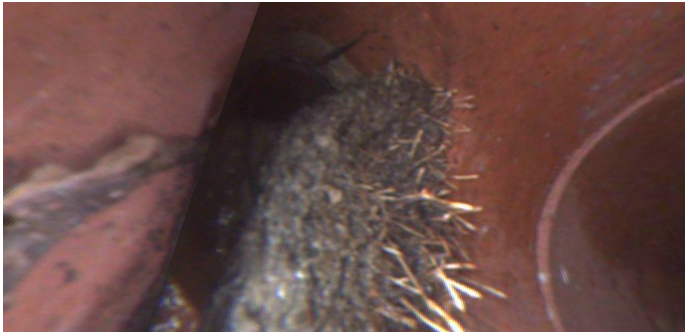
Code: **RML**
Description: **Roots Medium Lateral**

Distance (ft): **49.5**
Structural Grade: **0**
O&M Grade: **3**
Clock Start/From: **1**
Clock To: **6**
1st Value:
2nd Value:
Value Percent: **40.000**
Continuous Index:
Within 8" of Joint: **NO**
Remarks: **around tap**

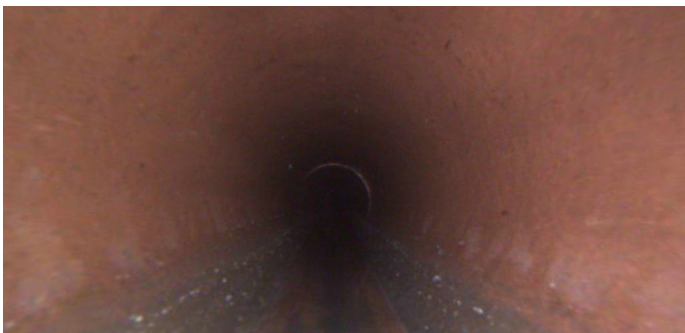
Code: **RFJ**
Description: **Roots Fine Joint**

Distance (ft): **52.2**
Structural Grade: **0**
O&M Grade: **1**
Clock Start/From: **8**
Clock To: **4**
1st Value:
2nd Value:
Value Percent:
Continuous Index: **F02**
Within 8" of Joint: **YES**
Remarks:

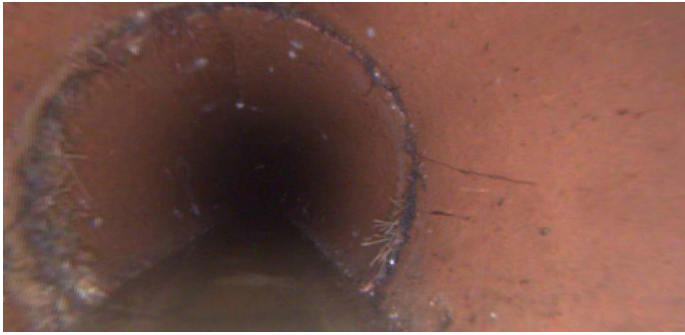
Code: **RFJ**
Description: **Roots Fine Joint**

Distance (ft): **97.5**
Structural Grade: **0**
O&M Grade: **1**
Clock Start/From: **7**
Clock To: **5**
1st Value:
2nd Value:
Value Percent:
Continuous Index:
Within 8" of Joint: **YES**
Remarks:

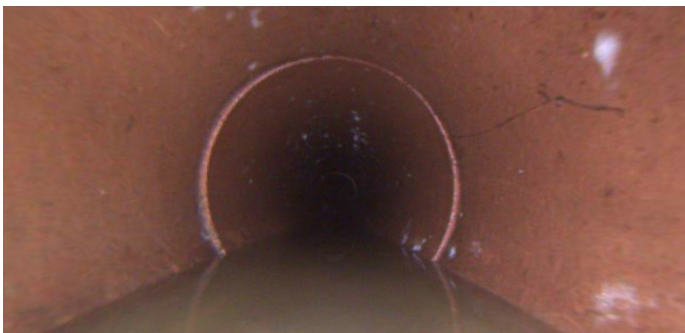
Code: **RFJ**
Description: **Roots Fine Joint**

Distance (ft): **113.1**
Structural Grade: **0**
O&M Grade: **1**
Clock Start/From: **2**
Clock To:
1st Value:
2nd Value:
Value Percent:
Continuous Index:
Within 8" of Joint: **YES**
Remarks:

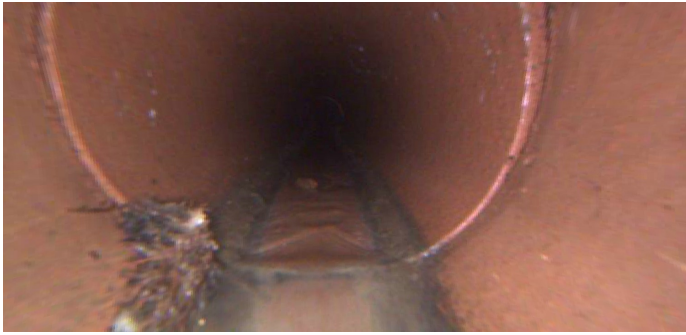
Code: **RFJ**
Description: **Roots Fine Joint**

Distance (ft): **118.9**
Structural Grade: **0**
O&M Grade: **1**
Clock Start/From: **7**
Clock To:
1st Value:
2nd Value:
Value Percent:
Continuous Index: **S01**
Within 8" of Joint: **YES**
Remarks: **wandering**

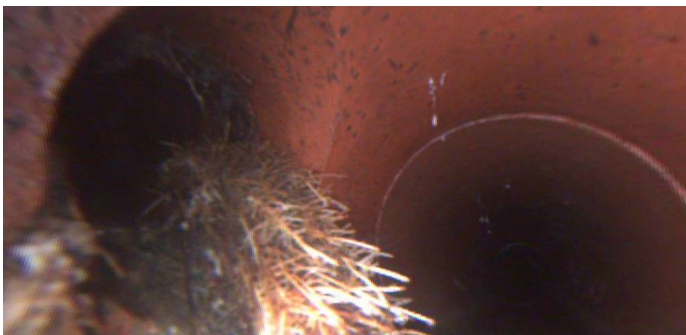
Code: **RML**
Description: **Roots Medium Lateral**

Distance (ft): **141.8**
Structural Grade: **0**
O&M Grade: **3**
Clock Start/From: **3**
Clock To: **5**
1st Value:
2nd Value:
Value Percent: **5.000**
Continuous Index:
Within 8" of Joint: **NO**
Remarks: **around tap**

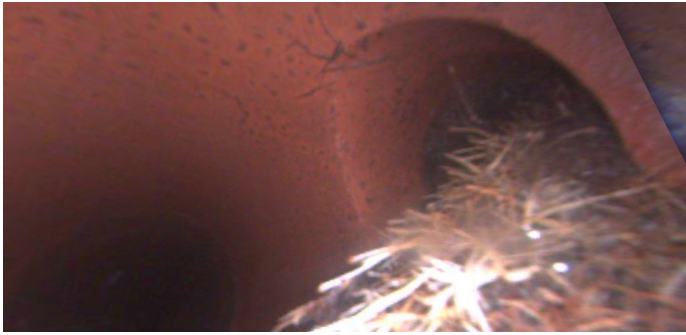
Code: **TFD**
Description: **Tap Factory Defective**

Distance (ft): **142.5**
Structural Grade: **0**
O&M Grade: **2**
Clock Start/From: **10**
Clock To:
1st Value: **4.000**
2nd Value:
Value Percent:
Continuous Index:
Within 8" of Joint:
Remarks: **roots**

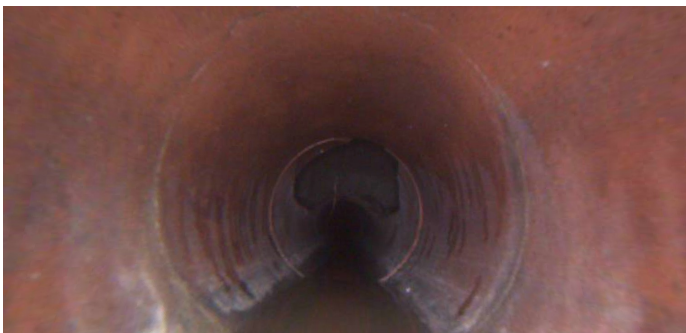
Code: **FC**
Description: **Fracture Circumferential**

Distance (ft): **200.0**
Structural Grade: **2**
O&M Grade: **0**
Clock Start/From: **8**
Clock To: **4**
1st Value:
2nd Value:
Value Percent:
Continuous Index:
Within 8" of Joint:
Remarks:

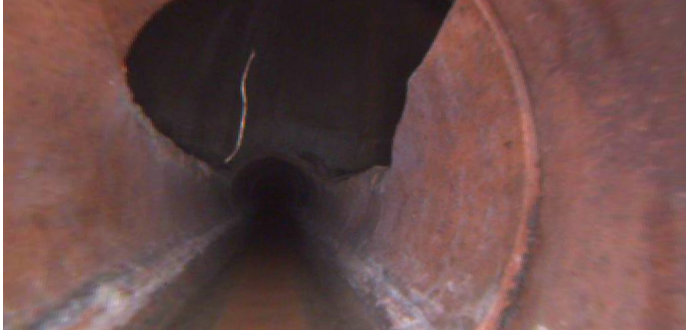
Code: **RFJ**
Description: **Roots Fine Joint**

Distance (ft): **201.3**
Structural Grade: **0**
O&M Grade: **1**
Clock Start/From: **7**
Clock To:
1st Value:
2nd Value:
Value Percent:
Continuous Index: **F01**
Within 8" of Joint: **YES**
Remarks: **wandering**
