Profile/Photo Observation Report

Street:	OFF 15TH PL	Flow Control:	Not Controlled
City:	Hobart, IN	Year Renewed:	
Location:	Light Highway	Tape/Media #:	
Purpose:	Routine Assessment	Dia/Height:	10"
Use:	Sanitary	Material:	VCP
Drain Area:	NA	Lining:	
Category:	NA		
Comment:	Flow direction wrong

Location Details:		Direction of Survey:	Upstream
US MH:	M-108-040	DS MH:	M-108-039
		Total Length Surveyed (ft):	174.0

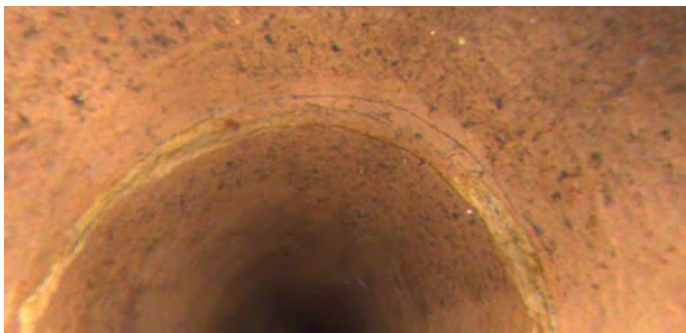
Code: **FM**
Description: **Fracture Multiple**

Distance (ft): **.0**
Structural Grade: **4**
O&M Grade: **0**
Clock Start/From: **9**
Clock To: **3**
1st Value:
2nd Value:
Value Percent:
Continuous Index:
Within 8" of Joint: **YES**
Remarks:

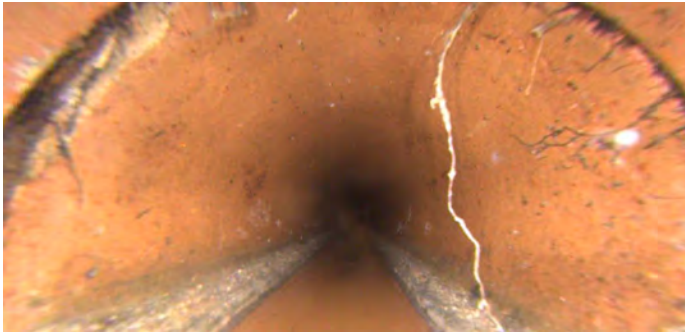
Code: **RFJ**
Description: **Roots Fine Joint**

Distance (ft): **4.9**
Structural Grade: **0**
O&M Grade: **1**
Clock Start/From: **8**
Clock To: **4**
1st Value:
2nd Value:
Value Percent:
Continuous Index:
Within 8" of Joint: **YES**
Remarks:

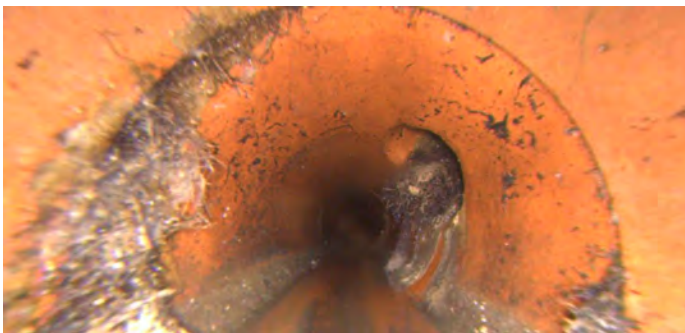
Code: **RMJ**
Description: **Roots Medium Joint**

Distance (ft): **9.8**
Structural Grade: **0**
O&M Grade: **3**
Clock Start/From: **8**
Clock To: **4**
1st Value:
2nd Value:
Value Percent: **10.000**
Continuous Index: **S04**
Within 8" of Joint: **YES**
Remarks:

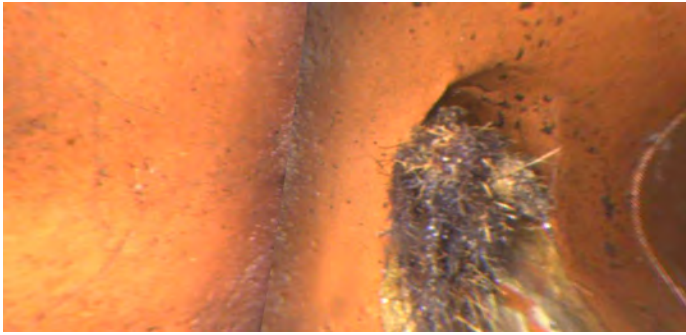
Code: **TFD**
Description: **Tap Factory Defective**

Distance (ft): **11.4**
Structural Grade: **0**
O&M Grade: **2**
Clock Start/From: **2**
Clock To:
1st Value: **4.000**
2nd Value:
Value Percent:
Continuous Index:
Within 8" of Joint: **YES**
Remarks: **blocked by roots**

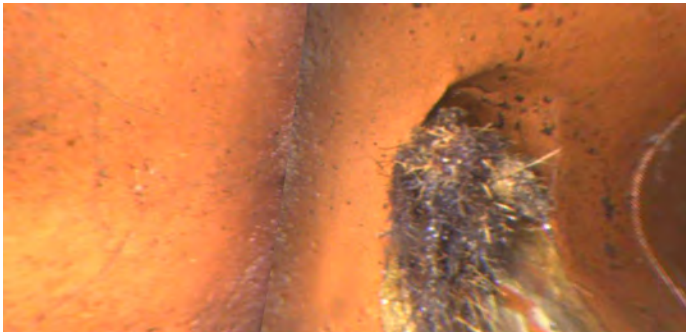
Code: **RML**
Description: **Roots Medium Lateral**

Distance (ft): **11.4**
Structural Grade: **0**
O&M Grade: **3**
Clock Start/From: **6**
Clock To: **11**
1st Value:
2nd Value:
Value Percent: **25.000**
Continuous Index:
Within 8" of Joint: **NO**
Remarks:

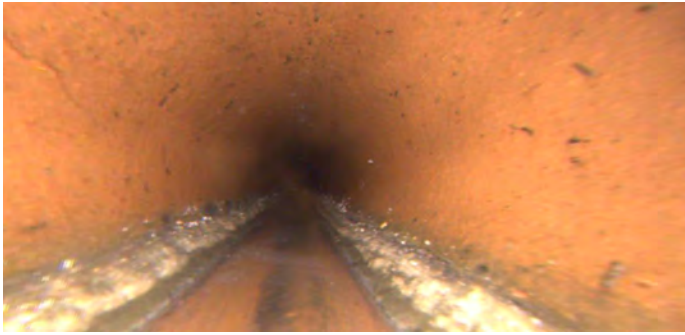
Code: **DAGS**
Description: **Deposits Attached Grease**

Distance (ft): **43.8**
Structural Grade: **0**
O&M Grade: **2**
Clock Start/From: **7**
Clock To: **5**
1st Value:
2nd Value:
Value Percent: **5.000**
Continuous Index: **S02**
Within 8" of Joint: **NO**
Remarks: **7 and 5 oclock**

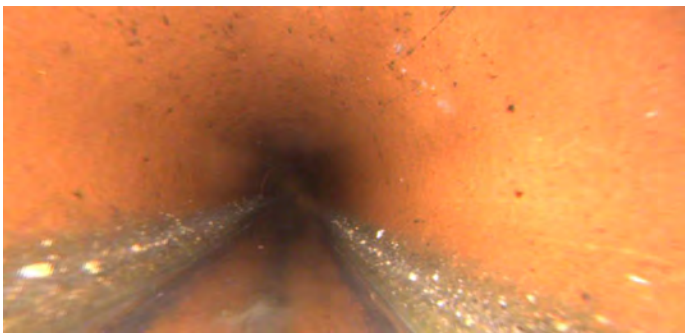
Code: **DAGS**
Description: **Deposits Attached Grease**

Distance (ft): **60.1**
Structural Grade: **0**
O&M Grade: **2**
Clock Start/From: **7**
Clock To: **5**
1st Value:
2nd Value:
Value Percent: **5.000**
Continuous Index: **F02**
Within 8" of Joint: **NO**
Remarks: **7 and 5 oclock**

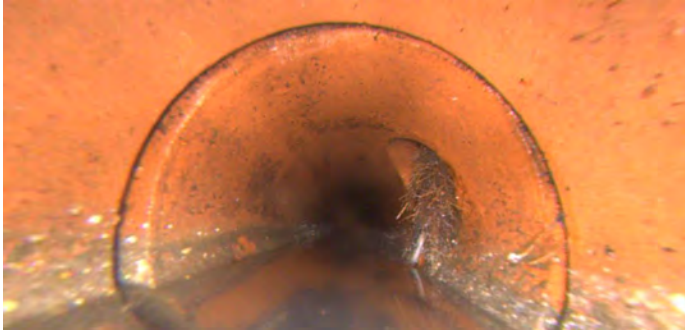
Code: **RMJ**
Description: **Roots Medium Joint**

Distance (ft): **83.6**
Structural Grade: **0**
O&M Grade: **3**
Clock Start/From: **8**
Clock To: **4**
1st Value:
2nd Value:
Value Percent: **10.000**
Continuous Index: **F04**
Within 8" of Joint: **YES**
Remarks:

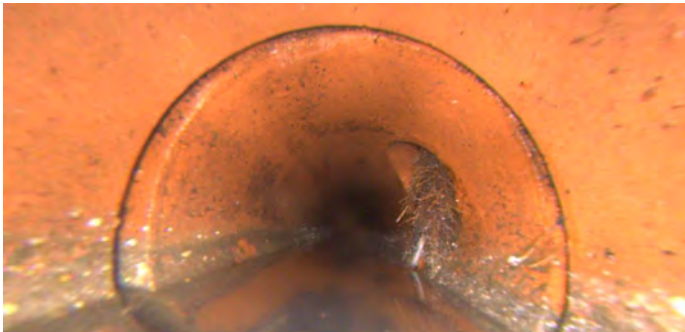
Code: **RFJ**
Description: **Roots Fine Joint**

Distance (ft): **83.6**
Structural Grade: **0**
O&M Grade: **1**
Clock Start/From: **8**
Clock To: **4**
1st Value:
2nd Value:
Value Percent:
Continuous Index: **S05**
Within 8" of Joint: **YES**
Remarks:

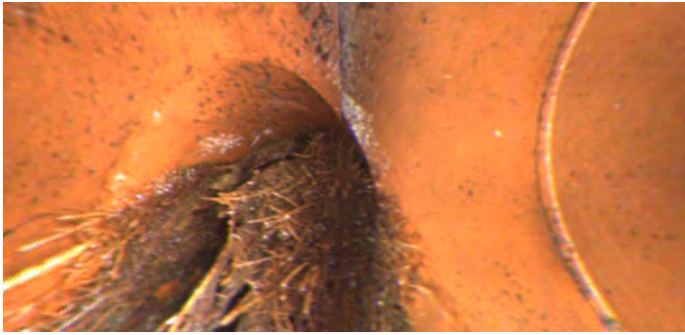
Code: **TFD**
Description: **Tap Factory Defective**

Distance (ft): **84.5**
Structural Grade: **0**
O&M Grade: **2**
Clock Start/From: **2**
Clock To:
1st Value: **4.000**
2nd Value:
Value Percent:
Continuous Index:
Within 8" of Joint: **YES**
Remarks: **blocked by roots**

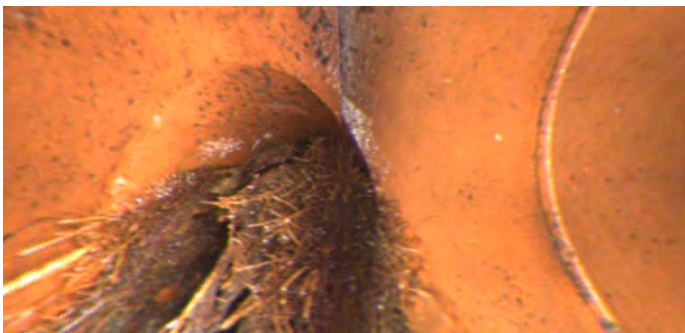
Code: **RML**
Description: **Roots Medium Lateral**

Distance (ft): **84.5**
Structural Grade: **0**
O&M Grade: **3**
Clock Start/From: **7**
Clock To: **5**
1st Value:
2nd Value:
Value Percent: **30.000**
Continuous Index:
Within 8" of Joint: **NO**
Remarks:

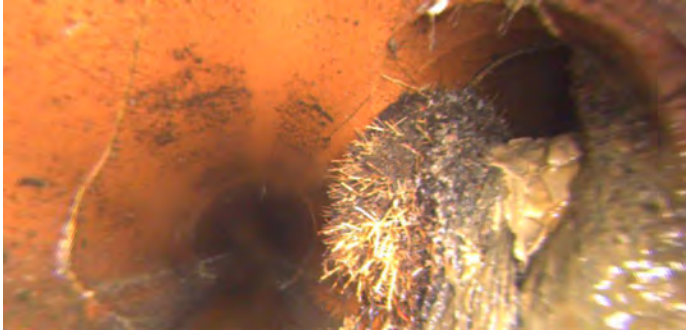
Code: **TFD**
Description: **Tap Factory Defective**

Distance (ft): **137.7**
Structural Grade: **0**
O&M Grade: **2**
Clock Start/From: **2**
Clock To:
1st Value: **4.000**
2nd Value:
Value Percent:
Continuous Index:
Within 8" of Joint:
Remarks: **blocked by roots/debris**

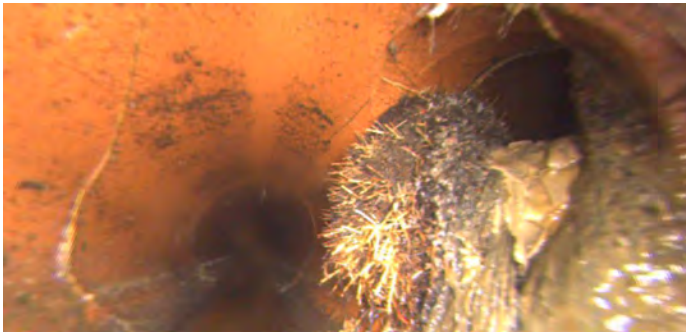
Code: **RML**
Description: **Roots Medium Lateral**

Distance (ft): **137.7**
Structural Grade: **0**
O&M Grade: **3**
Clock Start/From: **6**
Clock To: **12**
1st Value:
2nd Value:
Value Percent: **25.000**
Continuous Index:
Within 8" of Joint: **NO**
Remarks:

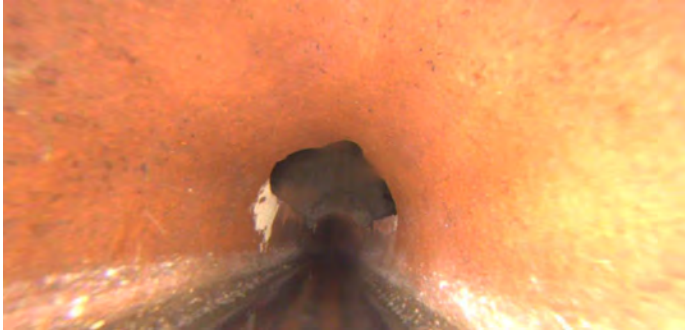
Code: **RFJ**
Description: **Roots Fine Joint**

Distance (ft): **171.1**
Structural Grade: **0**
O&M Grade: **1**
Clock Start/From: **8**
Clock To: **4**
1st Value:
2nd Value:
Value Percent:
Continuous Index: **F05**
Within 8" of Joint: **YES**
Remarks:
