## Profile/Photo Observation Report

| P.O.#: | | Surveyor: | <b>Byrd Fitzgerald</b> | PSR: | <b>P-108-040-041</b> |

| Street: | <b>OFF 15TH PL</b> | Flow Control: | <b>Not Controlled</b> |
| City: | <b>Hobart, IN</b> | Year Renewed: | |

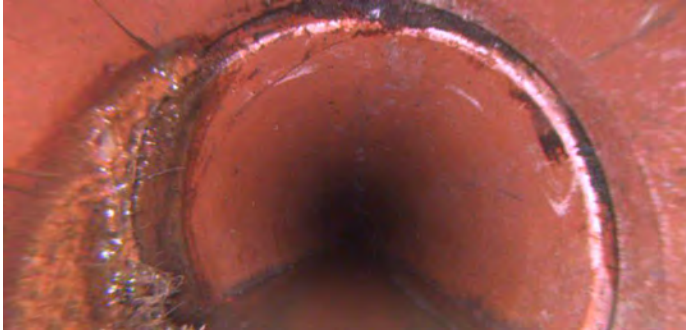
| | Position | Code | Observation | Video (sec) | Grade |
|--|---|---|---|---|---|
| | 15.2 | IW | Infil Weeper | 63 | M 2 |

Code: **IW**  
Description: **Infil Weeper**

Distance (ft): **15.2**  
Structural Grade: **0**  
O&M Grade: **2**  
Clock Start/From: **8**  
Clock To: **11**  
1st Value:  
2nd Value:  
Value Percent:  
Continuous Index:  
Within 8" of Joint: **YES**  
Remarks:

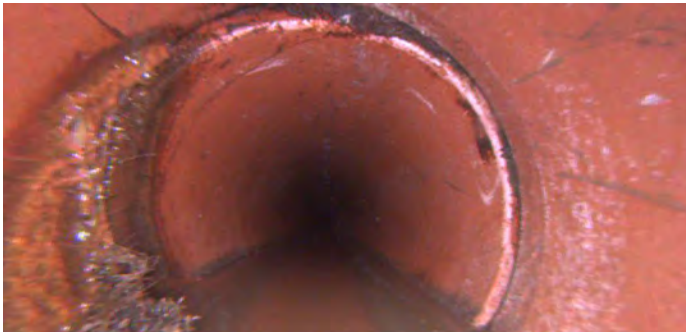
| | Position | Code | Observation | Video (sec) | Grade |
|--|---|---|---|---|---|
| | 15.2 | CM | Crack Multiple | 74 | S 3 |

Code: **CM**  
Description: **Crack Multiple**

Distance (ft): **15.2**  
Structural Grade: **3**  
O&M Grade: **0**  
Clock Start/From: **7**  
Clock To: **12**  
1st Value:  
2nd Value:  
Value Percent:  
Continuous Index:  
Within 8" of Joint: **YES**  
Remarks:

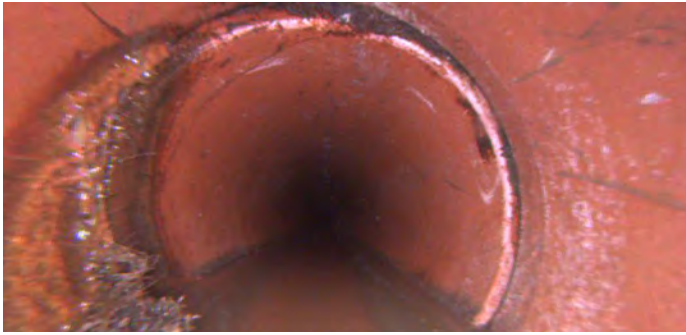
| | Position | Code | Observation | Video (sec) | Grade |
|--|---|---|---|---|---|
| | 15.2 | RFJ | Roots Fine Joint | 85 | M 1 |

Code: **RFJ**  
Description: **Roots Fine Joint**

Distance (ft): **15.2**  
Structural Grade: **0**  
O&M Grade: **1**  
Clock Start/From: **7**  
Clock To: **10**  
1st Value:  
2nd Value:  
Value Percent:  
Continuous Index:  
Within 8" of Joint: **YES**  
Remarks:

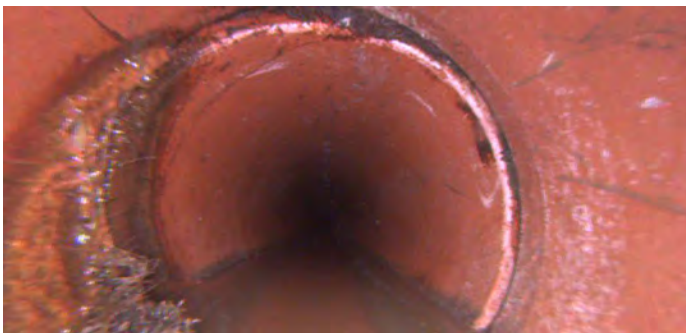
| | Position | Code | Observation | Video (sec) | Grade |
|--|---|---|---|---|---|
| | 15.2 | DAE | Deposits Attached Encrustation | 95 | M 2 |

Code: **DAE**  
Description: **Deposits Attached Encrustation**

Distance (ft): **15.2**  
Structural Grade: **0**  
O&M Grade: **2**  
Clock Start/From: **7**  
Clock To: **11**  
1st Value:  
2nd Value:  
Value Percent: **5.000**  
Continuous Index:  
Within 8" of Joint: **YES**  
Remarks:

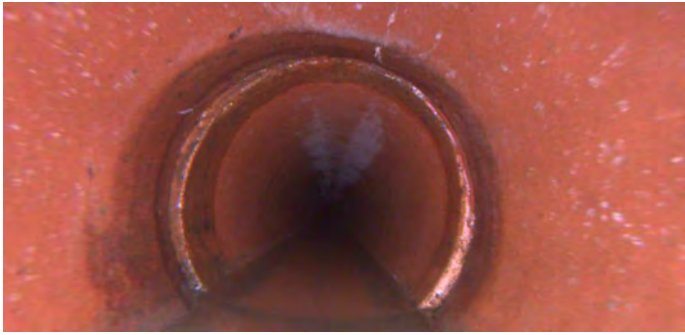
| | Position | Code | Observation | Video (sec) | Grade |
|--|---|---|---|---|---|
| | 24.9 | IW | Infil Weeper | 126 | M 2 |

Code: **IW**  
Description: **Infil Weeper**

Distance (ft): **24.9**  
Structural Grade: **0**  
O&M Grade: **2**  
Clock Start/From: **8**  
Clock To: **4**  
1st Value:  
2nd Value:  
Value Percent:  
Continuous Index:  
Within 8" of Joint: **YES**  
Remarks:

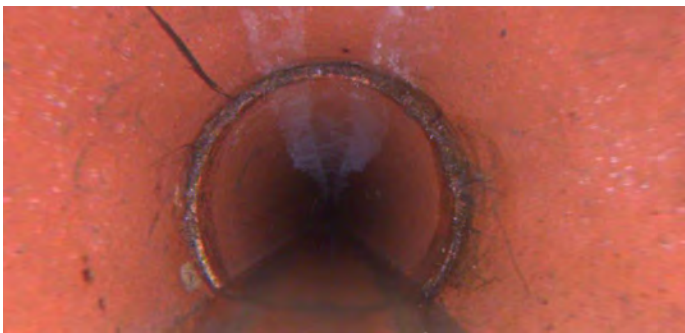
| | Position | Code | Observation | Video (sec) | Grade |
|--|---|---|---|---|---|
| | 29.7 | IW | Infil Weeper | 147 | M 2 |

Code: **IW**  
Description: **Infil Weeper**

Distance (ft): **29.7**  
Structural Grade: **0**  
O&M Grade: **2**  
Clock Start/From: **8**  
Clock To: **4**  
1st Value:  
2nd Value:  
Value Percent:  
Continuous Index:  
Within 8" of Joint: **YES**  
Remarks:

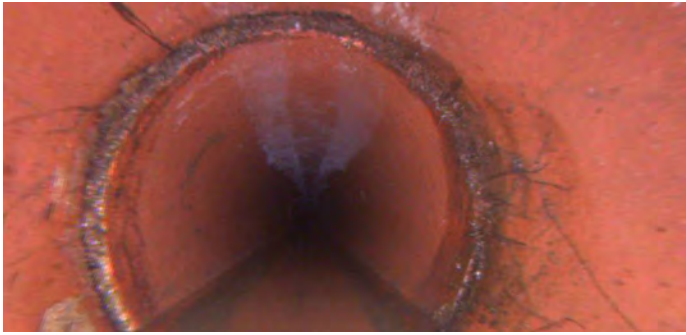
| | Position | Code | Observation | Video (sec) | Grade |
|--|---|---|---|---|---|
| | 30.0 | RFJ(S01) | Roots Fine Joint | 159 | M 1 |

Code: **RFJ**  
Description: **Roots Fine Joint**

Distance (ft): **30.0**  
Structural Grade: **0**  
O&M Grade: **1**  
Clock Start/From: **7**  
Clock To: **5**  
1st Value:  
2nd Value:  
Value Percent:  
Continuous Index: **S01**  
Within 8" of Joint: **YES**  
Remarks: **wandering**

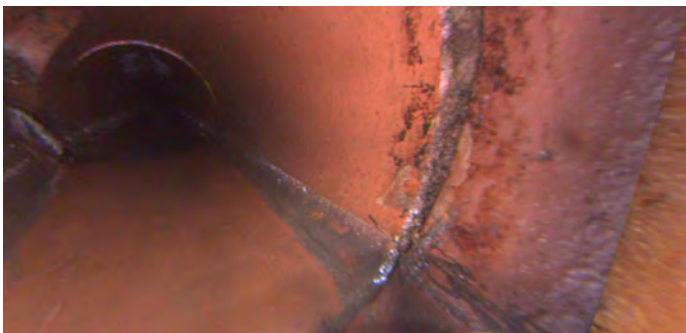
| | Position | Code | Observation | Video (sec) | Grade |
|--|---|---|---|---|---|
| | 55.0 | RFJ | Roots Fine Joint | 220 | M 1 |

Code: **RFJ**  
Description: **Roots Fine Joint**

Distance (ft): **55.0**  
Structural Grade: **0**  
O&M Grade: **1**  
Clock Start/From: **4**  
Clock To:  
1st Value:  
2nd Value:  
Value Percent:  
Continuous Index:  
Within 8" of Joint: **YES**  
Remarks:

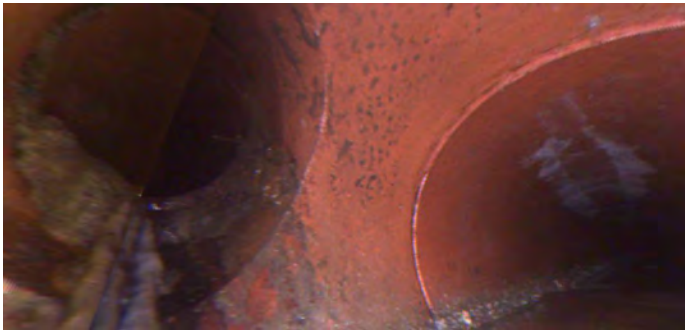
| | Position | Code | Observation | Video (sec) | Grade |
|--|---|---|---|---|---|
| | 56.7 | DAZ | Deposits Attached Other | 246 | M 2 |

Code: **DAZ**  
Description: **Deposits Attached Other**

Distance (ft): **56.7**  
Structural Grade: **0**  
O&M Grade: **2**  
Clock Start/From: **3**  
Clock To: **9**  
1st Value:  
2nd Value:  
Value Percent: **5.000**  
Continuous Index:  
Within 8" of Joint: **NO**  
Remarks: **inside tap**

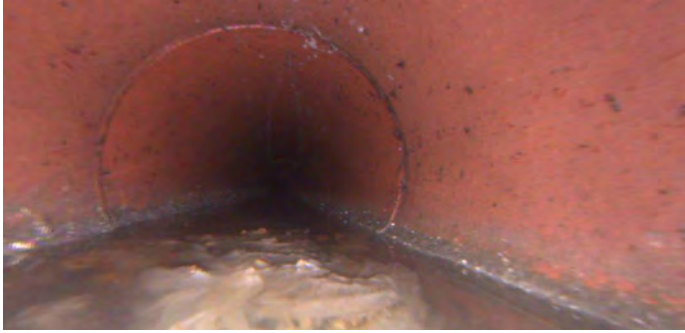
| | Position | Code | Observation | Video (sec) | Grade |
|--|---|---|---|---|---|
| | 61.6 | DSZ | Deposits Settled Other | 268 | M 2 |

Code: **DSZ**  
Description: **Deposits Settled Other**

Distance (ft): **61.6**  
Structural Grade: **0**  
O&M Grade: **2**  
Clock Start/From: **6**  
Clock To:  
1st Value:  
2nd Value:  
Value Percent: **5.000**  
Continuous Index:  
Within 8" of Joint: **NO**  
Remarks: **tissue**

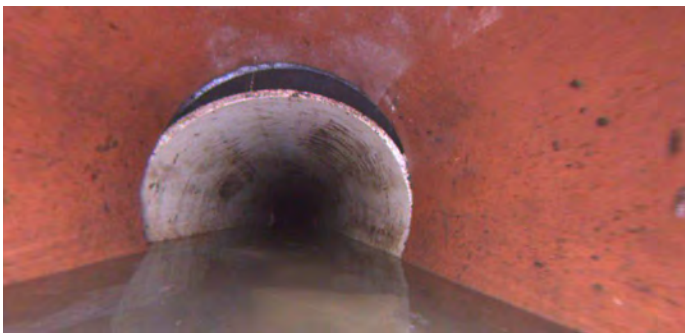
| | Position | Code | Observation | Video (sec) | Grade |
|--|---|---|---|---|---|
| | 95.0 | JOL | Joint Offset Large | 346 | S 2 |

Code: **JOL**  
Description: **Joint Offset Large**

Distance (ft): **95.0**  
Structural Grade: **2**  
O&M Grade: **0**  
Clock Start/From:  
Clock To:  
1st Value:  
2nd Value:  
Value Percent:  
Continuous Index:  
Within 8" of Joint: **NO**  
Remarks:

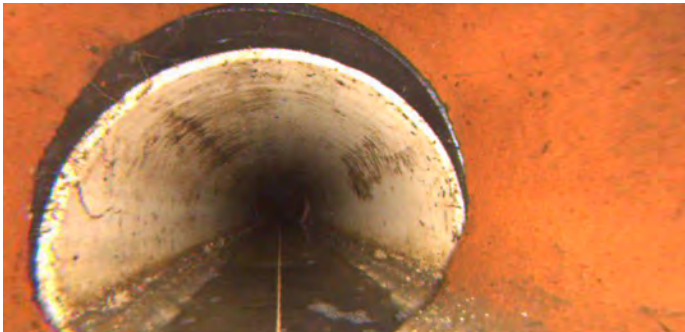
| | Position | Code | Observation | Video (sec) | Grade |
|--|---|---|---|---|---|
| | 100.7 | JOL | Joint Offset Large | 381 | S 2 |

Code: **JOL**  
Description: **Joint Offset Large**

Distance (ft): **100.7**  
Structural Grade: **2**  
O&M Grade: **0**  
Clock Start/From:  
Clock To:  
1st Value:  
2nd Value:  
Value Percent:  
Continuous Index:  
Within 8" of Joint: **NO**  
Remarks:

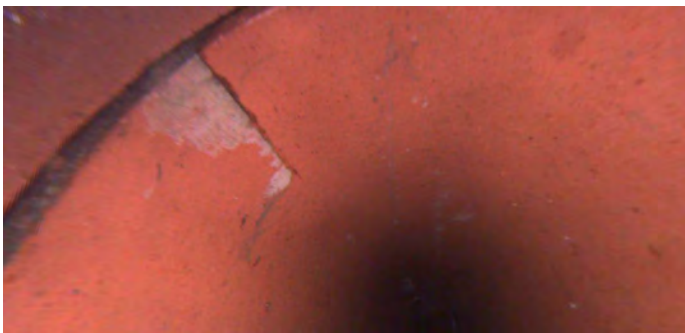
| | Position | Code | Observation | Video (sec) | Grade |
|--|---|---|---|---|---|
| | 118.1 | CL | Crack Longitudinal | 441 | S 2 |

Code: **CL**  
Description: **Crack Longitudinal**

Distance (ft): **118.1**  
Structural Grade: **2**  
O&M Grade: **0**  
Clock Start/From: **11**  
Clock To:  
1st Value:  
2nd Value:  
Value Percent:  
Continuous Index:  
Within 8" of Joint: **YES**  
Remarks:

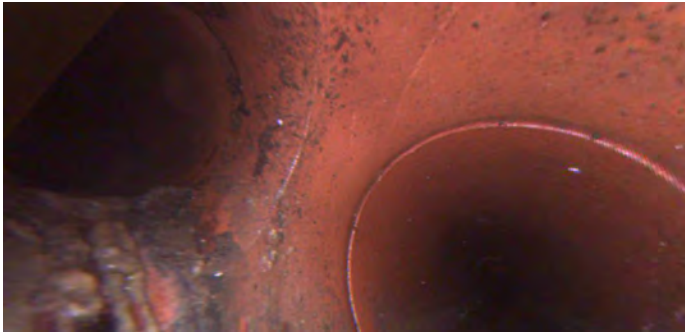
| | Position | Code | Observation | Video (sec) | Grade |
|--|---|---|---|---|---|
| | 134.6 | TFD | Tap Factory Defective | 485 | M 2 |

Code: **TFD**  
Description: **Tap Factory Defective**

Distance (ft): **134.6**  
Structural Grade: **0**  
O&M Grade: **2**  
Clock Start/From: **10**  
Clock To:  
1st Value: **4.000**  
2nd Value:  
Value Percent:  
Continuous Index:  
Within 8" of Joint: **YES**  
Remarks: **ROOTS**

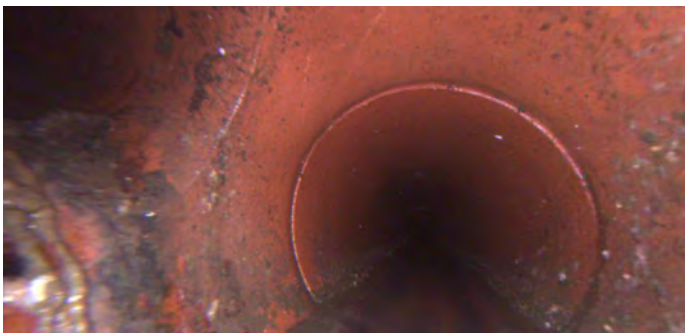
| | Position | Code | Observation | Video (sec) | Grade |
|--|---|---|---|---|---|
| | 134.6 | RFL | Roots Fine Lateral | 496 | M 1 |

Code: **RFL**  
Description: **Roots Fine Lateral**

Distance (ft): **134.6**  
Structural Grade: **0**  
O&M Grade: **1**  
Clock Start/From: **9**  
Clock To:  
1st Value:  
2nd Value:  
Value Percent:  
Continuous Index:  
Within 8" of Joint: **NO**  
Remarks:

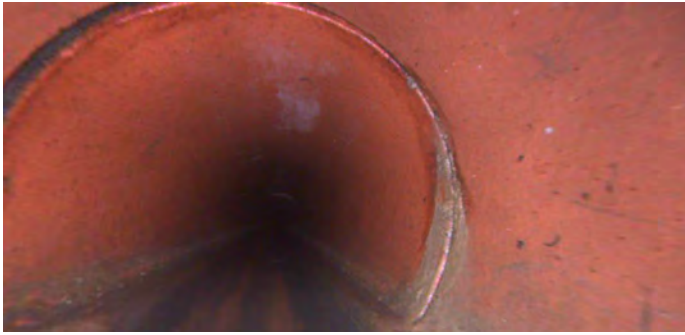
| | Position | Code | Observation | Video (sec) | Grade |
|--|---|---|---|---|---|
| | 139.9 | IW | Infil Weeper | 518 | M 2 |

Code: **IW**  
Description: **Infil Weeper**

Distance (ft): **139.9**  
Structural Grade: **0**  
O&M Grade: **2**  
Clock Start/From: **2**  
Clock To: **4**  
1st Value:  
2nd Value:  
Value Percent:  
Continuous Index:  
Within 8" of Joint: **YES**  
Remarks:

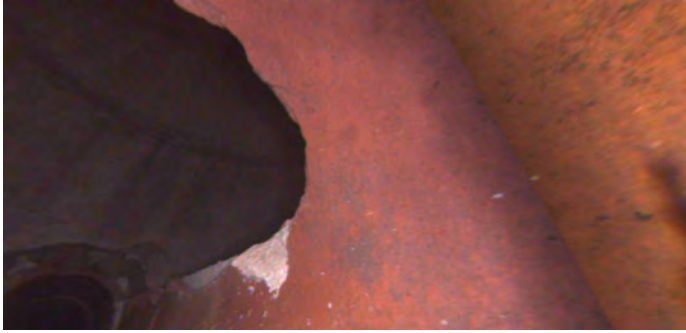
| | Position | Code | Observation | Video (sec) | Grade |
|--|---|---|---|---|---|
| | 247.0 | RFJ(F01) | Roots Fine Joint | 780 | M 1 |

Code: **RFJ**  
Description: **Roots Fine Joint**

Distance (ft): **247.0**  
Structural Grade: **0**  
O&M Grade: **1**  
Clock Start/From: **7**  
Clock To: **5**  
1st Value:  
2nd Value:  
Value Percent:  
Continuous Index: **F01**  
Within 8" of Joint: **YES**  
Remarks: **wandering**
