Profile/Photo Observation Report

Date:	03/24/2018	Weather:		Coding:	PACP 6.0
Pipe Length (ft):	115.6	Owner:	NA	Pre Clean:	No Pre-Cleaning
P.O.#:		Surveyor:	Byrd Fitzgerald	PSR:	P-108-035-046
Customer:		Clean Date:	01/01/1900	Shape:	C

Street:	MISSISSIPPI PL	Flow Control:	Not Controlled
City:	Hobart, IN	Year Renewed:	
Location:	Light Highway	Tape/Media #:	
Purpose:	Routine Assessment	Dia/Height:	12"
Use:	Sanitary	Material:	VCP
Drain Area:	NA	Lining:	
Category:	NA		
Comment:	Flow direction wrong

Location Details:		Direction of Survey:	Upstream
US MH:	M-108-046	DS MH:	M-108-035
		Total Length Surveyed (ft):	103.2

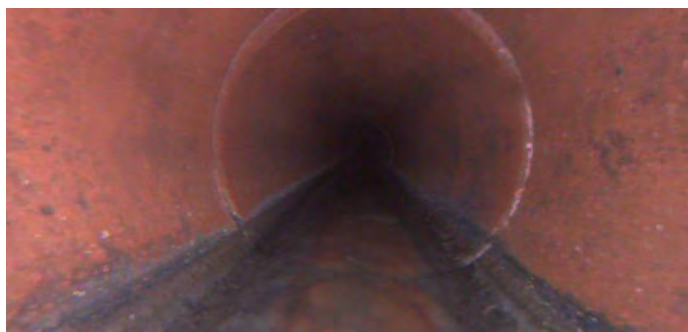
Code: **AMH**
 Description: **Manhole**
 Distance (ft): **.0**
 Structural Grade: **0**
 O&M Grade: **0**
 Clock Start/From:
 Clock To:
 1st Value:
 2nd Value:
 Value Percent:
 Continuous Index:
 Within 8" of Joint: **NO**
 Remarks: **M-108-035**

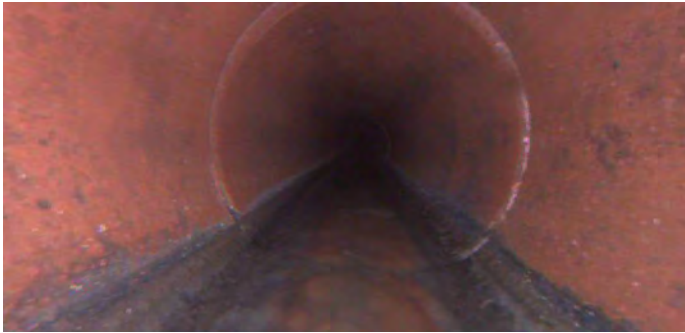
Code:	MWL
Description:	Water Level

Distance (ft):	.0
Structural Grade:	0
O&M Grade:	0
Clock Start/From:	
Clock To:	
1st Value:	
2nd Value:	
Value Percent:	5.000
Continuous Index:	
Within 8" of Joint:	NO
Remarks:

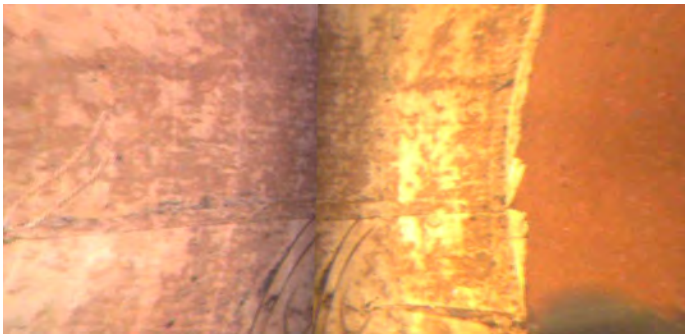
Code:	RPL
Description:	Repair Localized Liner

Distance (ft):	12.3
Structural Grade:	0
O&M Grade:	0
Clock Start/From:	7
Clock To:	5
1st Value:	
2nd Value:	
Value Percent:	
Continuous Index:	S01
Within 8" of Joint:	NO
Remarks:	lining

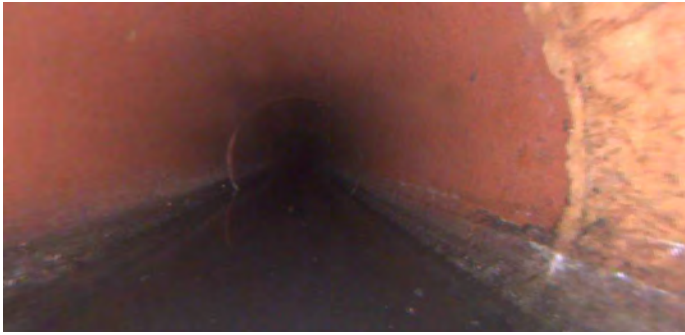
Code: **RPL**
Description: **Repair Localized Liner**

Distance (ft): **15.6**
Structural Grade: **0**
O&M Grade: **0**
Clock Start/From: **7**
Clock To: **5**
1st Value:
2nd Value:
Value Percent:
Continuous Index: **F01**
Within 8" of Joint: **NO**
Remarks: **lining**

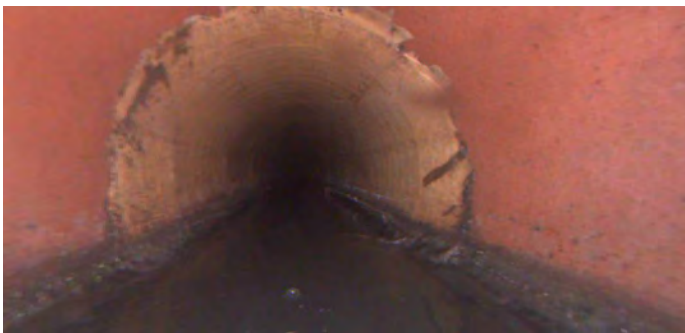
Code: **RPL**
Description: **Repair Localized Liner**

Distance (ft): **18.9**
Structural Grade: **0**
O&M Grade: **0**
Clock Start/From: **7**
Clock To: **5**
1st Value:
2nd Value:
Value Percent:
Continuous Index: **S02**
Within 8" of Joint: **NO**
Remarks: **lining**

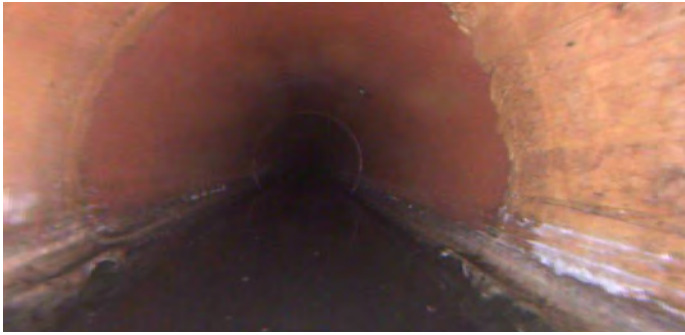
Code: **RPL**
Description: **Repair Localized Liner**

Distance (ft): **22.9**
Structural Grade: **0**
O&M Grade: **0**
Clock Start/From: **7**
Clock To: **5**
1st Value:
2nd Value:
Value Percent:
Continuous Index: **F02**
Within 8" of Joint: **NO**
Remarks: **lining**

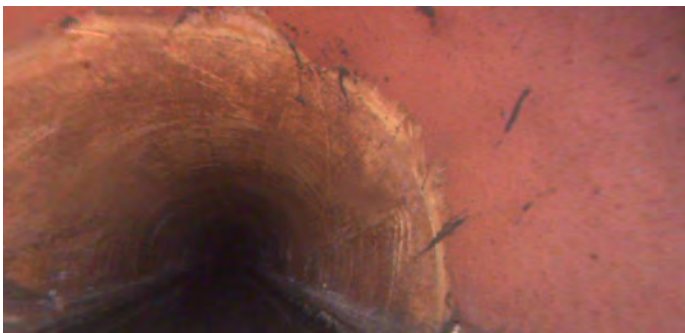
Code: **RPL**
Description: **Repair Localized Liner**

Distance (ft): **27.0**
Structural Grade: **0**
O&M Grade: **0**
Clock Start/From: **7**
Clock To: **5**
1st Value:
2nd Value:
Value Percent:
Continuous Index: **S03**
Within 8" of Joint: **NO**
Remarks: **lining**

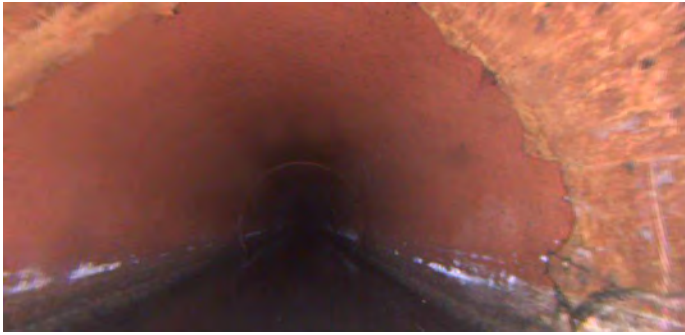
Code: **RPL**
Description: **Repair Localized Liner**

Distance (ft): **31.1**
Structural Grade: **0**
O&M Grade: **0**
Clock Start/From: **7**
Clock To: **5**
1st Value:
2nd Value:
Value Percent:
Continuous Index: **F03**
Within 8" of Joint: **NO**
Remarks: **lining**

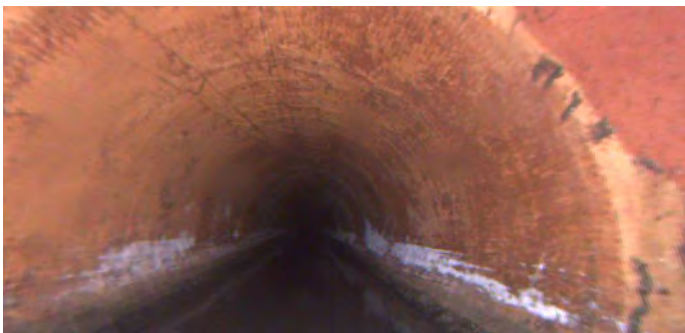
Code: **RPL**
Description: **Repair Localized Liner**

Distance (ft): **35.3**
Structural Grade: **0**
O&M Grade: **0**
Clock Start/From: **7**
Clock To: **5**
1st Value:
2nd Value:
Value Percent:
Continuous Index: **S04**
Within 8" of Joint: **NO**
Remarks: **lining**

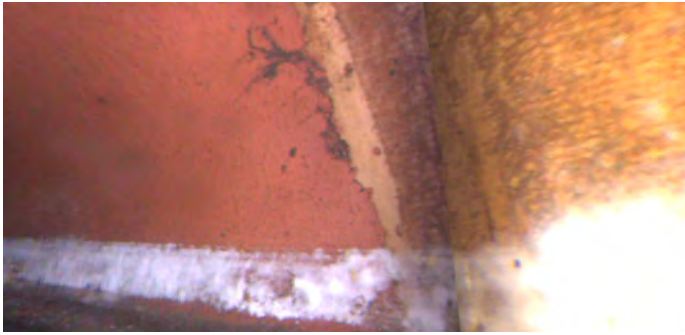
Code: **RPL**
Description: **Repair Localized Liner**

Distance (ft): **39.5**
Structural Grade: **0**
O&M Grade: **0**
Clock Start/From: **7**
Clock To: **5**
1st Value:
2nd Value:
Value Percent:
Continuous Index: **F04**
Within 8" of Joint: **NO**
Remarks: **lining**

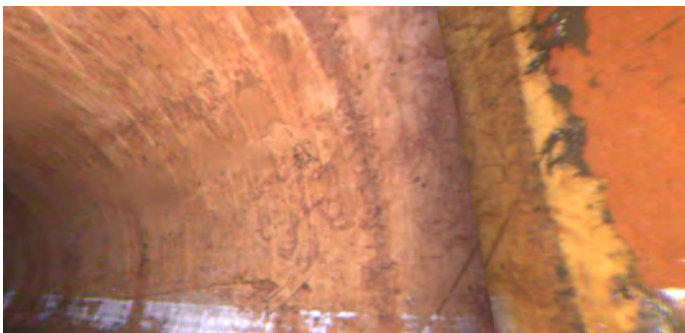
Code: **RPL**
Description: **Repair Localized Liner**

Distance (ft): **43.7**
Structural Grade: **0**
O&M Grade: **0**
Clock Start/From: **7**
Clock To: **5**
1st Value:
2nd Value:
Value Percent:
Continuous Index: **S05**
Within 8" of Joint: **NO**
Remarks: **lining**

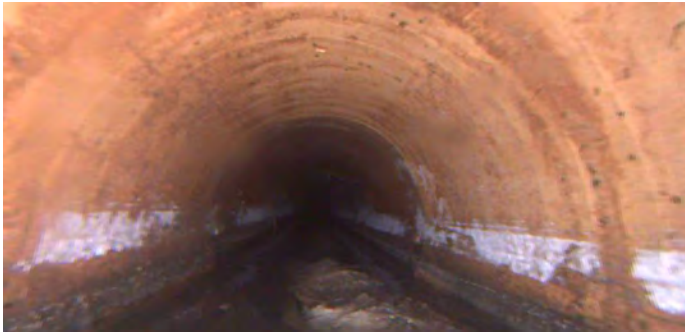
Code: **DSZ**
Description: **Deposits Settled Other**

Distance (ft): **46.1**
Structural Grade: **0**
O&M Grade: **2**
Clock Start/From: **6**
Clock To:
1st Value:
2nd Value:
Value Percent: **5.000**
Continuous Index:
Within 8" of Joint: **NO**
Remarks: **tissue**

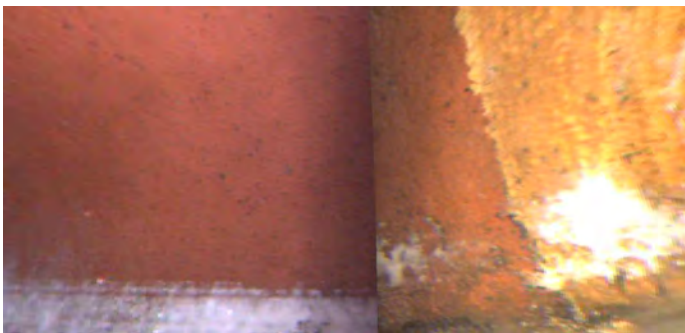
Code: **RPL**
Description: **Repair Localized Liner**

Distance (ft): **47.8**
Structural Grade: **0**
O&M Grade: **0**
Clock Start/From: **7**
Clock To: **5**
1st Value:
2nd Value:
Value Percent:
Continuous Index: **F05**
Within 8" of Joint: **NO**
Remarks: **lining**

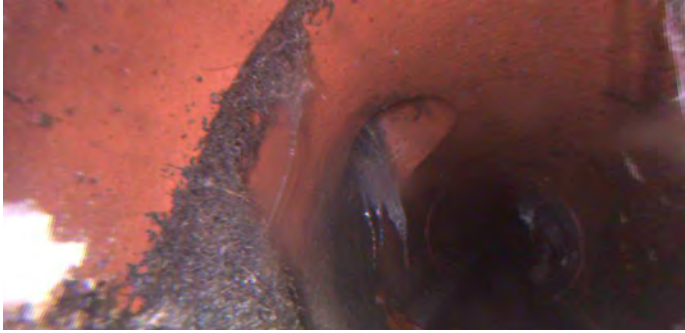
Code: **RMJ**
Description: **Roots Medium Joint**

Distance (ft): **61.0**
Structural Grade: **0**
O&M Grade: **3**
Clock Start/From: **7**
Clock To: **5**
1st Value:
2nd Value:
Value Percent: **10.000**
Continuous Index:
Within 8" of Joint: **YES**
Remarks:

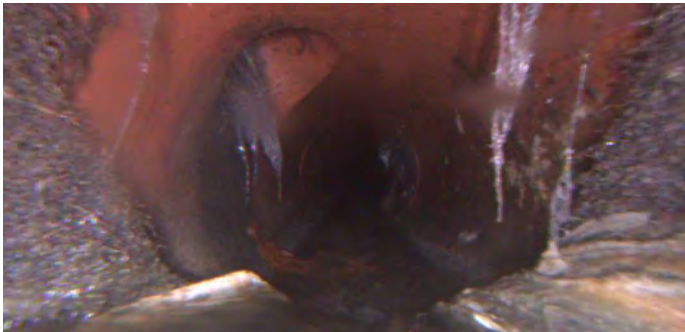
Code: **LD**
Description: **Alignment Down**

Distance (ft): **61.0**
Structural Grade: **0**
O&M Grade: **1**
Clock Start/From:
Clock To:
1st Value:
2nd Value:
Value Percent: **5.000**
Continuous Index:
Within 8" of Joint: **NO**
Remarks:

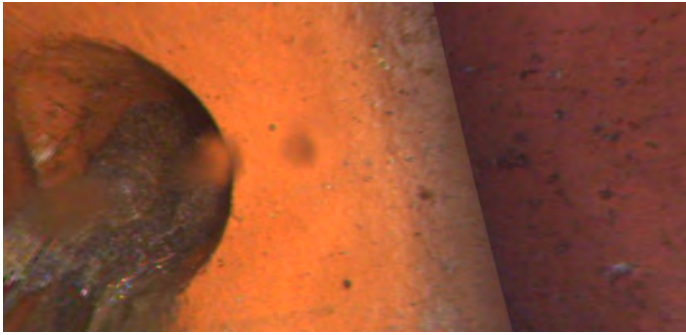
Code: **TFD**
Description: **Tap Factory Defective**

Distance (ft): **62.7**
Structural Grade: **0**
O&M Grade: **2**
Clock Start/From: **10**
Clock To:
1st Value: **4.000**
2nd Value:
Value Percent:
Continuous Index:
Within 8" of Joint: **YES**
Remarks: **blocked by roots**

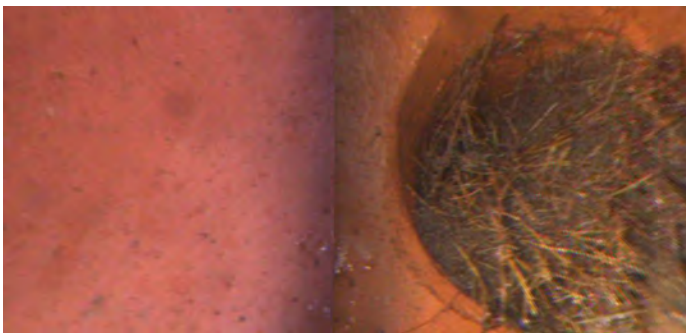
Code: **TFD**
Description: **Tap Factory Defective**

Distance (ft): **64.3**
Structural Grade: **0**
O&M Grade: **2**
Clock Start/From: **2**
Clock To:
1st Value: **4.000**
2nd Value:
Value Percent:
Continuous Index:
Within 8" of Joint: **YES**
Remarks: **blocked by roots**

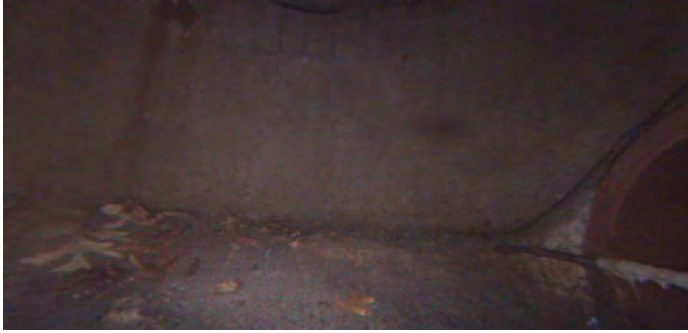
Code:	AMH
Description:	Manhole
Distance (ft):	103.2
Structural Grade:	0
O&M Grade:	0
Clock Start/From:	
Clock To:	
1st Value:	
2nd Value:	
Value Percent:	
Continuous Index:	
Within 8" of Joint:	NO
Remarks:	M-108-046
