Profile/Photo Observation Report

Street:	FOXCROFT STREET	Flow Control:	Not Controlled
City:	Hobart, IN	Year Renewed:	
Location:	Light Highway	Tape/Media #:	
Purpose:	Routine Assessment	Dia/Height:	12"
Use:	Sanitary	Material:	VCP
Drain Area:	NA	Lining:	
Category:	NA		
Comment:	Flow direction wrong

Location Details:		Direction of Survey:	Upstream
US MH:	M-108-046	DS MH:	M-108-035
		Total Length Surveyed (ft):	103.2

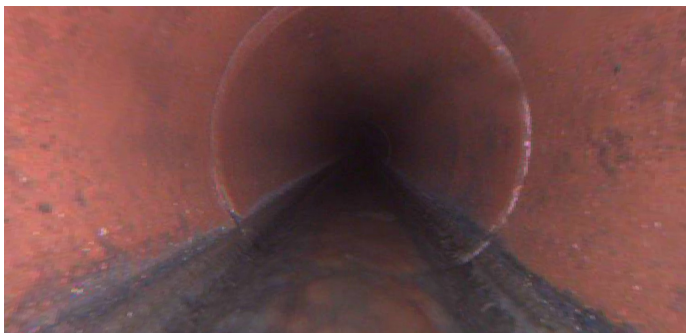
Code: **AMH**
Description: **Manhole**

Distance (ft): **.0**
Structural Grade: **0**
O&M Grade: **0**
Clock Start/From:
Clock To:
1st Value:
2nd Value:
Value Percent:
Continuous Index:
Within 8" of Joint: **NO**
Remarks: **M-108-035**

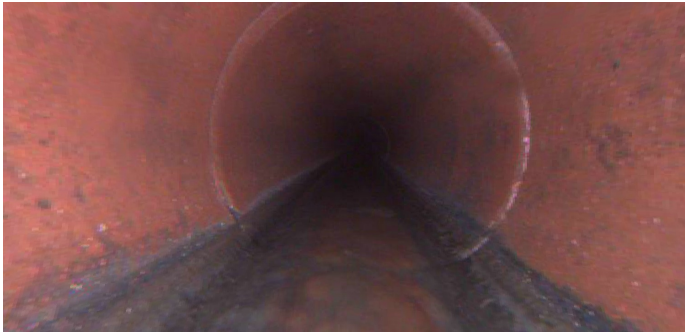
Code:	MWL
Description:	Water Level

Distance (ft):	.0
Structural Grade:	0
O&M Grade:	0
Clock Start/From:	
Clock To:	
1st Value:	
2nd Value:	
Value Percent:	5.000
Continuous Index:	
Within 8" of Joint:	NO
Remarks:

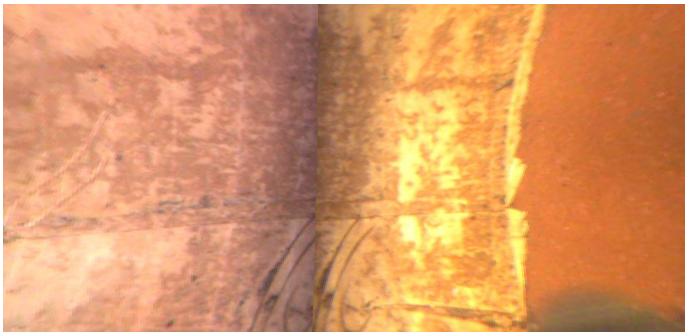
Code:	RPL
Description:	Repair Localized Liner

Distance (ft):	12.3
Structural Grade:	0
O&M Grade:	0
Clock Start/From:	7
Clock To:	5
1st Value:	
2nd Value:	
Value Percent:	
Continuous Index:	S01
Within 8" of Joint:	NO
Remarks:	lining

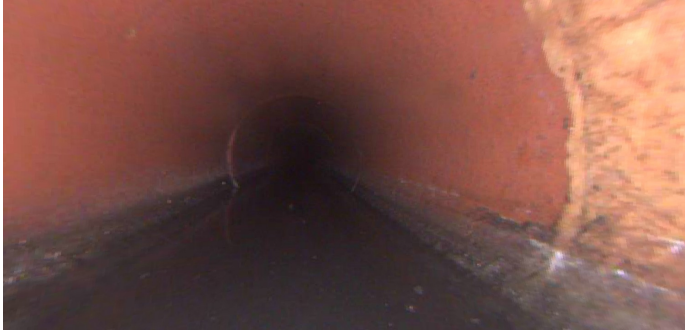
Code: **RPL**
Description: **Repair Localized Liner**

Distance (ft): **15.6**
Structural Grade: **0**
O&M Grade: **0**
Clock Start/From: **7**
Clock To: **5**
1st Value:
2nd Value:
Value Percent:
Continuous Index: **F01**
Within 8" of Joint: **NO**
Remarks: **lining**

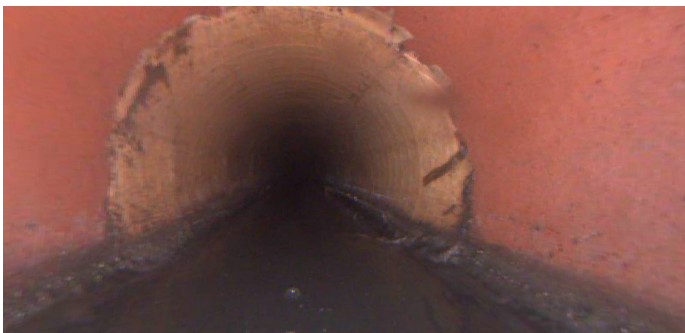
Code: **RPL**
Description: **Repair Localized Liner**

Distance (ft): **18.9**
Structural Grade: **0**
O&M Grade: **0**
Clock Start/From: **7**
Clock To: **5**
1st Value:
2nd Value:
Value Percent:
Continuous Index: **S02**
Within 8" of Joint: **NO**
Remarks: **lining**

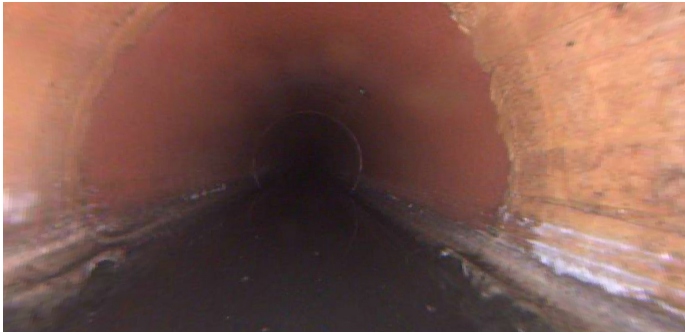
Code: **RPL**
Description: **Repair Localized Liner**

Distance (ft): **22.9**
Structural Grade: **0**
O&M Grade: **0**
Clock Start/From: **7**
Clock To: **5**
1st Value:
2nd Value:
Value Percent:
Continuous Index: **F02**
Within 8" of Joint: **NO**
Remarks: **lining**

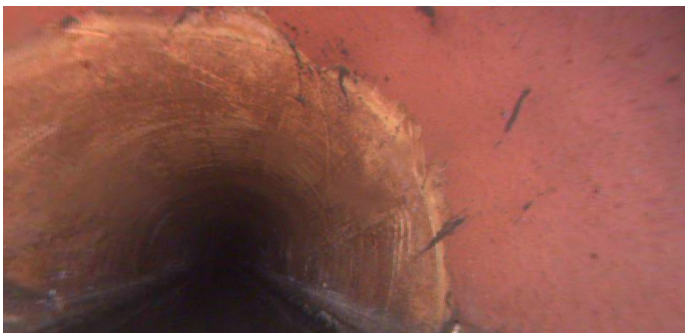
Code: **RPL**
Description: **Repair Localized Liner**

Distance (ft): **27.0**
Structural Grade: **0**
O&M Grade: **0**
Clock Start/From: **7**
Clock To: **5**
1st Value:
2nd Value:
Value Percent:
Continuous Index: **S03**
Within 8" of Joint: **NO**
Remarks: **lining**

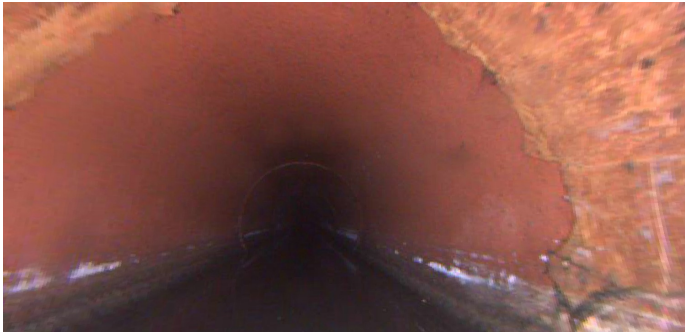
Code: **RPL**
Description: **Repair Localized Liner**

Distance (ft): **31.1**
Structural Grade: **0**
O&M Grade: **0**
Clock Start/From: **7**
Clock To: **5**
1st Value:
2nd Value:
Value Percent:
Continuous Index: **F03**
Within 8" of Joint: **NO**
Remarks: **lining**

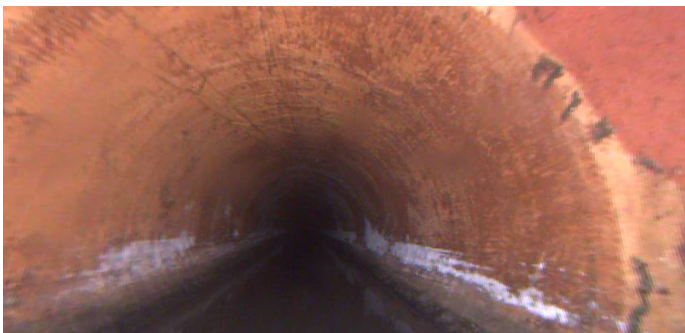
Code: **RPL**
Description: **Repair Localized Liner**

Distance (ft): **35.3**
Structural Grade: **0**
O&M Grade: **0**
Clock Start/From: **7**
Clock To: **5**
1st Value:
2nd Value:
Value Percent:
Continuous Index: **S04**
Within 8" of Joint: **NO**
Remarks: **lining**

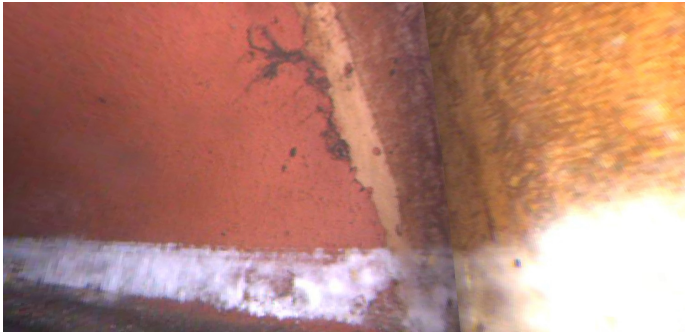
Code: **RPL**
Description: **Repair Localized Liner**

Distance (ft): **39.5**
Structural Grade: **0**
O&M Grade: **0**
Clock Start/From: **7**
Clock To: **5**
1st Value:
2nd Value:
Value Percent:
Continuous Index: **F04**
Within 8" of Joint: **NO**
Remarks: **lining**

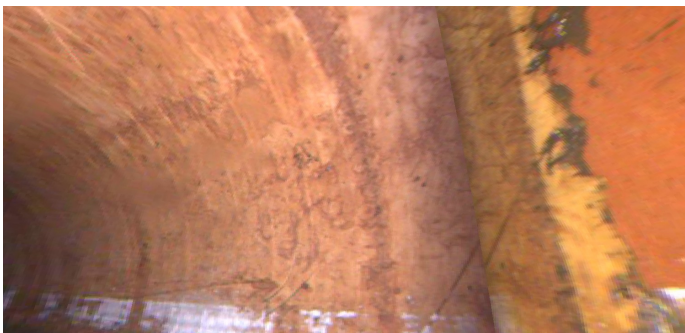
Code: **RPL**
Description: **Repair Localized Liner**

Distance (ft): **43.7**
Structural Grade: **0**
O&M Grade: **0**
Clock Start/From: **7**
Clock To: **5**
1st Value:
2nd Value:
Value Percent:
Continuous Index: **S05**
Within 8" of Joint: **NO**
Remarks: **lining**

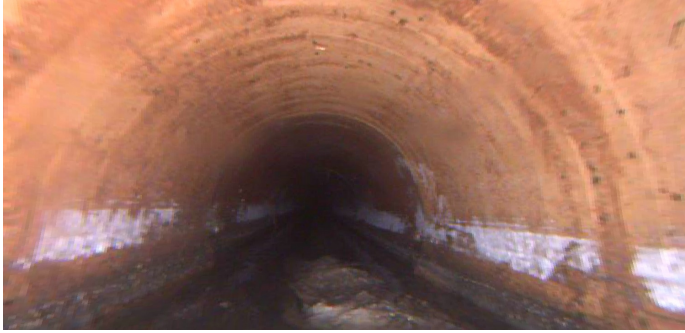
Code: **DSZ**
Description: **Deposits Settled Other**

Distance (ft): **46.1**
Structural Grade: **0**
O&M Grade: **2**
Clock Start/From: **6**
Clock To:
1st Value:
2nd Value:
Value Percent: **5.000**
Continuous Index:
Within 8" of Joint: **NO**
Remarks: **tissue**

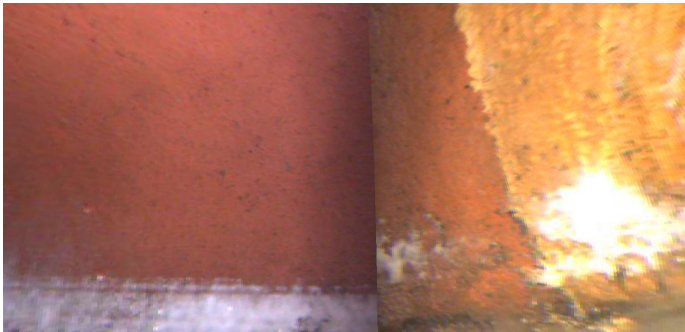
Code: **RPL**
Description: **Repair Localized Liner**

Distance (ft): **47.8**
Structural Grade: **0**
O&M Grade: **0**
Clock Start/From: **7**
Clock To: **5**
1st Value:
2nd Value:
Value Percent:
Continuous Index: **F05**
Within 8" of Joint: **NO**
Remarks: **lining**

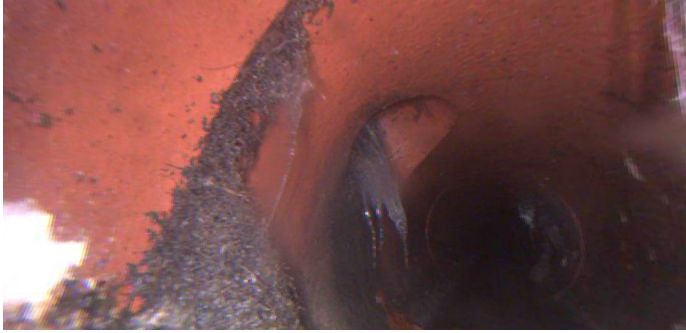
Code: **RMJ**
Description: **Roots Medium Joint**

Distance (ft): **61.0**
Structural Grade: **0**
O&M Grade: **3**
Clock Start/From: **7**
Clock To: **5**
1st Value:
2nd Value:
Value Percent: **10.000**
Continuous Index:
Within 8" of Joint: **YES**
Remarks:

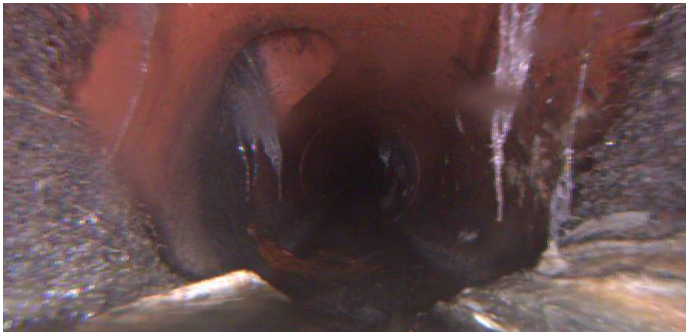
Code: **LD**
Description: **Alignment Down**

Distance (ft): **61.0**
Structural Grade: **0**
O&M Grade: **1**
Clock Start/From:
Clock To:
1st Value:
2nd Value:
Value Percent: **5.000**
Continuous Index:
Within 8" of Joint: **NO**
Remarks:

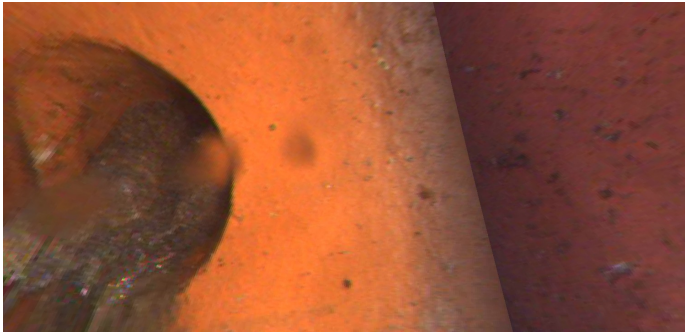
Code: **TFD**
Description: **Tap Factory Defective**

Distance (ft): **62.7**
Structural Grade: **0**
O&M Grade: **2**
Clock Start/From: **10**
Clock To:
1st Value: **4.000**
2nd Value:
Value Percent:
Continuous Index:
Within 8" of Joint: **YES**
Remarks: **blocked by roots**

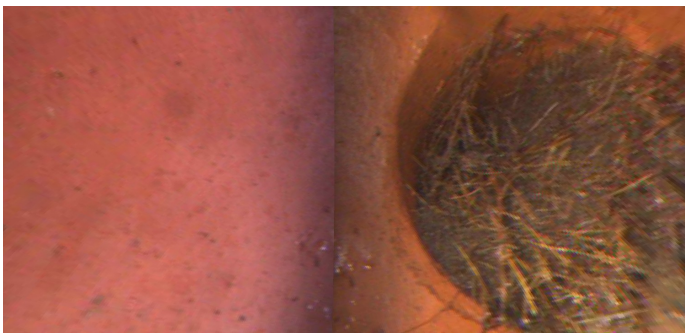
Code: **TFD**
Description: **Tap Factory Defective**

Distance (ft): **64.3**
Structural Grade: **0**
O&M Grade: **2**
Clock Start/From: **2**
Clock To:
1st Value: **4.000**
2nd Value:
Value Percent:
Continuous Index:
Within 8" of Joint: **YES**
Remarks: **blocked by roots**

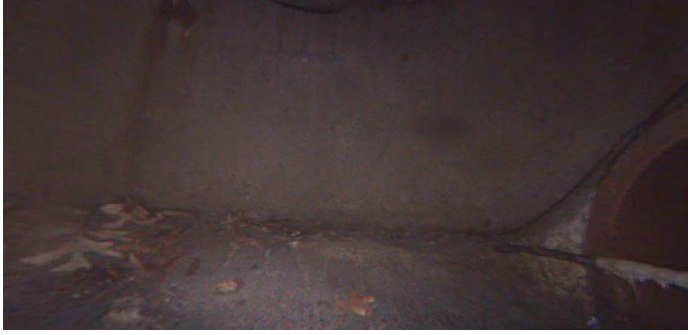
Code:	AMH
Description:	Manhole
Distance (ft):	103.2
Structural Grade:	0
O&M Grade:	0
Clock Start/From:	
Clock To:	
1st Value:	
2nd Value:	
Value Percent:	
Continuous Index:	
Within 8" of Joint:	NO
Remarks:	M-108-046
