Profile/Photo Observation Report

Date:	10/23/2021	Weather:		Coding:	PACP 6.0
Pipe Length (ft):		Owner:	Hobart, IN	Pre Clean:	Not Known
P.O.#:	988_1	Surveyor:	M. Pielacha	PSR:	M-108-047_M-108-047A
Customer:	Hobart, IN	Clean Date:		Shape:	C

Street:	57th Street	Flow Control:	
City:	Hobart, IN	Year Renewed:	
Location:	Light Highway	Tape/Media #:	988
Purpose:	Routine Assessment	Dia/Height:	12"
Use:	Sanitary	Material:	VCP
Drain Area:		Lining:	
Category:	NA

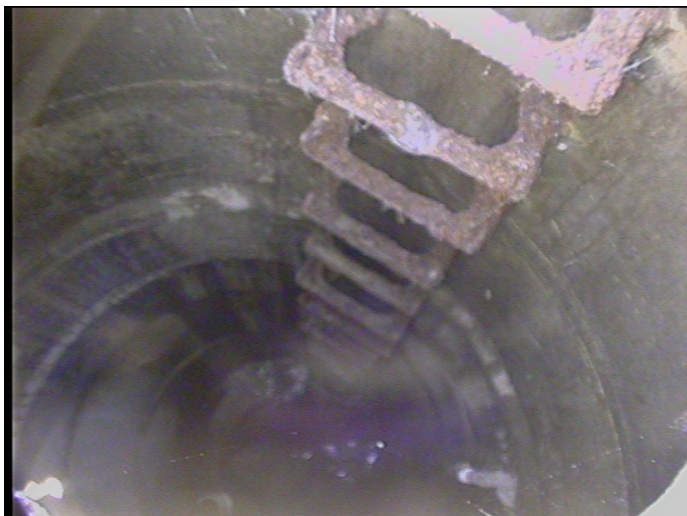
Code: **AMH**
 Description: **Manhole**

Distance (ft): **.0**
 Structural Grade: **0**
 O&M Grade: **0**
 Clock Start/From:
 Clock To:
 1st Value:
 2nd Value:
 Value Percent:
 Continuous Index:
 Within 8" of Joint: **NO**
 Remarks: **M-108-047**

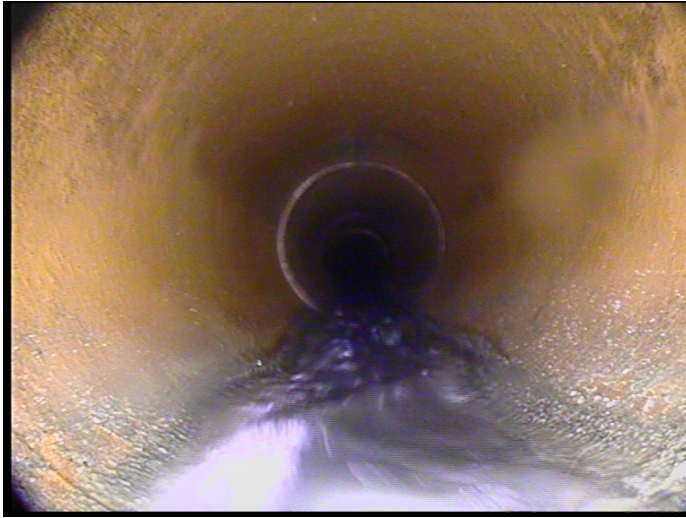
Code:	MWL
Description:	Water Level
Distance (ft):	.0
Structural Grade:	0
O&M Grade:	0
Clock Start/From:	
Clock To:	
1st Value:	
2nd Value:	
Value Percent:	5.000
Continuous Index:	
Within 8" of Joint:	NO
Remarks:

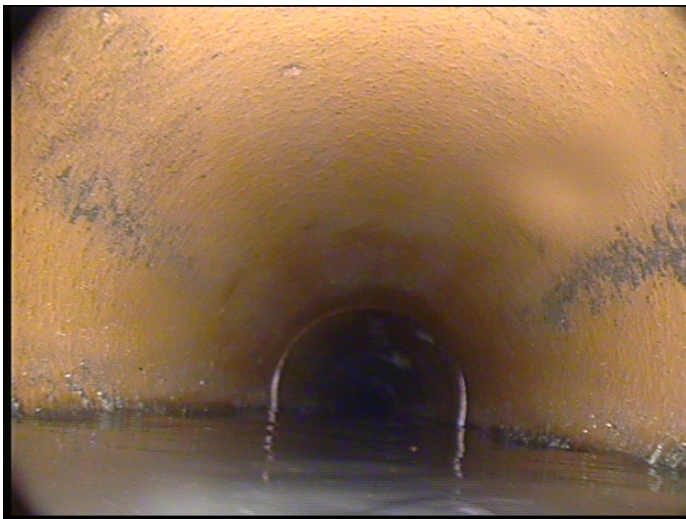
Code:	MWL
Description:	Water Level
Distance (ft):	29.4
Structural Grade:	0
O&M Grade:	0
Clock Start/From:	
Clock To:	
1st Value:	
2nd Value:	
Value Percent:	20.000
Continuous Index:	
Within 8" of Joint:	NO
Remarks:

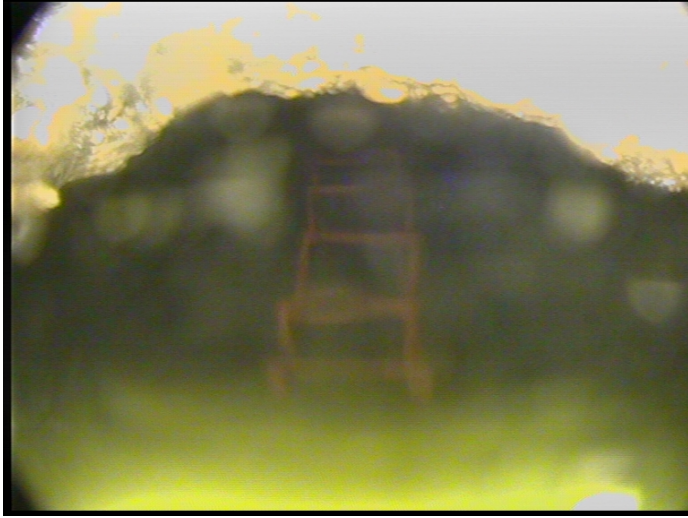
Code:	AMH
Description:	Manhole
Distance (ft):	79.9
Structural Grade:	0
O&M Grade:	0
Clock Start/From:	
Clock To:	
1st Value:	
2nd Value:	
Value Percent:	
Continuous Index:	
Within 8" of Joint:	NO
Remarks:	M-108-047A
