Profile/Photo Observation Report

Street:	HOWARD CT	Flow Control:	Not Controlled
City:	Hobart, IN	Year Renewed:	
Location:	Light Highway	Tape/Media #:	
Purpose:	Routine Assessment	Dia/Height:	8"
Use:	Sanitary	Material:	PVC
Drain Area:	NA	Lining:	
Category:	NA		
Comment:	MH_F at 2 ft False pipe starts at 8 inch and drops down to 6 inch.\nFlow direction wrong		
Location Details:		Direction of Survey:	Downstream
US MH:	M-108-048	DS MH:	M-108-001
		Total Length Surveyed (ft):	3.6

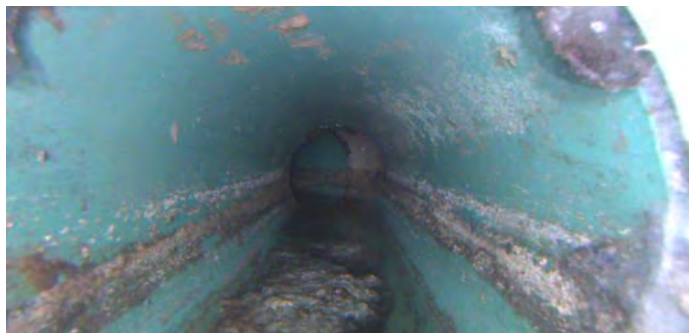
Code: **DAGS**
Description: **Deposits Attached Grease**

Distance (ft): **.0**
Structural Grade: **0**
O&M Grade: **2**
Clock Start/From: **8**
Clock To: **4**
1st Value:
2nd Value:
Value Percent: **5.000**
Continuous Index:
Within 8" of Joint: **NO**
Remarks:

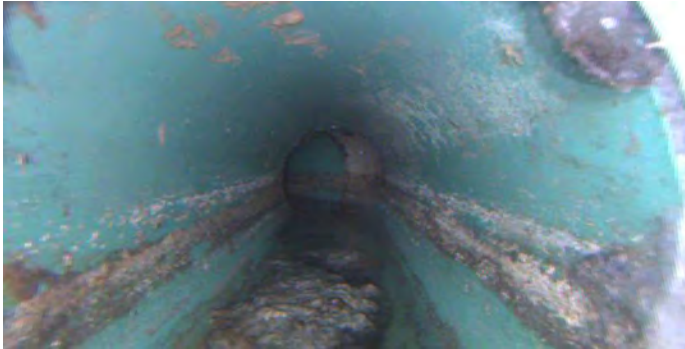
Code:	AMH
Description:	Manhole

Distance (ft):	.0
Structural Grade:	0
O&M Grade:	0
Clock Start/From:	
Clock To:	
1st Value:	
2nd Value:	
Value Percent:	
Continuous Index:	
Within 8" of Joint:	NO
Remarks:	M-108-048

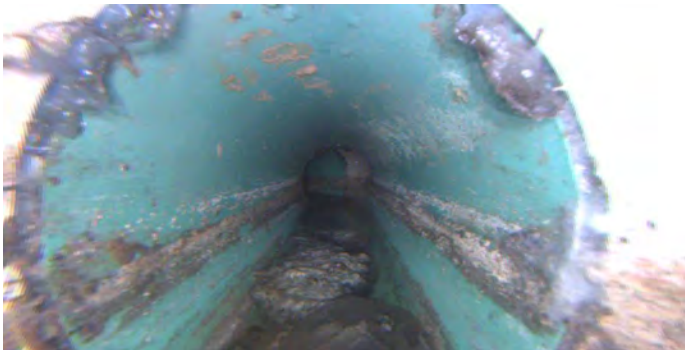
Code:	MWL
Description:	Water Level

Distance (ft):	.0
Structural Grade:	0
O&M Grade:	0
Clock Start/From:	
Clock To:	
1st Value:	
2nd Value:	
Value Percent:	5.000
Continuous Index:	
Within 8" of Joint:	NO
Remarks:

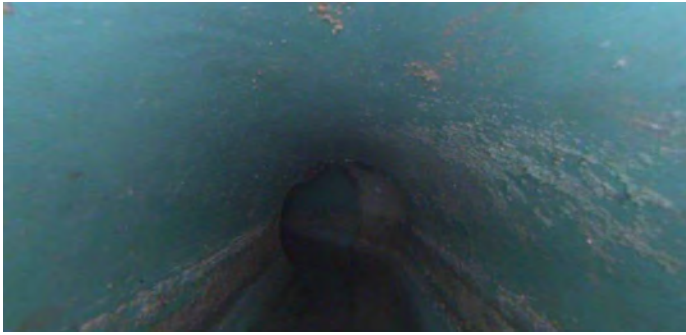
Code: **LL**
Description: **Alignment Left**

Distance (ft): **3.2**
Structural Grade: **0**
O&M Grade: **2**
Clock Start/From:
Clock To:
1st Value:
2nd Value:
Value Percent: **20.000**
Continuous Index:
Within 8" of Joint: **NO**
Remarks:

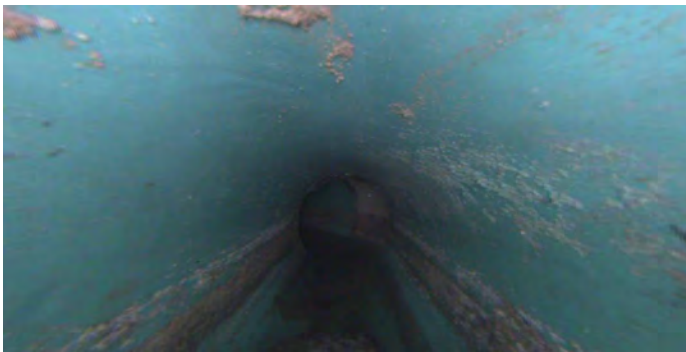
Code: **MGO**
Description: **General Observation**

Distance (ft): **3.5**
Structural Grade: **0**
O&M Grade: **0**
Clock Start/From:
Clock To:
1st Value:
2nd Value:
Value Percent:
Continuous Index:
Within 8" of Joint: **NO**
Remarks: **LL 25% ahead of camera**
