## Profile/Photo Observation Report

Street:	<b>FOXCROFT STREET</b>	Flow Control:	<b>Not Controlled</b>
City:	<b>Hobart, IN</b>	Year Renewed:	
Location:	<b>Light Highway</b>	Tape/Media #:	
Purpose:	<b>Routine Assessment</b>	Dia/Height:	<b>8"</b>
Use:	<b>Sanitary</b>	Material:	<b>PVC</b>
Drain Area:	<b>NA</b>	Lining:	
Category:	<b>NA</b>		
Comment:	<b>MH_F at 2 ft False pipe starts at 8 inch and drops down to 6 inch.\nFlow direction wrong</b>		
Location Details:		Direction of Survey:	<b>Downstream</b>
US MH:	<b>M-108-048</b>	DS MH:	<b>M-108-001</b>
		Total Length Surveyed (ft):	<b>3.6</b>

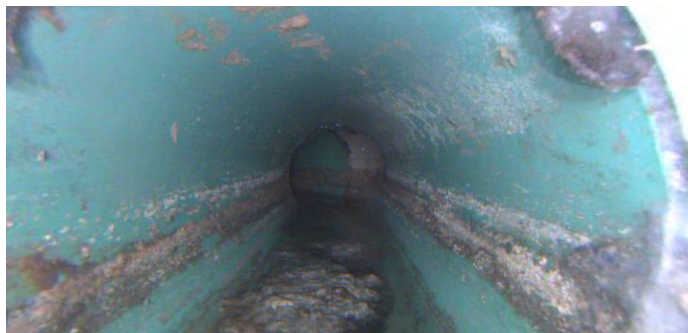
Code: **DAGS**  
Description: **Deposits Attached Grease**

Distance (ft): **.0**  
Structural Grade: **0**  
O&M Grade: **2**  
Clock Start/From: **8**  
Clock To: **4**  
1st Value:  
2nd Value:  
Value Percent: **5.000**  
Continuous Index:  
Within 8" of Joint: **NO**  
Remarks:

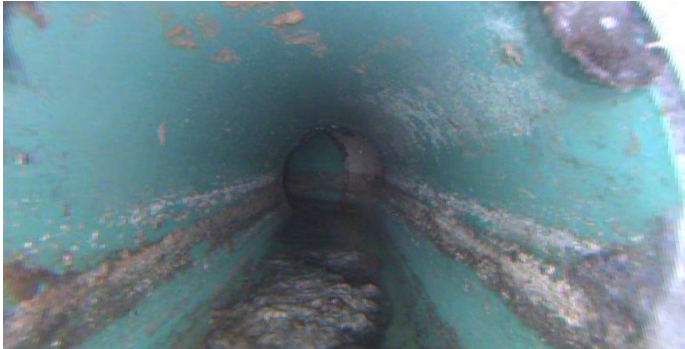
Code:	<b>AMH</b>
Description:	<b>Manhole</b>

Distance (ft):	<b>.0</b>
Structural Grade:	<b>0</b>
O&M Grade:	<b>0</b>
Clock Start/From:	
Clock To:	
1st Value:	
2nd Value:	
Value Percent:	
Continuous Index:	
Within 8" of Joint:	<b>NO</b>
Remarks:	<b>M-108-048</b>

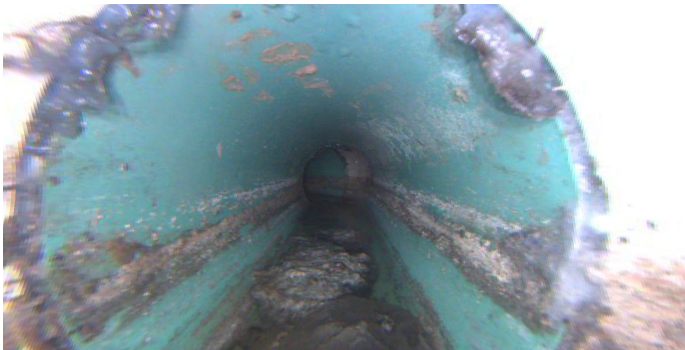
Code:	<b>MWL</b>
Description:	<b>Water Level</b>

Distance (ft):	<b>.0</b>
Structural Grade:	<b>0</b>
O&M Grade:	<b>0</b>
Clock Start/From:	
Clock To:	
1st Value:	
2nd Value:	
Value Percent:	<b>5.000</b>
Continuous Index:	
Within 8" of Joint:	<b>NO</b>
Remarks:

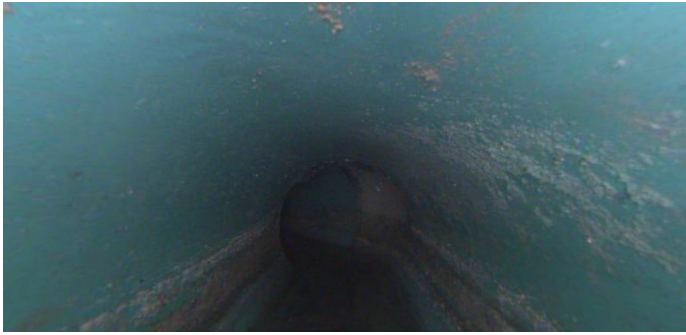
Code: **LL**  
Description: **Alignment Left**

Distance (ft): **3.2**  
Structural Grade: **0**  
O&M Grade: **2**  
Clock Start/From:  
Clock To:  
1st Value:  
2nd Value:  
Value Percent: **20.000**  
Continuous Index:  
Within 8" of Joint: **NO**  
Remarks:

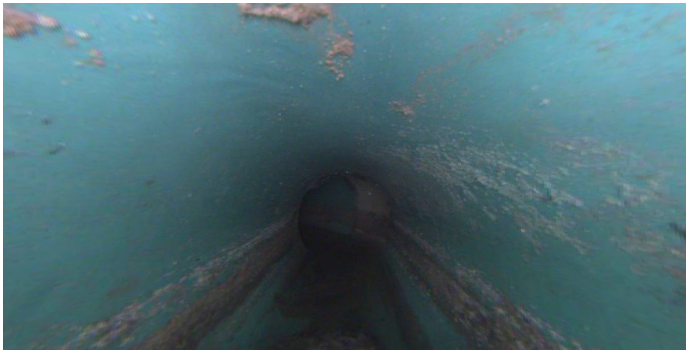
Code: **MGO**  
Description: **General Observation**

Distance (ft): **3.5**  
Structural Grade: **0**  
O&M Grade: **0**  
Clock Start/From:  
Clock To:  
1st Value:  
2nd Value:  
Value Percent:  
Continuous Index:  
Within 8" of Joint: **NO**  
Remarks: **LL 25% ahead of camera**
