Profile/Photo Observation Report

Street:	W 61ST AVE	Flow Control:	Not Controlled
City:	Hobart, IN	Year Renewed:	
Location:	Light Highway	Tape/Media #:	
Purpose:	Routine Assessment	Dia/Height:	10"
Use:	Sanitary	Material:	PVC
Drain Area:	NA	Lining:	
Category:	NA		
Comment:	Flow direction wrong

Location Details:		Direction of Survey:	Downstream
US MH:	M-108-052	DS MH:	M-108-051
		Total Length Surveyed (ft):	415.0

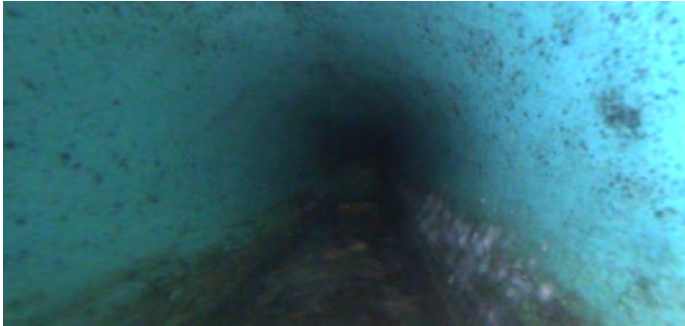
Code:	MWL
Description:	Water Level

Distance (ft):	.0
Structural Grade:	0
O&M Grade:	0
Clock Start/From:	
Clock To:	
1st Value:	
2nd Value:	
Value Percent:	10.000
Continuous Index:	
Within 8" of Joint:	NO
Remarks:

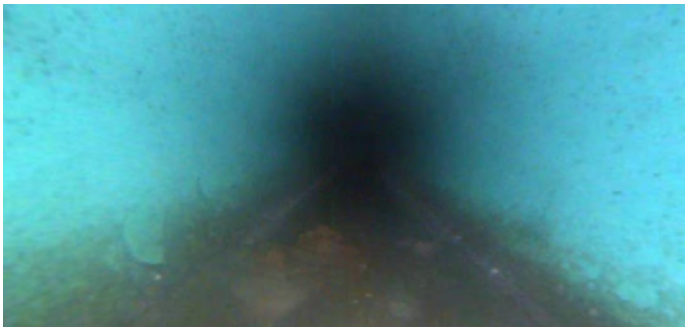
Code:	MWL
Description:	Water Level

Distance (ft):	16.1
Structural Grade:	0
O&M Grade:	0
Clock Start/From:	
Clock To:	
1st Value:	
2nd Value:	
Value Percent:	20.000
Continuous Index:	
Within 8" of Joint:	NO
Remarks:

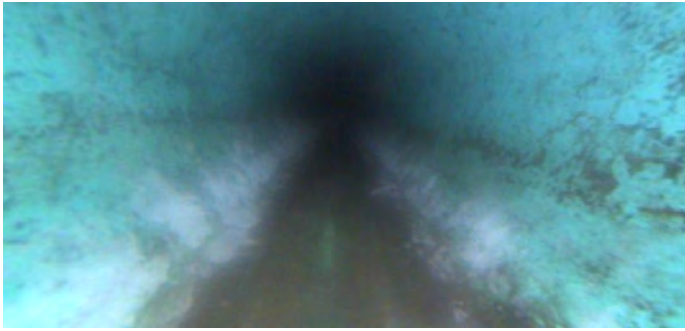
Code: **DAGS**
Description: **Deposits Attached Grease**

Distance (ft): **67.5**
Structural Grade: **0**
O&M Grade: **2**
Clock Start/From: **4**
Clock To: **8**
1st Value:
2nd Value:
Value Percent: **5.000**
Continuous Index: **S01**
Within 8" of Joint: **NO**
Remarks:

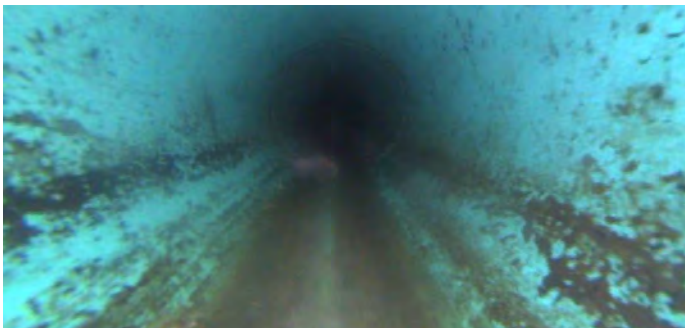
Code: **DAGS**
Description: **Deposits Attached Grease**

Distance (ft): **78.0**
Structural Grade: **0**
O&M Grade: **2**
Clock Start/From: **4**
Clock To: **8**
1st Value:
2nd Value:
Value Percent: **5.000**
Continuous Index: **F01**
Within 8" of Joint: **NO**
Remarks: **Clock positions vary**

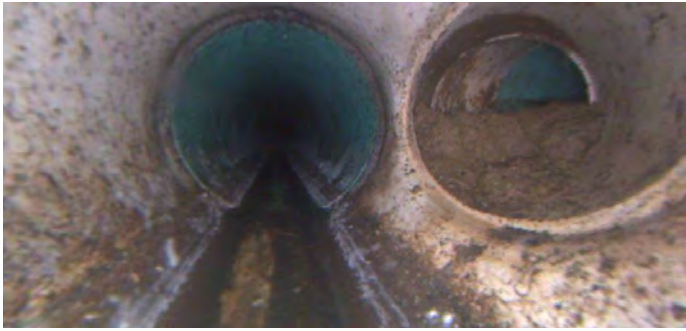
Code: **TFD**
Description: **Tap Factory Defective**

Distance (ft): **108.8**
Structural Grade: **0**
O&M Grade: **2**
Clock Start/From: **2**
Clock To:
1st Value: **4.000**
2nd Value:
Value Percent:
Continuous Index:
Within 8" of Joint:
Remarks: **DSF**

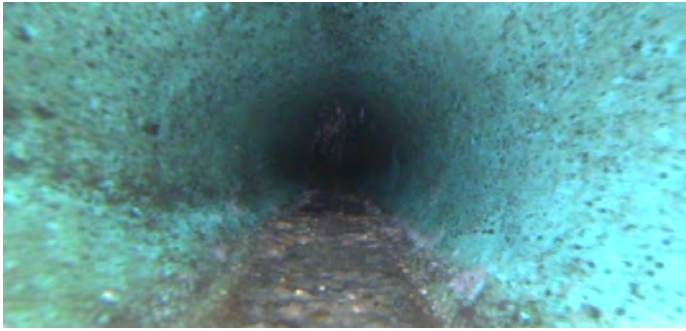
Code: **DSF**
Description: **Deposits Settled Fine**

Distance (ft): **298.9**
Structural Grade: **0**
O&M Grade: **2**
Clock Start/From: **5**
Clock To: **7**
1st Value:
2nd Value:
Value Percent: **10.000**
Continuous Index: **S02**
Within 8" of Joint: **NO**
Remarks:
