Profile/Photo Observation Report

Street:	FOXCROFT STREET	Flow Control:	Not Controlled
City:	Hobart, IN	Year Renewed:	
Location:	Light Highway	Tape/Media #:	
Purpose:	Routine Assessment	Dia/Height:	10"
Use:	Sanitary	Material:	PVC
Drain Area:	NA	Lining:	
Category:	NA		
Comment:	Flow direction wrong

Location Details:		Direction of Survey:	Downstream
US MH:	M-108-052	DS MH:	M-108-051
		Total Length Surveyed (ft):	415.0

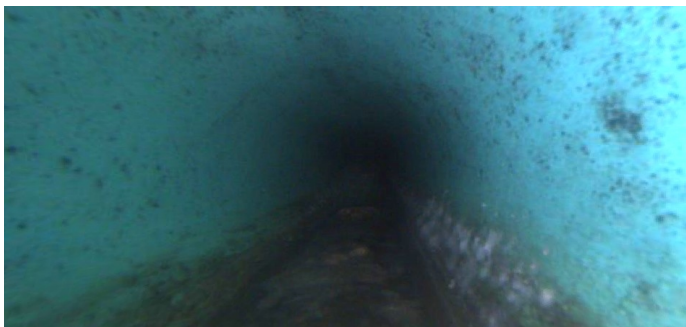
Code: **AMH**
Description: **Manhole**

Distance (ft): **.0**
Structural Grade: **0**
O&M Grade: **0**
Clock Start/From:
Clock To:
1st Value:
2nd Value:
Value Percent:
Continuous Index:
Within 8" of Joint: **NO**
Remarks: **M-108-052**

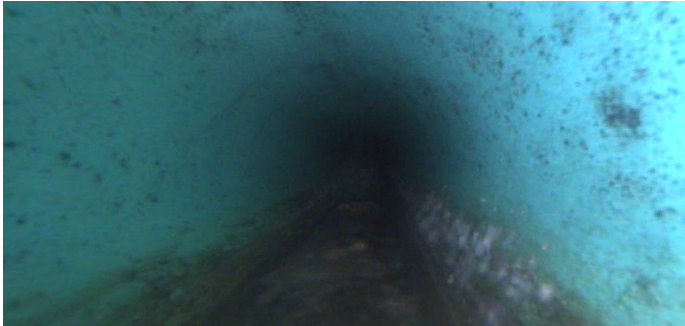
Code:	MWL
Description:	Water Level

Distance (ft):	.0
Structural Grade:	0
O&M Grade:	0
Clock Start/From:	
Clock To:	
1st Value:	
2nd Value:	
Value Percent:	10.000
Continuous Index:	
Within 8" of Joint:	NO
Remarks:

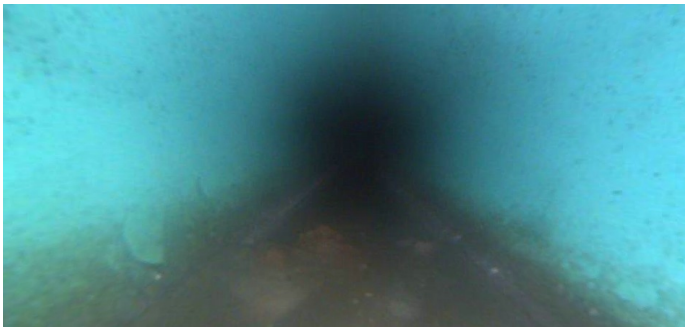
Code:	MWL
Description:	Water Level

Distance (ft):	16.1
Structural Grade:	0
O&M Grade:	0
Clock Start/From:	
Clock To:	
1st Value:	
2nd Value:	
Value Percent:	20.000
Continuous Index:	
Within 8" of Joint:	NO
Remarks:

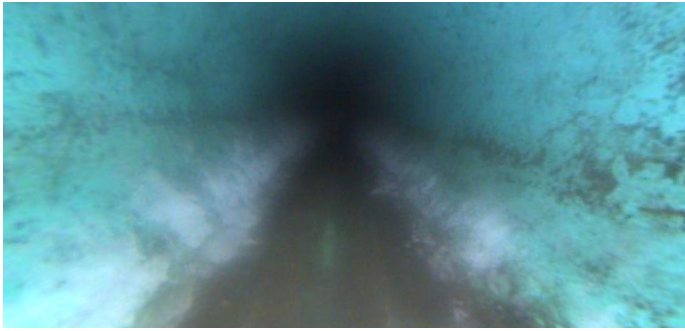
Code: **DAGS**
Description: **Deposits Attached Grease**

Distance (ft): **67.5**
Structural Grade: **0**
O&M Grade: **2**
Clock Start/From: **4**
Clock To: **8**
1st Value:
2nd Value:
Value Percent: **5.000**
Continuous Index: **S01**
Within 8" of Joint: **NO**
Remarks:

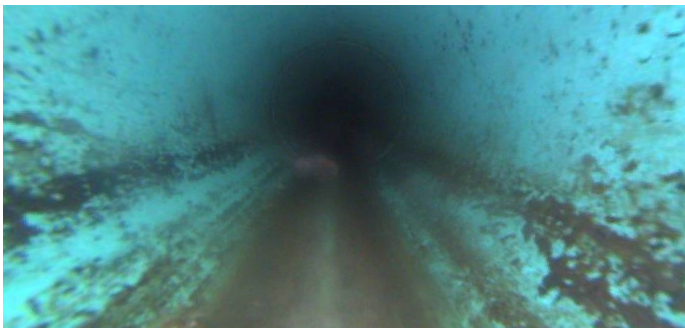
Code: **DAGS**
Description: **Deposits Attached Grease**

Distance (ft): **78.0**
Structural Grade: **0**
O&M Grade: **2**
Clock Start/From: **4**
Clock To: **8**
1st Value:
2nd Value:
Value Percent: **5.000**
Continuous Index: **F01**
Within 8" of Joint: **NO**
Remarks: **Clock positions vary**

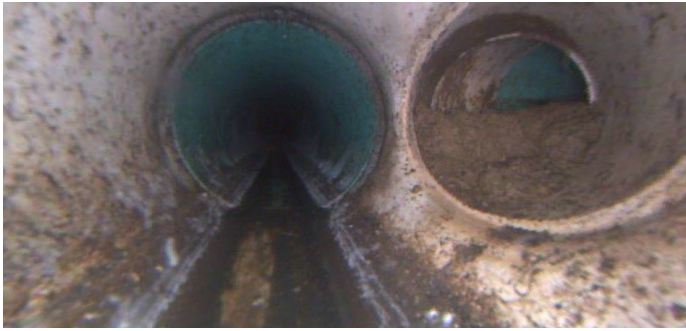
Code: **TFD**
Description: **Tap Factory Defective**

Distance (ft): **108.8**
Structural Grade: **0**
O&M Grade: **2**
Clock Start/From: **2**
Clock To:
1st Value: **4.000**
2nd Value:
Value Percent:
Continuous Index:
Within 8" of Joint:
Remarks: **DSF**

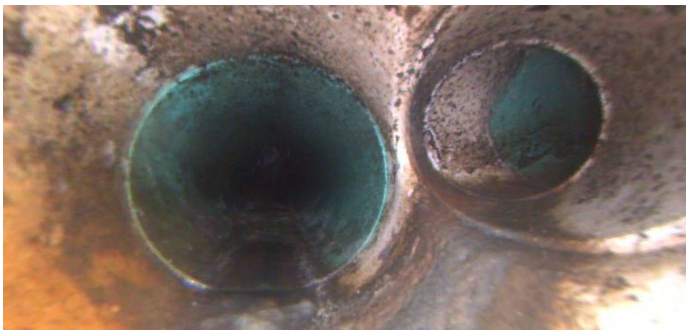
Code: **TF**
Description: **Tap Factory**

Distance (ft): **297.6**
Structural Grade: **0**
O&M Grade: **0**
Clock Start/From: **2**
Clock To:
1st Value: **4.000**
2nd Value:
Value Percent:
Continuous Index:
Within 8" of Joint:
Remarks:

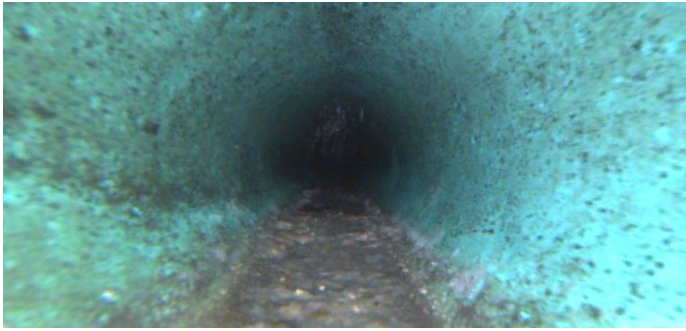
Code: **DSF**
Description: **Deposits Settled Fine**

Distance (ft): **298.9**
Structural Grade: **0**
O&M Grade: **2**
Clock Start/From: **5**
Clock To: **7**
1st Value:
2nd Value:
Value Percent: **10.000**
Continuous Index: **S02**
Within 8" of Joint: **NO**
Remarks:

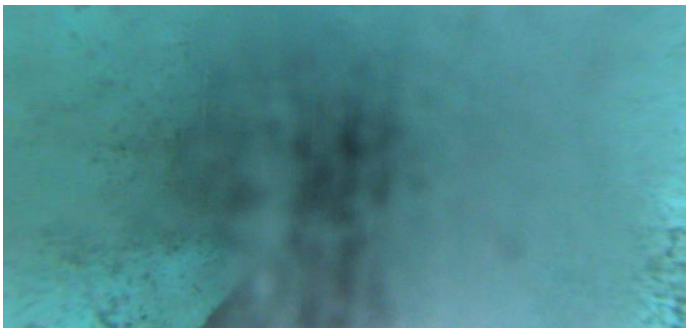
Code: **DSF**
Description: **Deposits Settled Fine**

Distance (ft): **311.3**
Structural Grade: **0**
O&M Grade: **2**
Clock Start/From: **5**
Clock To: **7**
1st Value:
2nd Value:
Value Percent: **10.000**
Continuous Index: **F02**
Within 8" of Joint: **NO**
Remarks: **Clock positions vary**

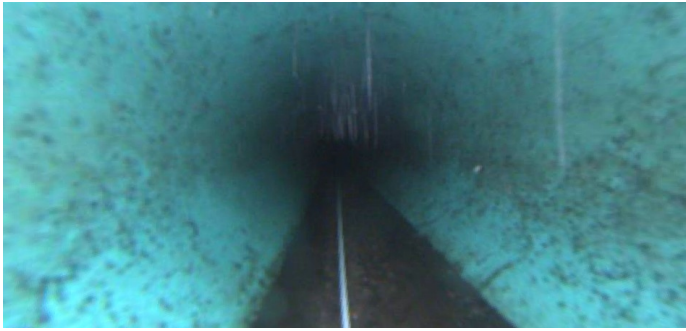
Code: **MGO**
Description: **General Observation**

Distance (ft): **311.3**
Structural Grade: **0**
O&M Grade: **0**
Clock Start/From:
Clock To:
1st Value:
2nd Value:
Value Percent:
Continuous Index:
Within 8" of Joint: **NO**
Remarks: **Switching to rear camera**

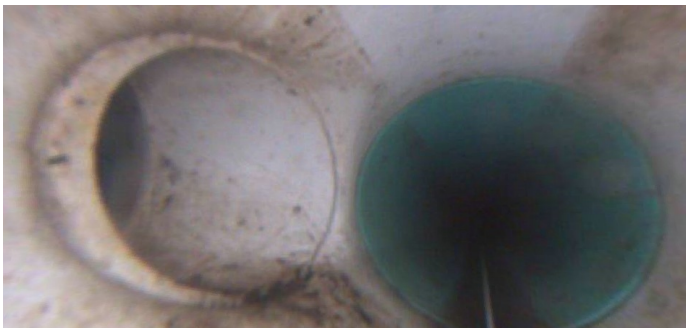
Code: **TF**
Description: **Tap Factory**

Distance (ft): **393.7**
Structural Grade: **0**
O&M Grade: **0**
Clock Start/From: **3**
Clock To:
1st Value: **4.000**
2nd Value:
Value Percent:
Continuous Index:
Within 8" of Joint:
Remarks:

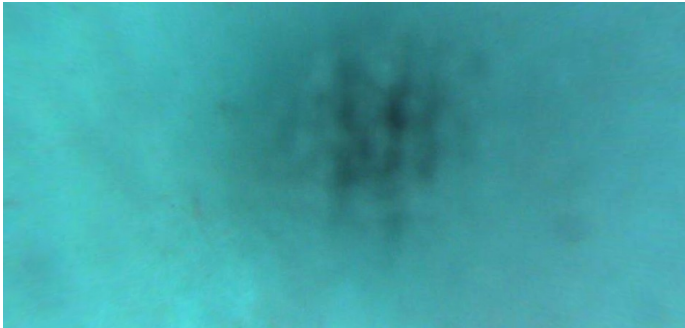
Code: **MGO**
Description: **General Observation**

Distance (ft): **407.1**
Structural Grade: **0**
O&M Grade: **0**
Clock Start/From:
Clock To:
1st Value:
2nd Value:
Value Percent:
Continuous Index:
Within 8" of Joint: **NO**
Remarks: **Switching to front camera**

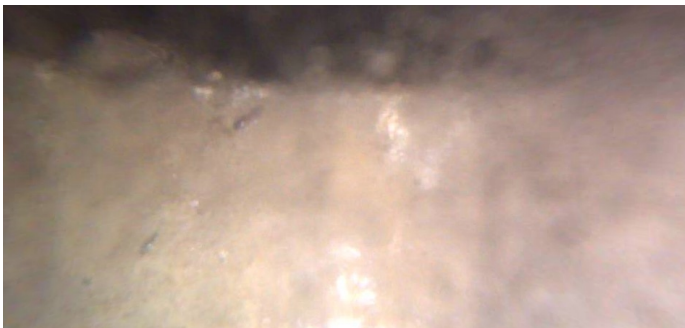
Code: **AMH**
Description: **Manhole**

Distance (ft): **415.0**
Structural Grade: **0**
O&M Grade: **0**
Clock Start/From:
Clock To:
1st Value:
2nd Value:
Value Percent:
Continuous Index:
Within 8" of Joint: **NO**
Remarks: **M-108-051**
