Profile/Photo Observation Report

Date:	03/20/2018	Weather:		Coding:	PACP 6.0
Pipe Length (ft):	399.0	Owner:	NA	Pre Clean:	No Pre-Cleaning
P.O.#:		Surveyor:	John Kuglmaier	PSR:	P-108-052-053
Customer:		Clean Date:	01/01/1900	Shape:	C

Street:	W 61ST AVE	Flow Control:	Not Controlled
City:	Hobart, IN	Year Renewed:	
Location:	Light Highway	Tape/Media #:	
Purpose:	Routine Assessment	Dia/Height:	10"
Use:	Sanitary	Material:	PVC
Drain Area:	NA	Lining:	
Category:	NA		
Comment:	P_C at 383 ft nothing visible. Flow direction wrong		
Location Details:		Direction of Survey:	Upstream
US MH:	M-108-053	DS MH:	M-108-052
		Total Length Surveyed (ft):	385.0

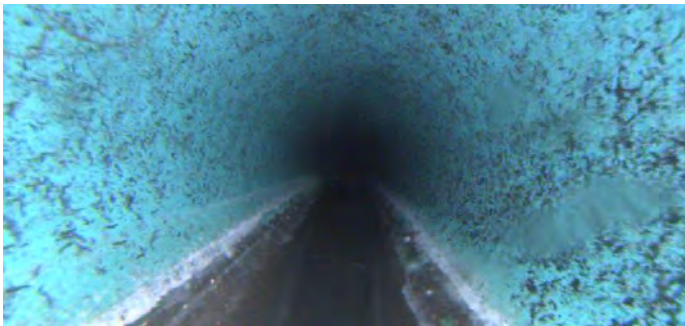
Code: **AMH**
Description: **Manhole**

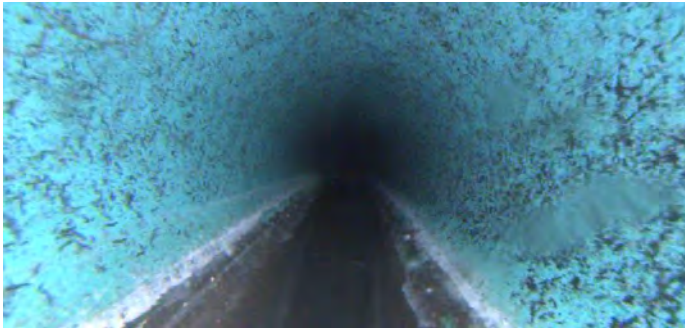
Code:	MWL
Description:	Water Level

Distance (ft):	.0
Structural Grade:	0
O&M Grade:	0
Clock Start/From:	
Clock To:	
1st Value:	
2nd Value:	
Value Percent:	5.000
Continuous Index:	
Within 8" of Joint:	NO
Remarks:

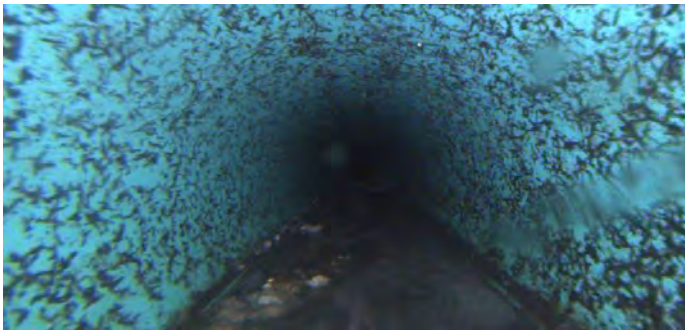
Code:	MWL
Description:	Water Level

Distance (ft):	166.0
Structural Grade:	0
O&M Grade:	0
Clock Start/From:	
Clock To:	
1st Value:	
2nd Value:	
Value Percent:	15.000
Continuous Index:	
Within 8" of Joint:	NO
Remarks:

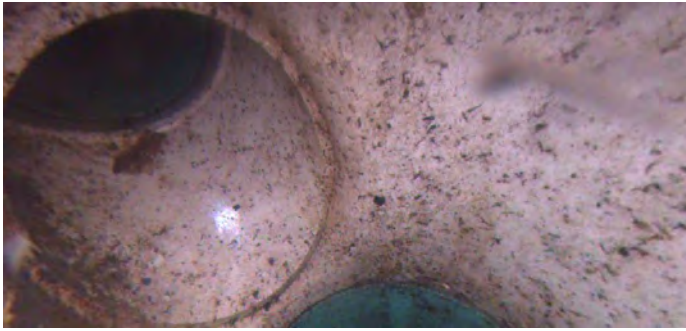
Code: **TF**
Description: **Tap Factory**

Distance (ft): **278.7**
Structural Grade: **0**
O&M Grade: **0**
Clock Start/From: **11**
Clock To:
1st Value: **4.000**
2nd Value:
Value Percent:
Continuous Index:
Within 8" of Joint:
Remarks:

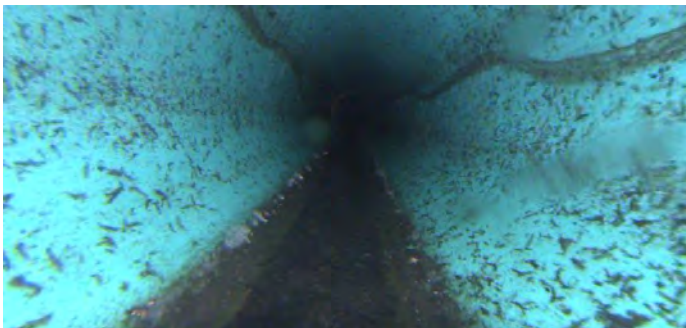
Code: **MSA**
Description: **Abandoned Survey**

Distance (ft): **385.0**
Structural Grade: **0**
O&M Grade: **0**
Clock Start/From:
Clock To:
1st Value:
2nd Value:
Value Percent:
Continuous Index:
Within 8" of Joint: **NO**
Remarks: **Unknown**
