Profile/Photo Observation Report

Date:	03/20/2018	Weather:		Coding:	PACP 6.0
Pipe Length (ft):	399.0	Owner:	NA	Pre Clean:	No Pre-Cleaning
P.O.#:		Surveyor:	John Kuglmaier	PSR:	P-108-052-053
Customer:		Clean Date:	01/01/1900	Shape:	C

Street:	W 61ST AVE	Flow Control:	Not Controlled
City:	Hobart, IN	Year Renewed:	
Location:	Light Highway	Tape/Media #:	
Purpose:	Routine Assessment	Dia/Height:	10"
Use:	Sanitary	Material:	PVC
Drain Area:	NA	Lining:	
Category:	NA		
Comment:	P_C at 253 ft nothing visible . Flow direction wrong		
Location Details:		Direction of Survey:	Downstream
US MH:	M-108-053	DS MH:	M-108-052
		Total Length Surveyed (ft):	254.1

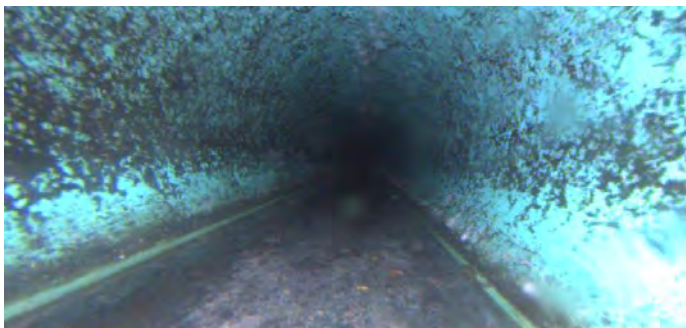
Code: **AMH**
Description: **Manhole**

Distance (ft): **.0**
Structural Grade: **0**
O&M Grade: **0**
Clock Start/From:
Clock To:
1st Value:
2nd Value:
Value Percent:
Continuous Index:
Within 8" of Joint: **NO**
Remarks: **M-108-053**

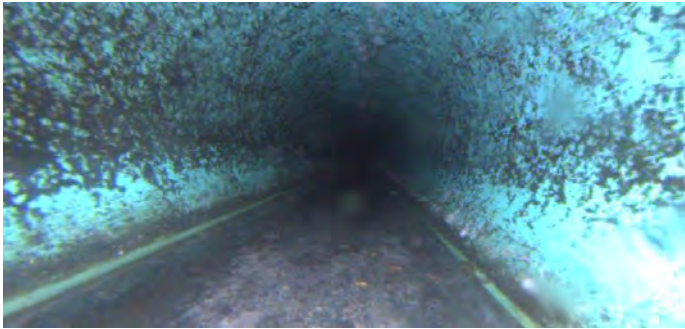
Code:	MWL
Description:	Water Level

Distance (ft):	.0
Structural Grade:	0
O&M Grade:	0
Clock Start/From:	
Clock To:	
1st Value:	
2nd Value:	
Value Percent:	20.000
Continuous Index:	
Within 8" of Joint:	NO
Remarks:

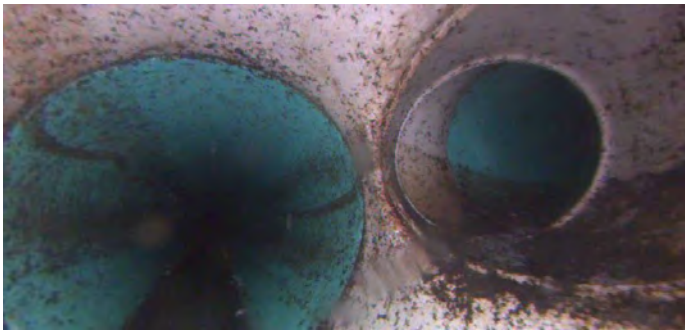
Code:	TF
Description:	Tap Factory

Distance (ft):	13.3
Structural Grade:	0
O&M Grade:	0
Clock Start/From:	2
Clock To:	
1st Value:	4.000
2nd Value:	
Value Percent:	
Continuous Index:	
Within 8" of Joint:	
Remarks:

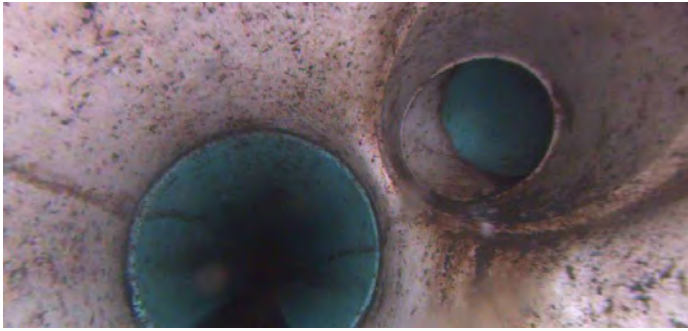
Code: **TF**
Description: **Tap Factory**

Distance (ft): **115.5**
Structural Grade: **0**
O&M Grade: **0**
Clock Start/From: **2**
Clock To:
1st Value: **4.000**
2nd Value:
Value Percent:
Continuous Index:
Within 8" of Joint:
Remarks:

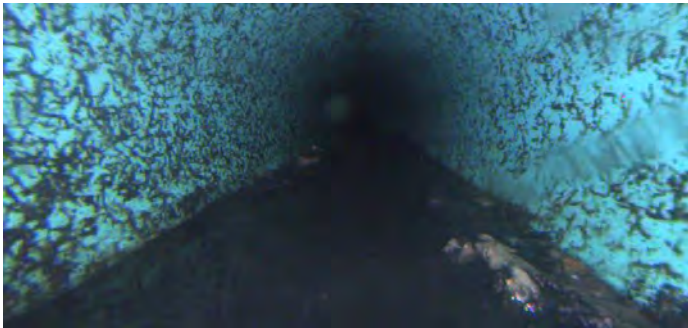
Code: **MWL**
Description: **Water Level**

Distance (ft): **228.8**
Structural Grade: **0**
O&M Grade: **0**
Clock Start/From:
Clock To:
1st Value:
2nd Value:
Value Percent: **25.000**
Continuous Index:
Within 8" of Joint: **NO**
Remarks:

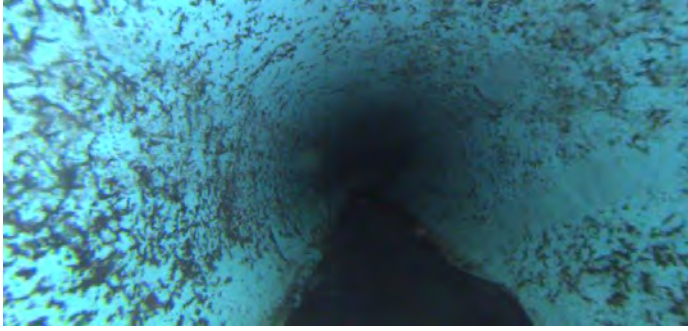
Code:	MSA
Description:	Abandoned Survey
Distance (ft):	254.1
Structural Grade:	0
O&M Grade:	0
Clock Start/From:	
Clock To:	
1st Value:	
2nd Value:	
Value Percent:	
Continuous Index:	
Within 8" of Joint:	NO
Remarks:	DSF
