Profile/Photo Observation Report

| Street: | FOXCROFT STREET | Flow Control: | Not Controlled |
| City: | Hobart, IN | Year Renewed: | |

| US MH: | M-108-054 | DS MH: | M-108-053 |

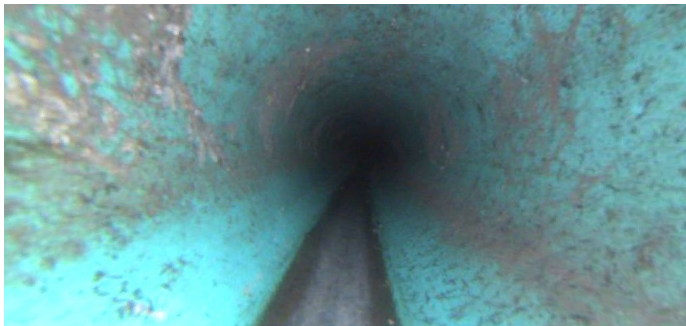
Code: **AMH**
Description: **Manhole**

Distance (ft): **.0**
Structural Grade: **0**
O&M Grade: **0**
Clock Start/From:
Clock To:
1st Value:
2nd Value:
Value Percent:
Continuous Index:
Within 8" of Joint: **NO**
Remarks: **M-108-053**

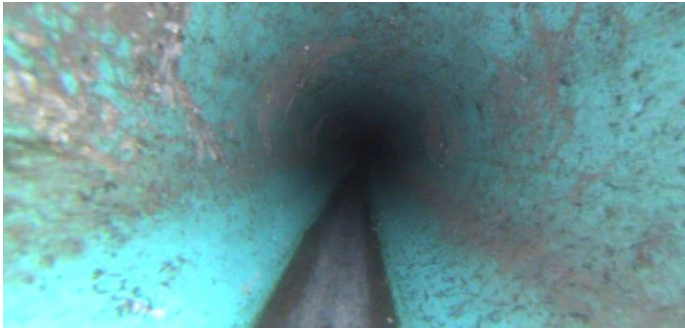
| Code: | MWL |
| Description: | Water Level |

| Distance (ft): | .0 |
| Value Percent: | 5.000 |

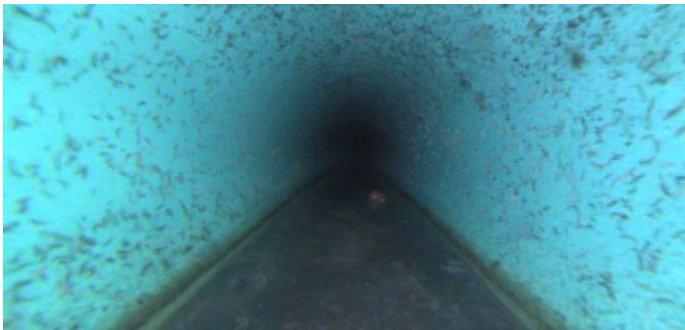
| Code: | MWL |
| Description: | Water Level |

| Distance (ft): | 81.9 |
| Value Percent: | 20.000 |

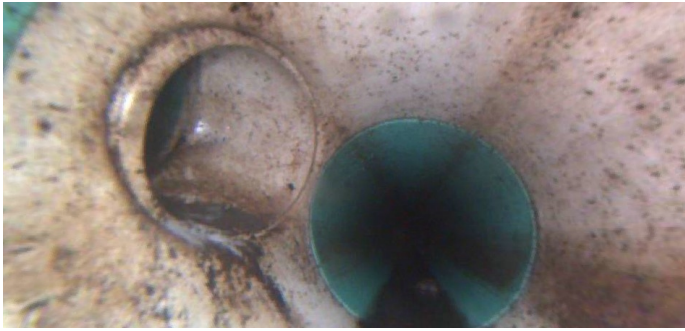
Code: **TF**
Description: **Tap Factory**

Distance (ft): **105.3**
Structural Grade: **0**
O&M Grade: **0**
Clock Start/From: **10**
Clock To:
1st Value: **4.000**
2nd Value:
Value Percent:
Continuous Index:
Within 8" of Joint:
Remarks:

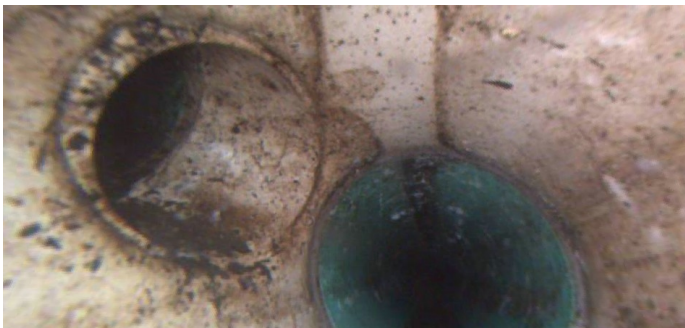
Code: **TF**
Description: **Tap Factory**

Distance (ft): **324.3**
Structural Grade: **0**
O&M Grade: **0**
Clock Start/From: **10**
Clock To:
1st Value: **4.000**
2nd Value:
Value Percent:
Continuous Index:
Within 8" of Joint:
Remarks:

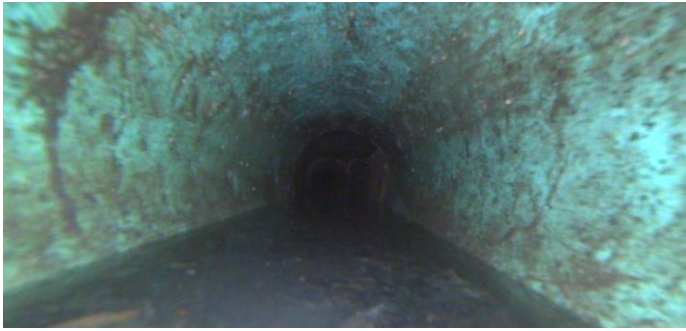
Code: **MWL**
Description: **Water Level**

Distance (ft): **409.0**
Structural Grade: **0**
O&M Grade: **0**
Clock Start/From:
Clock To:
1st Value:
2nd Value:
Value Percent: **30.000**
Continuous Index:
Within 8" of Joint: **NO**
Remarks:

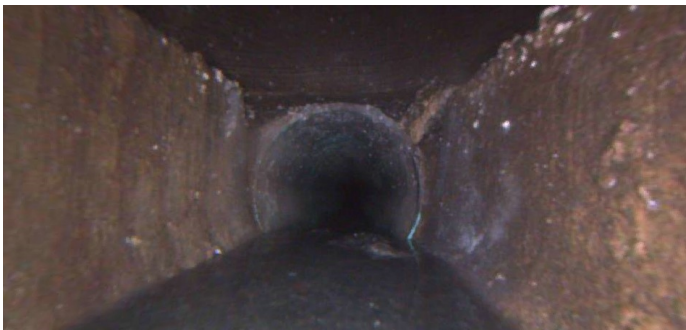
Code: **AMH**
Description: **Manhole**

Distance (ft): **413.4**
Structural Grade: **0**
O&M Grade: **0**
Clock Start/From:
Clock To:
1st Value:
2nd Value:
Value Percent:
Continuous Index:
Within 8" of Joint: **NO**
Remarks: **M-108-054**
