Profile/Photo Observation Report

Date:	04/05/2018	Weather:		Coding:	PACP 6.0
Pipe Length (ft):	336.8	Owner:	NA	Pre Clean:	Not Known
P.O.#:		Surveyor:	Jen Costello	PSR:	P-203-003-002
Customer:		Clean Date:	01/01/1900	Shape:	C

Street:	W OLD RIDGE RD & PARKER ST	Flow Control:	Not Controlled
City:	Hobart, IN	Year Renewed:	
Location:	Other	Tape/Media #:	
Purpose:	Not Known	Dia/Height:	12"
Use:	Sanitary	Material:	VCP
Drain Area:	NA	Lining:	
Category:	NA		
Comment:

Location Details:		Direction of Survey:	Downstream
US MH:	M-203-003	DS MH:	M-203-002
		Total Length Surveyed (ft):	323.1

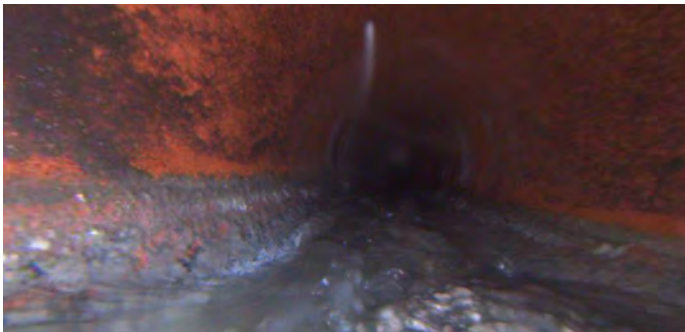
Code:	DAGS
Description:	Deposits Attached Grease

Distance (ft):	.0
Structural Grade:	0
O&M Grade:	2
Clock Start/From:	8
Clock To:	4
1st Value:	
2nd Value:	
Value Percent:	5.000
Continuous Index:	S01
Within 8" of Joint:	NO
Remarks:

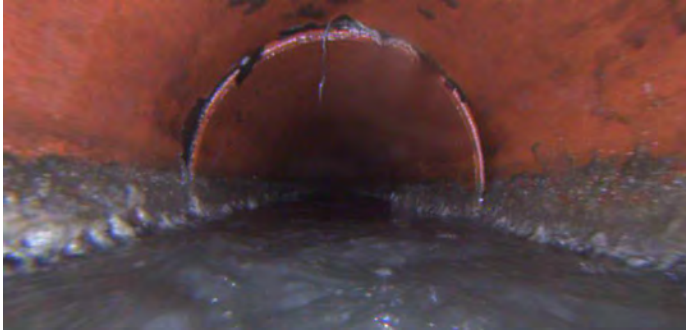
Code: **RFJ**
Description: **Roots Fine Joint**

Distance (ft): **52.6**
Structural Grade: **0**
O&M Grade: **1**
Clock Start/From: **12**
Clock To:
1st Value:
2nd Value:
Value Percent:
Continuous Index:
Within 8" of Joint: **YES**
Remarks:

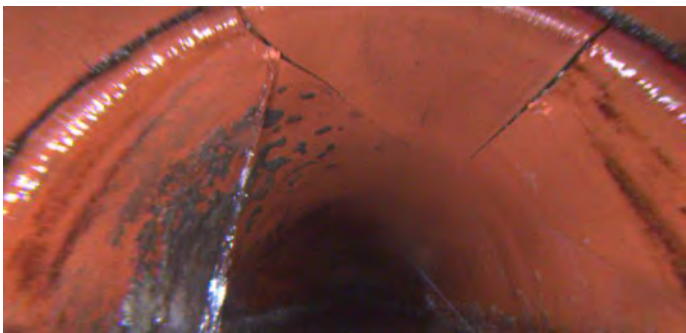
Code: **FM**
Description: **Fracture Multiple**

Distance (ft): **191.0**
Structural Grade: **4**
O&M Grade: **0**
Clock Start/From: **11**
Clock To: **1**
1st Value:
2nd Value:
Value Percent:
Continuous Index:
Within 8" of Joint: **YES**
Remarks:

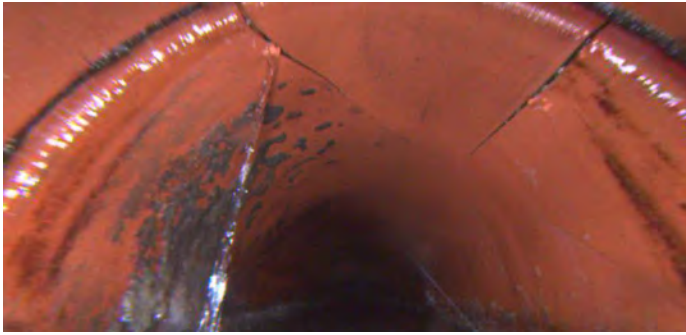
Code: **IR**
Description: **Infil Runner**

Distance (ft): **191.0**
Structural Grade: **0**
O&M Grade: **4**
Clock Start/From: **11**
Clock To: **1**
1st Value:
2nd Value:
Value Percent:
Continuous Index:
Within 8" of Joint: **YES**
Remarks:

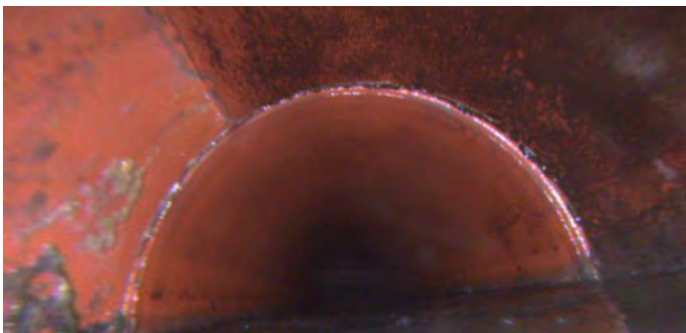
Code: **FL**
Description: **Fracture Longitudinal**

Distance (ft): **205.6**
Structural Grade: **3**
O&M Grade: **0**
Clock Start/From: **11**
Clock To:
1st Value:
2nd Value:
Value Percent:
Continuous Index:
Within 8" of Joint: **YES**
Remarks:

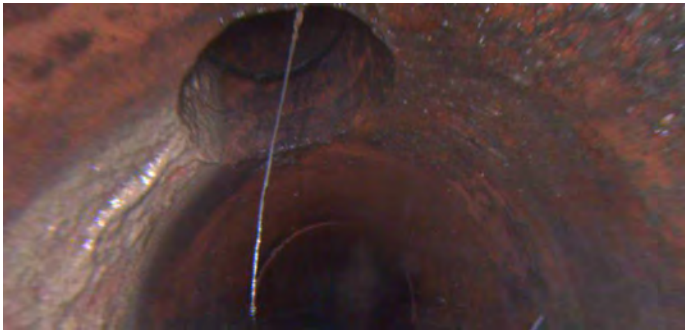
Code: **TFD**
Description: **Tap Factory Defective**

Distance (ft): **243.2**
Structural Grade: **0**
O&M Grade: **2**
Clock Start/From: **12**
Clock To:
1st Value: **4.000**
2nd Value: **1.000**
Value Percent:
Continuous Index:
Within 8" of Joint:
Remarks: **RFL**

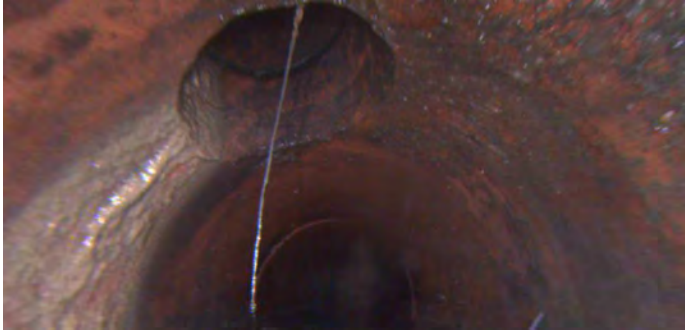
Code: **RFL**
Description: **Roots Fine Lateral**

Distance (ft): **243.2**
Structural Grade: **0**
O&M Grade: **1**
Clock Start/From: **11**
Clock To:
1st Value:
2nd Value:
Value Percent:
Continuous Index:
Within 8" of Joint: **NO**
Remarks:

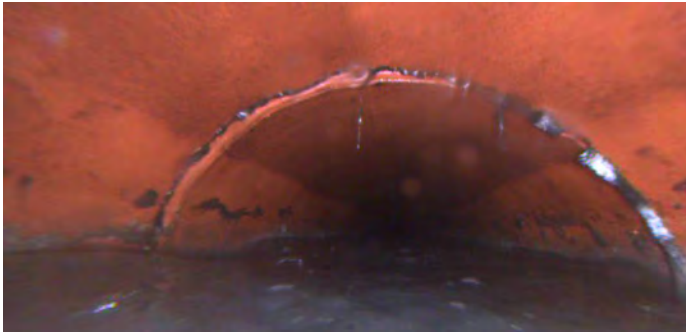
Code: **RFJ**
Description: **Roots Fine Joint**

Distance (ft): **253.5**
Structural Grade: **0**
O&M Grade: **1**
Clock Start/From: **11**
Clock To: **1**
1st Value:
2nd Value:
Value Percent:
Continuous Index:
Within 8" of Joint: **YES**
Remarks:

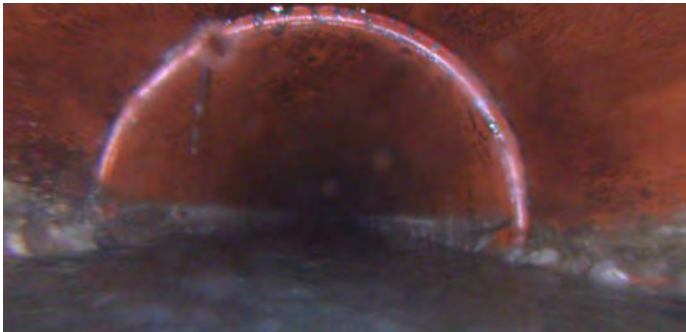
Code: **RFJ**
Description: **Roots Fine Joint**

Distance (ft): **303.1**
Structural Grade: **0**
O&M Grade: **1**
Clock Start/From: **11**
Clock To:
1st Value:
2nd Value:
Value Percent:
Continuous Index:
Within 8" of Joint: **YES**
Remarks:

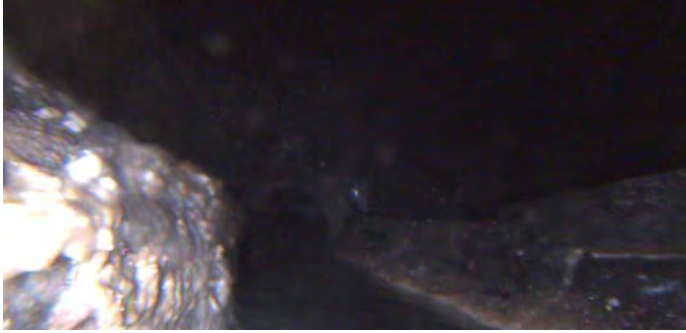
Code: **DAGS**
Description: **Deposits Attached Grease**

Distance (ft): **323.1**
Structural Grade: **0**
O&M Grade: **2**
Clock Start/From: **8**
Clock To: **4**
1st Value:
2nd Value:
Value Percent: **5.000**
Continuous Index: **F01**
Within 8" of Joint: **NO**
Remarks:
