Profile/Photo Observation Report

Date:	04/05/2018	Weather:		Coding:	PACP 6.0
Pipe Length (ft):	329.2	Owner:	NA	Pre Clean:	Not Known
P.O.#:		Surveyor:	Jen Costello	PSR:	P-203-006-003
Customer:		Clean Date:	01/01/1900	Shape:	C

Street:	W OLD RIDGE RD	Flow Control:	Not Controlled
City:	Hobart, IN	Year Renewed:	
Location:	Other	Tape/Media #:	
Purpose:	Not Known	Dia/Height:	12"
Use:	Sanitary	Material:	VCP
Drain Area:	NA	Lining:	
Category:	NA		
Comment:

Location Details:		Direction of Survey:	Downstream
US MH:	M-203-006	DS MH:	M-203-003
		Total Length Surveyed (ft):	320.7

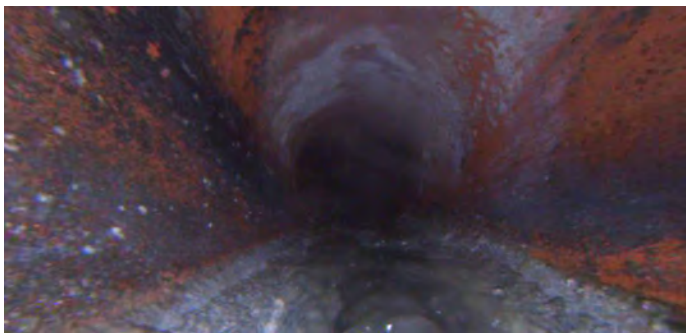
Code: **AMH**
Description: **Manhole**

Distance (ft): **.0**
Structural Grade: **0**
O&M Grade: **0**
Clock Start/From:
Clock To:
1st Value:
2nd Value:
Value Percent:
Continuous Index:
Within 8" of Joint: **NO**
Remarks: **M-203-006**

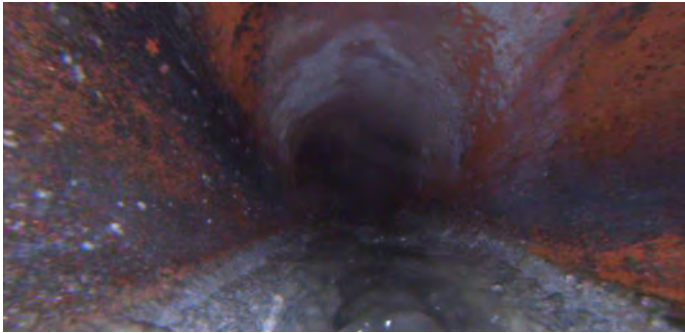
Code:	MWL
Description:	Water Level

Distance (ft):	.0
Structural Grade:	0
O&M Grade:	0
Clock Start/From:	
Clock To:	
1st Value:	
2nd Value:	
Value Percent:	5.000
Continuous Index:	
Within 8" of Joint:	NO
Remarks:

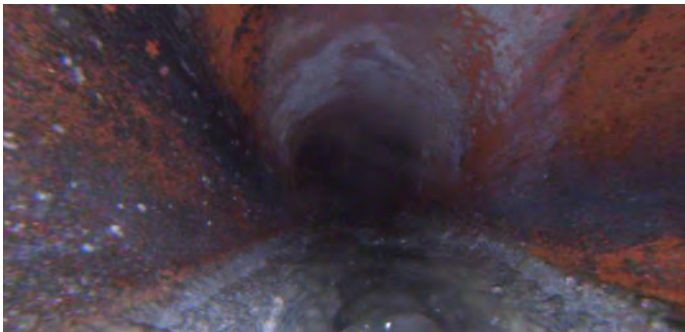
Code:	DAGS
Description:	Deposits Attached Grease

Distance (ft):	.0
Structural Grade:	0
O&M Grade:	2
Clock Start/From:	8
Clock To:	4
1st Value:	
2nd Value:	
Value Percent:	5.000
Continuous Index:	S01
Within 8" of Joint:	NO
Remarks:

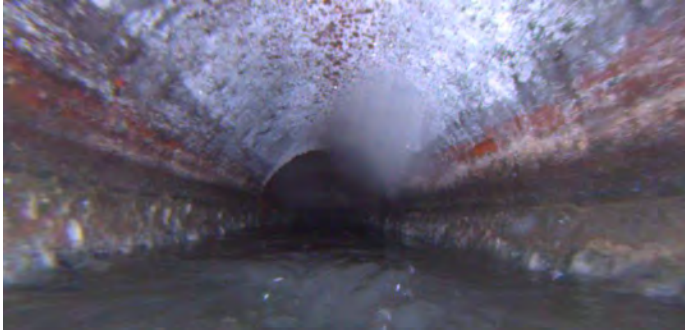
Code: **MWL**
Description: **Water Level**

Distance (ft): **14.9**
Structural Grade: **0**
O&M Grade: **0**
Clock Start/From:
Clock To:
1st Value:
2nd Value:
Value Percent: **30.000**
Continuous Index:
Within 8" of Joint: **NO**
Remarks:

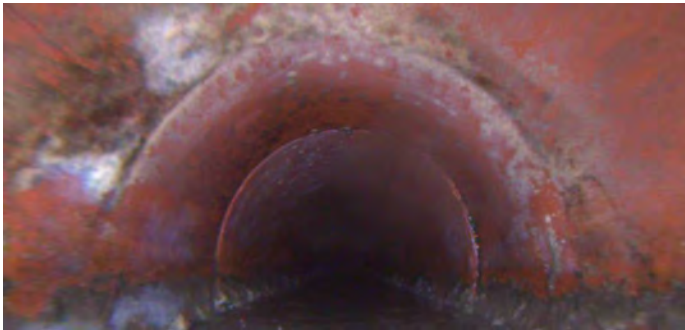
Code: **FC**
Description: **Fracture Circumferential**

Distance (ft): **75.6**
Structural Grade: **2**
O&M Grade: **0**
Clock Start/From: **9**
Clock To: **3**
1st Value:
2nd Value:
Value Percent:
Continuous Index:
Within 8" of Joint:
Remarks:

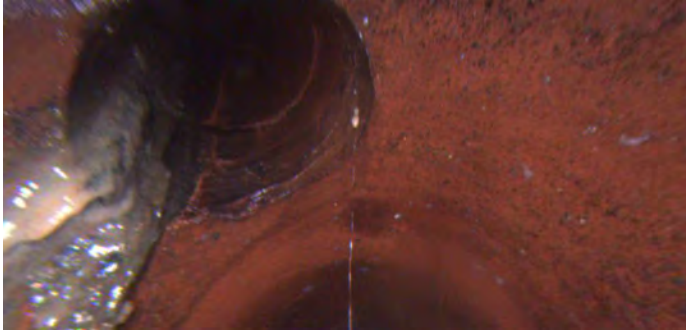
Code: **TFD**
Description: **Tap Factory Defective**

Distance (ft): **102.0**
Structural Grade: **0**
O&M Grade: **2**
Clock Start/From: **11**
Clock To:
1st Value: **4.000**
2nd Value:
Value Percent:
Continuous Index:
Within 8" of Joint:
Remarks: **DAGS**

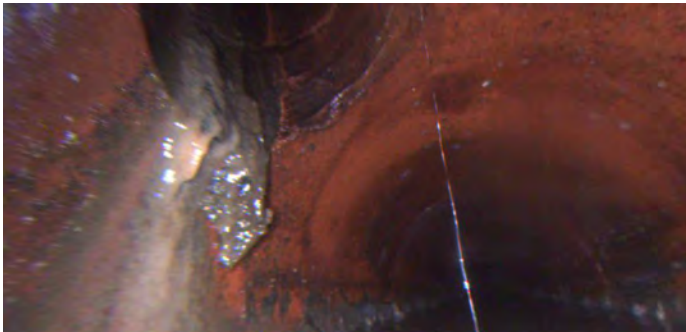
Code: **DAGS**
Description: **Deposits Attached Grease**

Distance (ft): **102.0**
Structural Grade: **0**
O&M Grade: **2**
Clock Start/From: **9**
Clock To: **10**
1st Value:
2nd Value:
Value Percent: **5.000**
Continuous Index:
Within 8" of Joint: **NO**
Remarks:

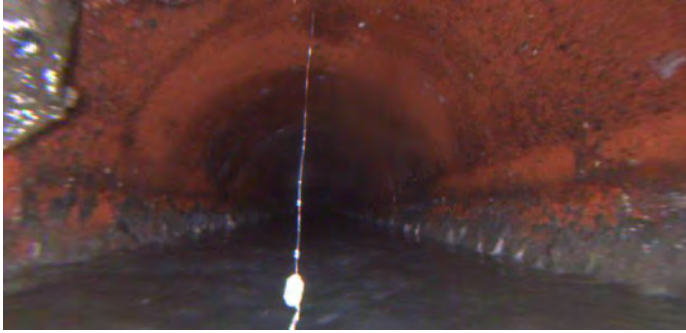
Code: **RFL**
Description: **Roots Fine Lateral**

Distance (ft): **102.0**
Structural Grade: **0**
O&M Grade: **1**
Clock Start/From: **12**
Clock To:
1st Value:
2nd Value:
Value Percent:
Continuous Index:
Within 8" of Joint: **NO**
Remarks:

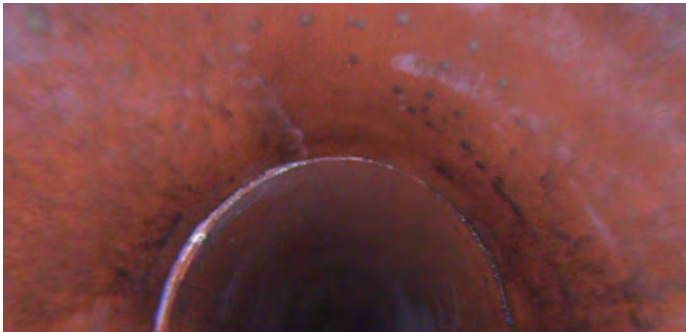
Code: **CL**
Description: **Crack Longitudinal**

Distance (ft): **132.8**
Structural Grade: **2**
O&M Grade: **0**
Clock Start/From: **12**
Clock To:
1st Value:
2nd Value:
Value Percent:
Continuous Index:
Within 8" of Joint: **YES**
Remarks:

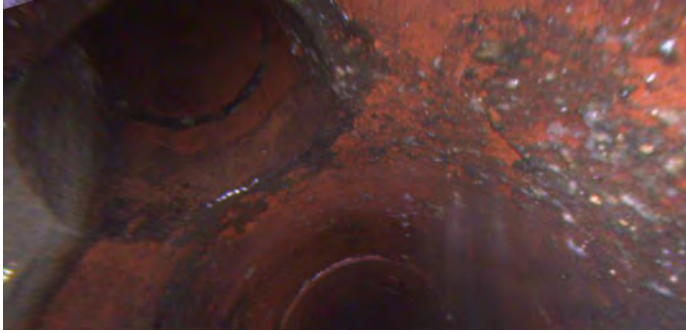
Code: **TFA**
Description: **Tap Factory Active**

Distance (ft): **149.3**
Structural Grade: **0**
O&M Grade: **0**
Clock Start/From: **11**
Clock To:
1st Value: **4.000**
2nd Value:
Value Percent:
Continuous Index:
Within 8" of Joint:
Remarks:

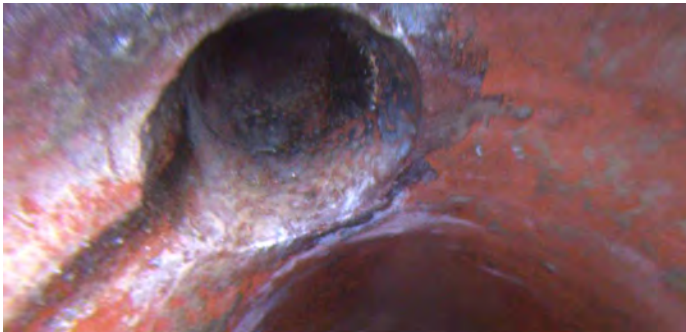
Code: **TF**
Description: **Tap Factory**

Distance (ft): **231.6**
Structural Grade: **0**
O&M Grade: **0**
Clock Start/From: **11**
Clock To:
1st Value: **4.000**
2nd Value:
Value Percent:
Continuous Index:
Within 8" of Joint:
Remarks:

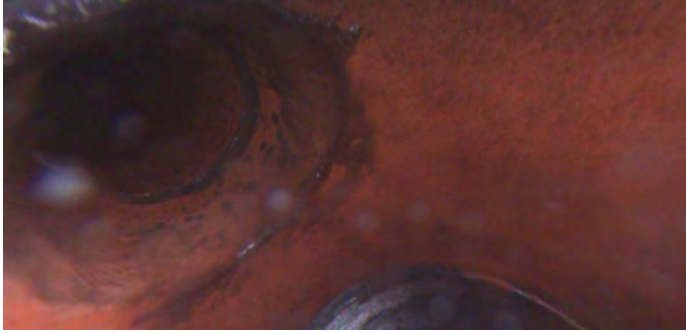
Code: **TF**
Description: **Tap Factory**

Distance (ft): **244.1**
Structural Grade: **0**
O&M Grade: **0**
Clock Start/From: **1**
Clock To:
1st Value: **4.000**
2nd Value:
Value Percent:
Continuous Index:
Within 8" of Joint:
Remarks:

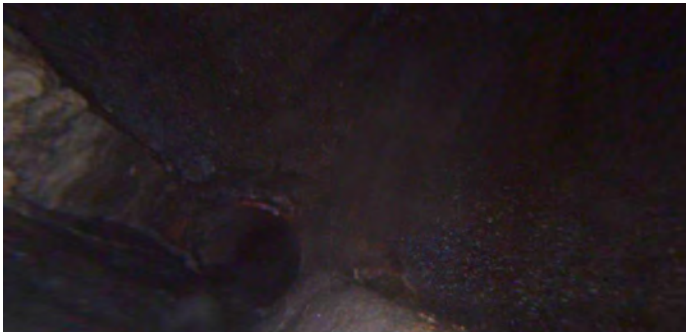
Code: **DAGS**
Description: **Deposits Attached Grease**

Distance (ft): **320.0**
Structural Grade: **0**
O&M Grade: **2**
Clock Start/From: **8**
Clock To: **4**
1st Value:
2nd Value:
Value Percent: **5.000**
Continuous Index: **F01**
Within 8" of Joint: **NO**
Remarks:

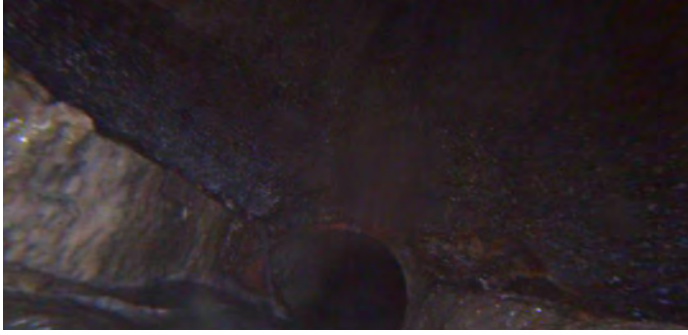
Code:	AMH
Description:	Manhole
Distance (ft):	320.7
Structural Grade:	0
O&M Grade:	0
Clock Start/From:	
Clock To:	
1st Value:	
2nd Value:	
Value Percent:	
Continuous Index:	
Within 8" of Joint:	NO
Remarks:	M-203-003
