# Profile/Photo Observation Report

Street:	<b>W OLD RIDGE RD &amp; BARNES ST</b>	Flow Control:	<b>Not Controlled</b>
City:	<b>Hobart, IN</b>	Year Renewed:	
Location:	<b>Other</b>	Tape/Media #:	
Purpose:	<b>Not Known</b>	Dia/Height:	<b>10"</b>
Use:	<b>Sanitary</b>	Material:	<b>VCP</b>
Drain Area:	<b>NA</b>	Lining:	
Category:	<b>NA</b>		
Comment:			
Location Details:		Direction of Survey:	<b>Downstream</b>
US MH:	<b>M-203-006</b>	DS MH:	<b>M-203-007</b>
		Total Length Surveyed (ft):	<b>2.9</b>

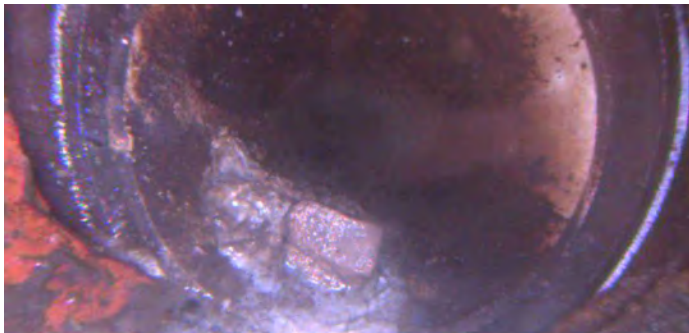
Code: **AMH**  
Description: **Manhole**

Distance (ft): **.0**  
Structural Grade: **0**  
O&M Grade: **0**  
Clock Start/From:  
Clock To:  
1st Value:  
2nd Value:  
Value Percent:  
Continuous Index:  
Within 8" of Joint: **NO**  
Remarks: **M-203-006**

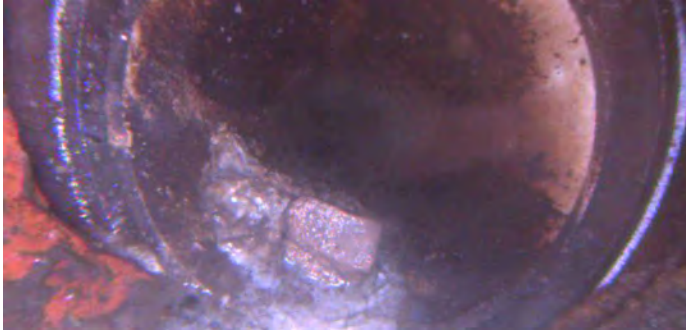
Code: **MWL**  
Description: **Water Level**

Distance (ft): **.0**  
Structural Grade: **0**  
O&M Grade: **0**  
Clock Start/From:  
Clock To:  
1st Value:  
2nd Value:  
Value Percent: **5.000**  
Continuous Index:  
Within 8" of Joint: **NO**  
Remarks:

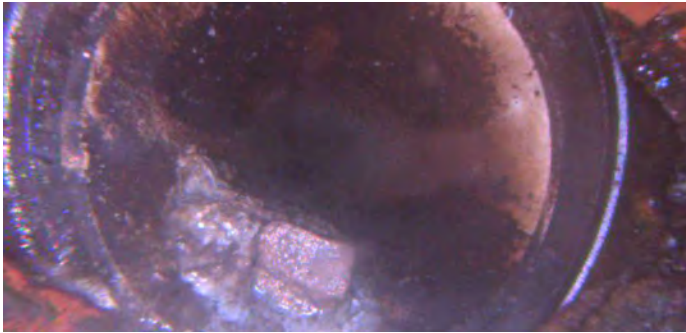
Code: **OBR**  
Description: **Obstacle Rocks**

Distance (ft): **.0**  
Structural Grade: **0**  
O&M Grade: **2**  
Clock Start/From: **6**  
Clock To: **9**  
1st Value:  
2nd Value:  
Value Percent: **10.000**  
Continuous Index:  
Within 8" of Joint: **NO**  
Remarks:

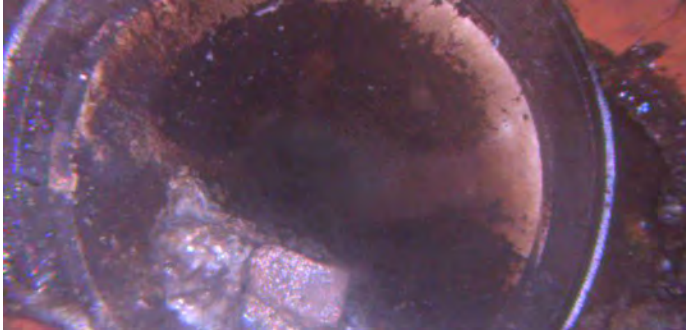
Code: **JOM**  
Description: **Joint Offset Medium**

Distance (ft): **.0**  
Structural Grade: **1**  
O&M Grade: **0**  
Clock Start/From:  
Clock To:  
1st Value:  
2nd Value:  
Value Percent:  
Continuous Index:  
Within 8" of Joint: **NO**  
Remarks:

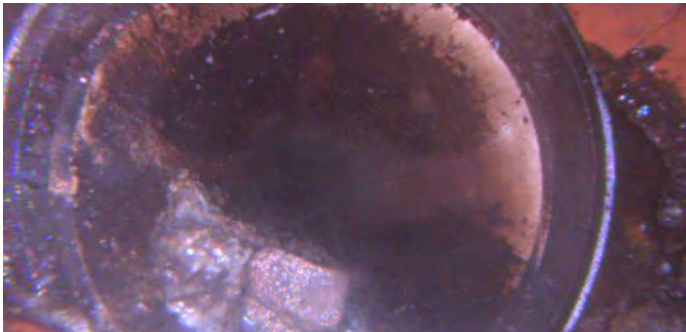
Code: **MMC**  
Description: **Material Change**

Distance (ft): **.0**  
Structural Grade: **0**  
O&M Grade: **0**  
Clock Start/From:  
Clock To:  
1st Value:  
2nd Value:  
Value Percent:  
Continuous Index:  
Within 8" of Joint: **NO**  
Remarks: **PVC**

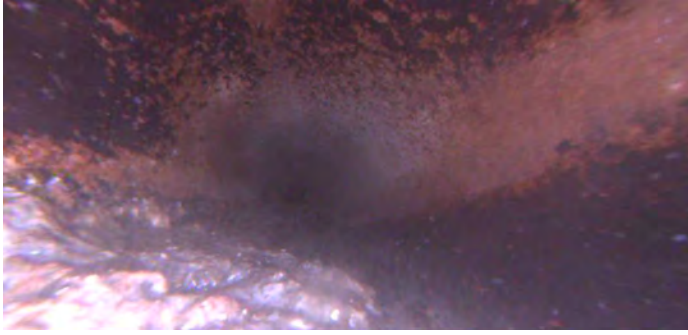
Code: **MSA**  
Description: **Abandoned Survey**

Distance (ft): **1.8**  
Structural Grade: **0**  
O&M Grade: **0**  
Clock Start/From:  
Clock To:  
1st Value:  
2nd Value:  
Value Percent:  
Continuous Index:  
Within 8" of Joint: **NO**  
Remarks: **OBR**
