## Profile/Photo Observation Report

Street:	<b>old ridge rd</b>	Flow Control:	<b>Not Controlled</b>
City:	<b>Hobart, IN</b>	Year Renewed:	
Location:	<b>Other</b>	Tape/Media #:	
Purpose:	<b>Not Known</b>	Dia/Height:	<b>10"</b>
Use:	<b>Sanitary</b>	Material:	<b>VCP</b>
Drain Area:	<b>NA</b>	Lining:	
Category:	<b>NA</b>		
Comment:

Location Details:		Direction of Survey:	<b>Downstream</b>
US MH:	<b>M-203-006</b>	DS MH:	<b>M-203-007</b>
		Total Length Surveyed (ft):	<b>2.9</b>

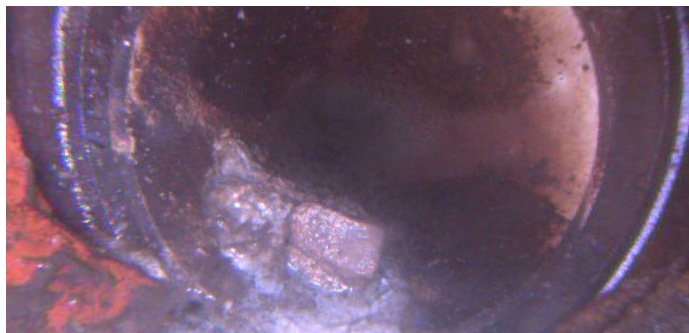
Code: **AMH**  
Description: **Manhole**

Distance (ft): **.0**  
Structural Grade: **0**  
O&M Grade: **0**  
Clock Start/From:  
Clock To:  
1st Value:  
2nd Value:  
Value Percent:  
Continuous Index:  
Within 8" of Joint: **NO**  
Remarks: **M-203-006**

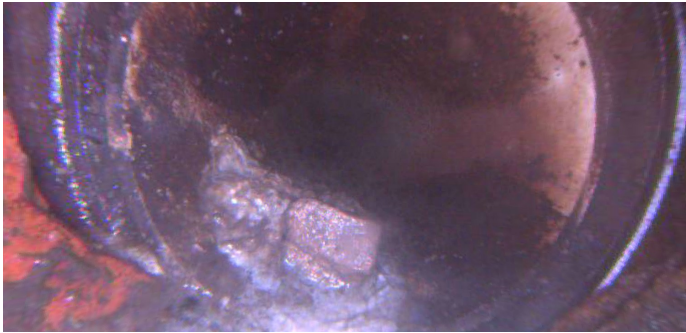
Code:	<b>MWL</b>
Description:	<b>Water Level</b>

Distance (ft):	<b>.0</b>
Structural Grade:	<b>0</b>
O&M Grade:	<b>0</b>
Clock Start/From:	
Clock To:	
1st Value:	
2nd Value:	
Value Percent:	<b>5.000</b>
Continuous Index:	
Within 8" of Joint:	<b>NO</b>
Remarks:

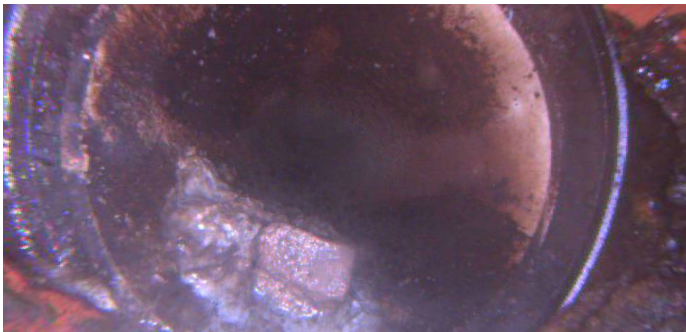
Code:	<b>OBR</b>
Description:	<b>Obstacle Rocks</b>

Distance (ft):	<b>.0</b>
Structural Grade:	<b>0</b>
O&M Grade:	<b>2</b>
Clock Start/From:	<b>6</b>
Clock To:	<b>9</b>
1st Value:	
2nd Value:	
Value Percent:	<b>10.000</b>
Continuous Index:	
Within 8" of Joint:	<b>NO</b>
Remarks:

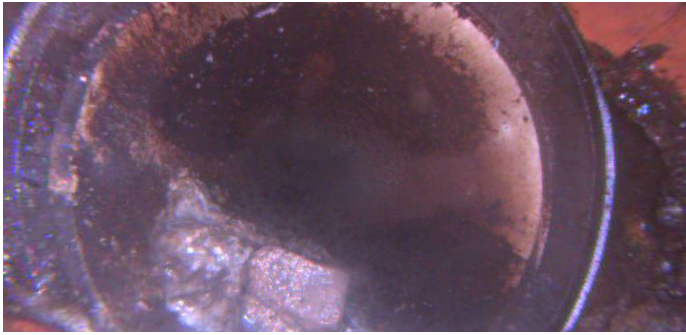
Code: **JOM**  
Description: **Joint Offset Medium**

Distance (ft): **.0**  
Structural Grade: **1**  
O&M Grade: **0**  
Clock Start/From:  
Clock To:  
1st Value:  
2nd Value:  
Value Percent:  
Continuous Index:  
Within 8" of Joint: **NO**  
Remarks:

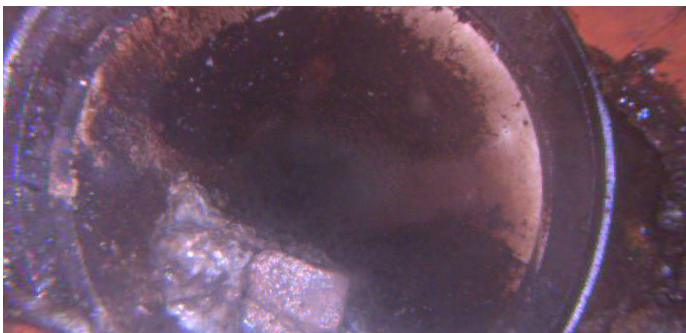
Code: **MMC**  
Description: **Material Change**

Distance (ft): **.0**  
Structural Grade: **0**  
O&M Grade: **0**  
Clock Start/From:  
Clock To:  
1st Value:  
2nd Value:  
Value Percent:  
Continuous Index:  
Within 8" of Joint: **NO**  
Remarks: **PVC**

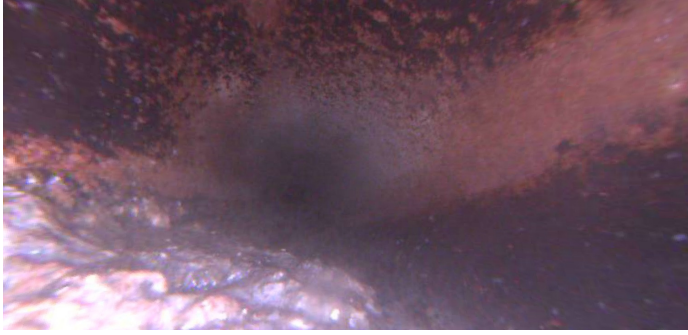
Code:	<b>MSA</b>
Description:	<b>Abandoned Survey</b>
Distance (ft):	<b>1.8</b>
Structural Grade:	<b>0</b>
O&M Grade:	<b>0</b>
Clock Start/From:	
Clock To:	
1st Value:	
2nd Value:	
Value Percent:	
Continuous Index:	
Within 8" of Joint:	<b>NO</b>
Remarks:	<b>OBR</b>
