## Profile/Photo Observation Report

Date:	<b>04/05/2018</b>	Weather:		Coding:	<b>PACP 6.0</b>
Pipe Length (ft):	<b>293.9</b>	Owner:	<b>NA</b>	Pre Clean:	<b>Not Known</b>
P.O.#:		Surveyor:	<b>Jen Costello</b>	PSR:	<b>P-203-010-009</b>
Customer:		Clean Date:	<b>01/01/1900</b>	Shape:	<b>C</b>

Street:	<b>W OLD RIDGE RD</b>	Flow Control:	<b>Not Controlled</b>
City:	<b>Hobart, IN</b>	Year Renewed:	
Location:	<b>Other</b>	Tape/Media #:	
Purpose:	<b>Not Known</b>	Dia/Height:	<b>12"</b>
Use:	<b>Sanitary</b>	Material:	<b>VCP</b>
Drain Area:	<b>NA</b>	Lining:	
Category:	<b>NA</b>		
Comment:

Location Details:		Direction of Survey:	<b>Downstream</b>
US MH:	<b>M-203-010</b>	DS MH:	<b>M-203-009</b>
		Total Length Surveyed (ft):	<b>286.6</b>

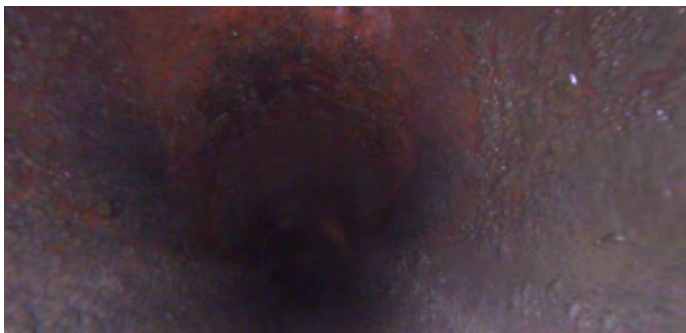
Code: **AMH**  
Description: **Manhole**

Distance (ft): **.0**  
Structural Grade: **0**  
O&M Grade: **0**  
Clock Start/From:  
Clock To:  
1st Value:  
2nd Value:  
Value Percent:  
Continuous Index:  
Within 8" of Joint: **NO**  
Remarks: **M-203-010**

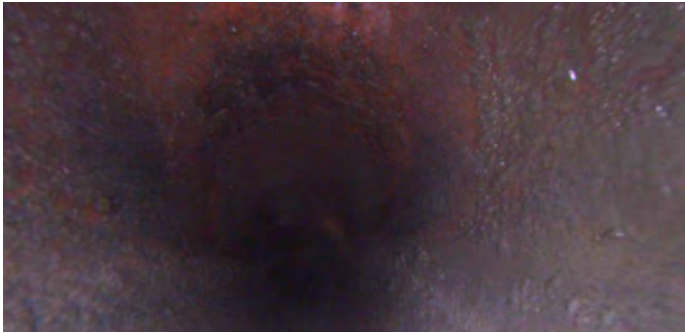
Code:	<b>MWL</b>
Description:	<b>Water Level</b>

Distance (ft):	<b>.0</b>
Structural Grade:	<b>0</b>
O&M Grade:	<b>0</b>
Clock Start/From:	
Clock To:	
1st Value:	
2nd Value:	
Value Percent:	<b>5.000</b>
Continuous Index:	
Within 8" of Joint:	<b>NO</b>
Remarks:

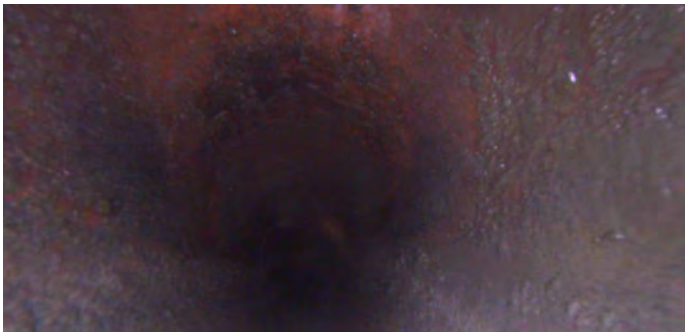
Code:	<b>DAGS</b>
Description:	<b>Deposits Attached Grease</b>

Distance (ft):	<b>.0</b>
Structural Grade:	<b>0</b>
O&M Grade:	<b>2</b>
Clock Start/From:	<b>7</b>
Clock To:	<b>5</b>
1st Value:	
2nd Value:	
Value Percent:	<b>5.000</b>
Continuous Index:	<b>S01</b>
Within 8" of Joint:	<b>NO</b>
Remarks:

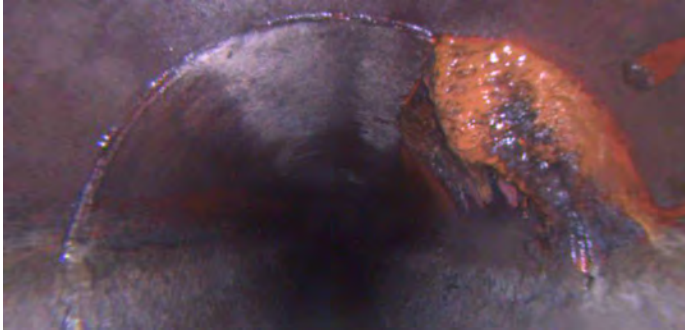
Code: **DAE**  
Description: **Deposits Attached Encrustation**

Distance (ft): **4.0**  
Structural Grade: **0**  
O&M Grade: **2**  
Clock Start/From: **1**  
Clock To: **3**  
1st Value:  
2nd Value:  
Value Percent: **5.000**  
Continuous Index:  
Within 8" of Joint: **YES**  
Remarks:

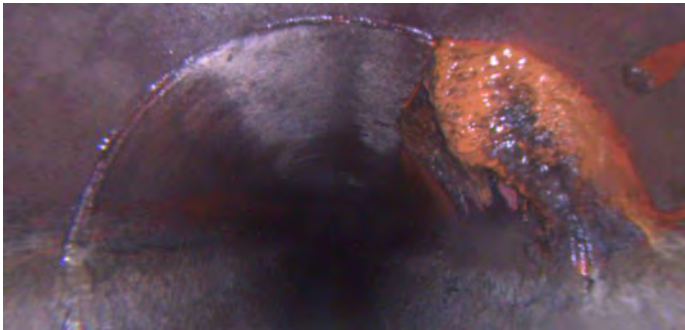
Code: **IW**  
Description: **Infil Weeper**

Distance (ft): **4.0**  
Structural Grade: **0**  
O&M Grade: **2**  
Clock Start/From: **1**  
Clock To: **4**  
1st Value:  
2nd Value:  
Value Percent:  
Continuous Index:  
Within 8" of Joint: **YES**  
Remarks:

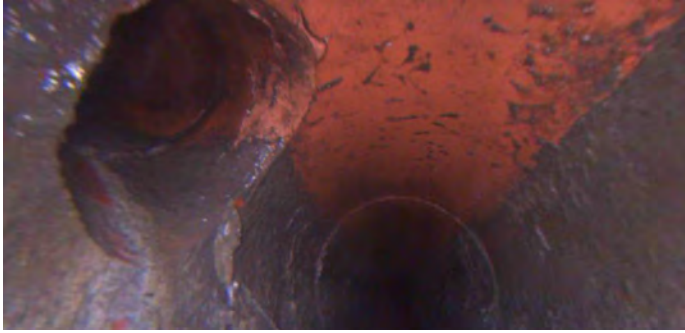
Code: **TF**  
Description: **Tap Factory**

Distance (ft): **51.1**  
Structural Grade: **0**  
O&M Grade: **0**  
Clock Start/From: **10**  
Clock To:  
1st Value: **4.000**  
2nd Value:  
Value Percent:  
Continuous Index:  
Within 8" of Joint:  
Remarks:

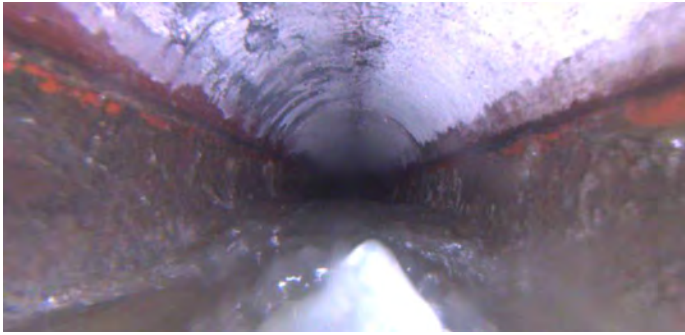
Code: **MCU**  
Description: **Camera Underwater**

Distance (ft): **92.0**  
Structural Grade: **0**  
O&M Grade: **4**  
Clock Start/From:  
Clock To:  
1st Value:  
2nd Value:  
Value Percent:  
Continuous Index: **F02**  
Within 8" of Joint: **NO**  
Remarks:

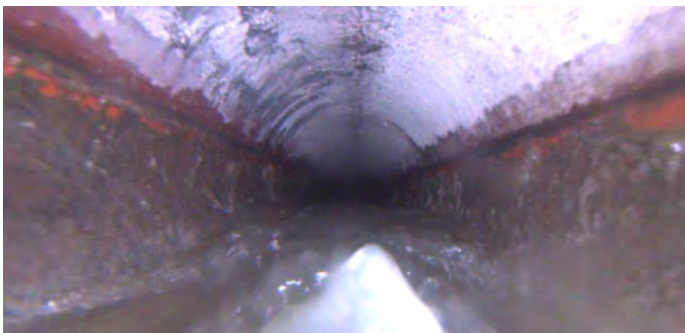
Code: **DAGS**  
Description: **Deposits Attached Grease**

Distance (ft): **92.0**  
Structural Grade: **0**  
O&M Grade: **2**  
Clock Start/From: **8**  
Clock To: **4**  
1st Value:  
2nd Value:  
Value Percent: **5.000**  
Continuous Index: **S03**  
Within 8" of Joint: **NO**  
Remarks:

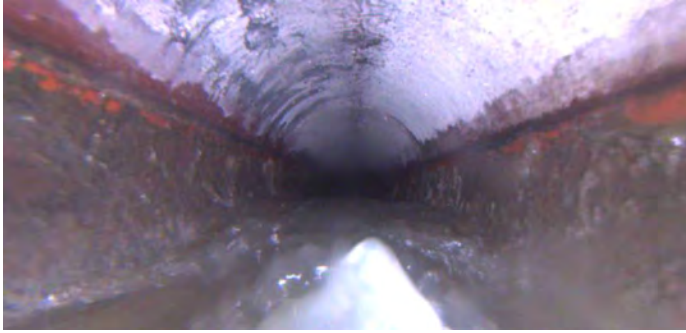
Code: **MWL**  
Description: **Water Level**

Distance (ft): **92.0**  
Structural Grade: **0**  
O&M Grade: **0**  
Clock Start/From:  
Clock To:  
1st Value:  
2nd Value:  
Value Percent: **20.000**  
Continuous Index:  
Within 8" of Joint: **NO**  
Remarks:

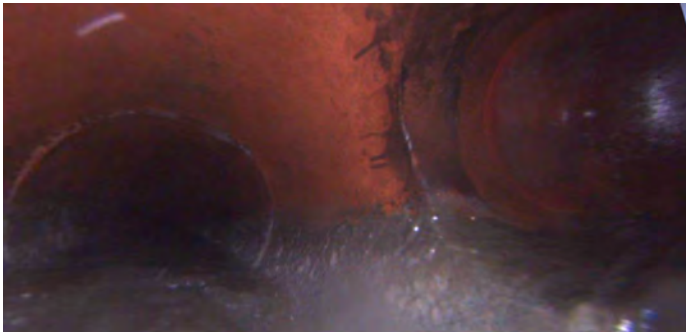
Code: **TFC**  
Description: **Tap Factory Capped**

Distance (ft): **115.3**  
Structural Grade: **0**  
O&M Grade: **0**  
Clock Start/From: **3**  
Clock To:  
1st Value: **4.000**  
2nd Value:  
Value Percent:  
Continuous Index:  
Within 8" of Joint:  
Remarks:

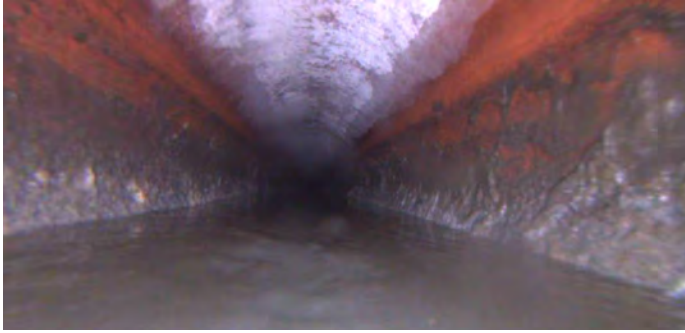
Code: **MWL**  
Description: **Water Level**

Distance (ft): **134.8**  
Structural Grade: **0**  
O&M Grade: **0**  
Clock Start/From:  
Clock To:  
1st Value:  
2nd Value:  
Value Percent: **40.000**  
Continuous Index:  
Within 8" of Joint: **NO**  
Remarks:

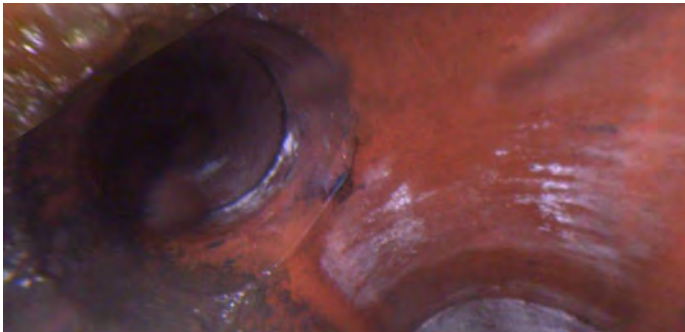
Code: **TF**  
Description: **Tap Factory**

Distance (ft): **143.4**  
Structural Grade: **0**  
O&M Grade: **0**  
Clock Start/From: **10**  
Clock To:  
1st Value: **4.000**  
2nd Value:  
Value Percent:  
Continuous Index:  
Within 8" of Joint:  
Remarks:

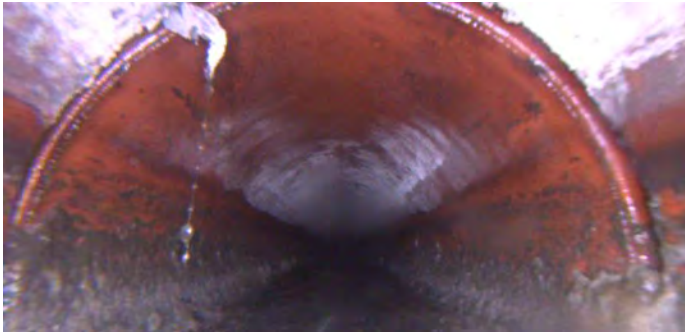
Code: ID  
Description: Infil Dripper

Distance (ft): 221.5  
Structural Grade: 0  
O&M Grade: 3  
Clock Start/From: 11  
Clock To:  
1st Value:  
2nd Value:  
Value Percent:  
Continuous Index:  
Within 8" of Joint: YES  
Remarks:

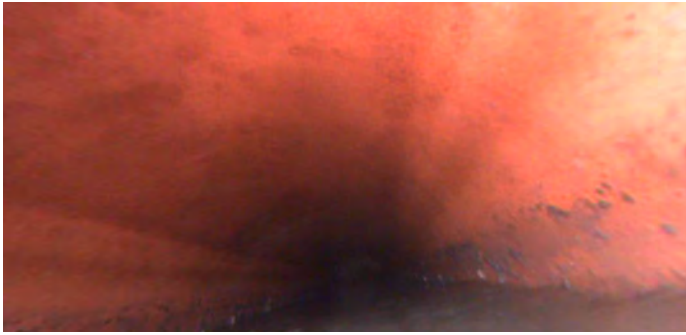
Code: **MCU**  
Description: **Camera Underwater**

Distance (ft): **258.2**  
Structural Grade: **0**  
O&M Grade: **4**  
Clock Start/From:  
Clock To:  
1st Value:  
2nd Value:  
Value Percent:  
Continuous Index: **F04**  
Within 8" of Joint: **NO**  
Remarks:

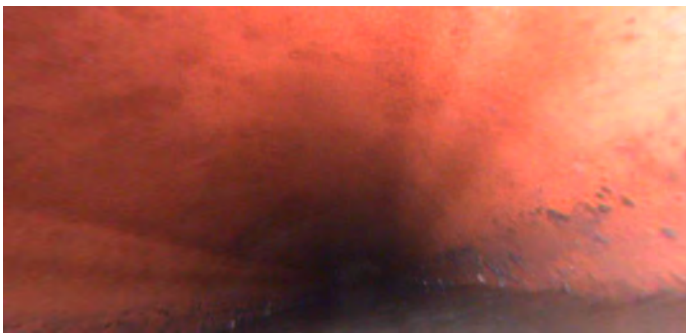
Code: **MWL**  
Description: **Water Level**

Distance (ft): **258.2**  
Structural Grade: **0**  
O&M Grade: **0**  
Clock Start/From:  
Clock To:  
1st Value:  
2nd Value:  
Value Percent: **40.000**  
Continuous Index:  
Within 8" of Joint: **NO**  
Remarks:
