## Profile/Photo Observation Report

Date:	<b>04/05/2018</b>	Weather:		Coding:	<b>PACP 6.0</b>
Pipe Length (ft):	<b>293.9</b>	Owner:	<b>NA</b>	Pre Clean:	<b>Not Known</b>
P.O.#:		Surveyor:	<b>Jen Costello</b>	PSR:	<b>P-203-010-009</b>
Customer:		Clean Date:	<b>01/01/1900</b>	Shape:	<b>C</b>

Street:	<b>old ridge rd</b>	Flow Control:	<b>Not Controlled</b>
City:	<b>Hobart, IN</b>	Year Renewed:	
Location:	<b>Other</b>	Tape/Media #:	
Purpose:	<b>Not Known</b>	Dia/Height:	<b>12"</b>
Use:	<b>Sanitary</b>	Material:	<b>VCP</b>
Drain Area:	<b>NA</b>	Lining:	
Category:	<b>NA</b>		
Comment:

Location Details:		Direction of Survey:	<b>Downstream</b>
US MH:	<b>M-203-010</b>	DS MH:	<b>M-203-009</b>
		Total Length Surveyed (ft):	<b>286.6</b>

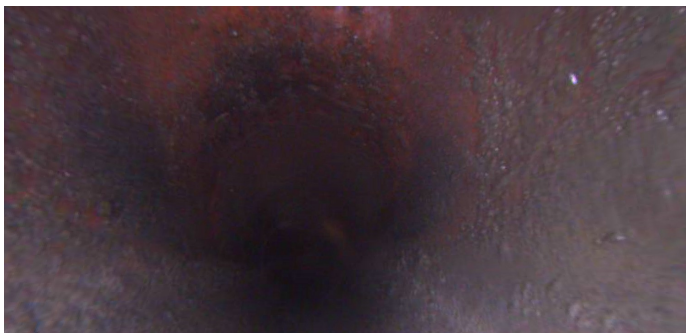
Code: **AMH**  
Description: **Manhole**

Distance (ft): **.0**  
Structural Grade: **0**  
O&M Grade: **0**  
Clock Start/From:  
Clock To:  
1st Value:  
2nd Value:  
Value Percent:  
Continuous Index:  
Within 8" of Joint: **NO**  
Remarks: **M-203-010**

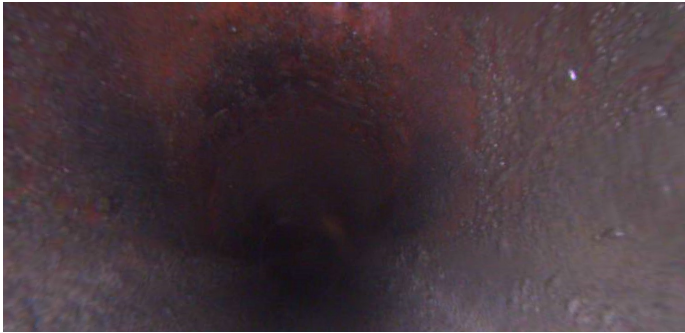
Code:	<b>MWL</b>
Description:	<b>Water Level</b>

Distance (ft):	<b>.0</b>
Structural Grade:	<b>0</b>
O&M Grade:	<b>0</b>
Clock Start/From:	
Clock To:	
1st Value:	
2nd Value:	
Value Percent:	<b>5.000</b>
Continuous Index:	
Within 8" of Joint:	<b>NO</b>
Remarks:

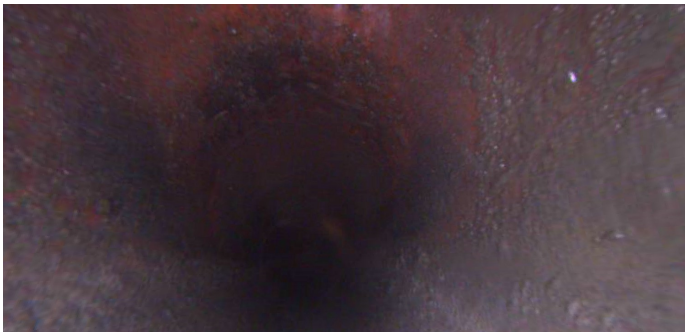
Code:	<b>DAGS</b>
Description:	<b>Deposits Attached Grease</b>

Distance (ft):	<b>.0</b>
Structural Grade:	<b>0</b>
O&M Grade:	<b>2</b>
Clock Start/From:	<b>7</b>
Clock To:	<b>5</b>
1st Value:	
2nd Value:	
Value Percent:	<b>5.000</b>
Continuous Index:	<b>S01</b>
Within 8" of Joint:	<b>NO</b>
Remarks:

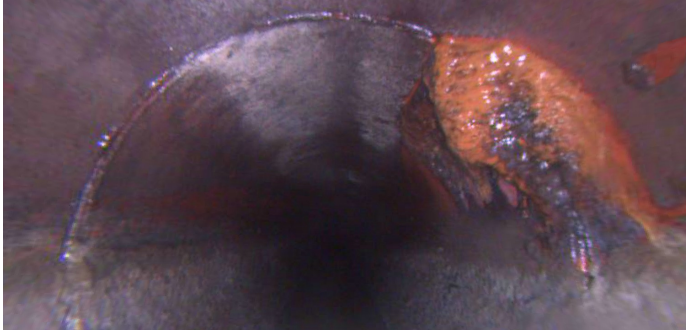
Code: **DAE**  
Description: **Deposits Attached Encrustation**

Distance (ft): **4.0**  
Structural Grade: **0**  
O&M Grade: **2**  
Clock Start/From: **1**  
Clock To: **3**  
1st Value:  
2nd Value:  
Value Percent: **5.000**  
Continuous Index:  
Within 8" of Joint: **YES**  
Remarks:

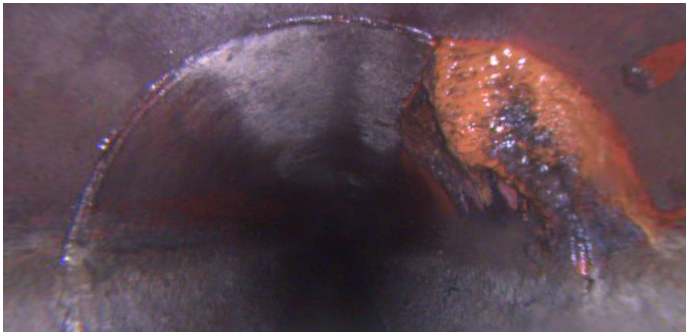
Code: **IW**  
Description: **Infil Weeper**

Distance (ft): **4.0**  
Structural Grade: **0**  
O&M Grade: **2**  
Clock Start/From: **1**  
Clock To: **4**  
1st Value:  
2nd Value:  
Value Percent:  
Continuous Index:  
Within 8" of Joint: **YES**  
Remarks:

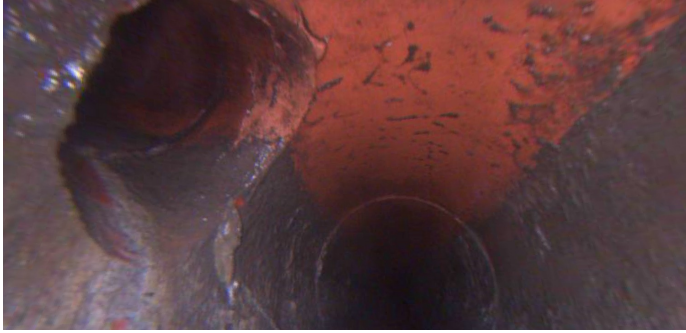
Code: **TF**  
Description: **Tap Factory**

Distance (ft): **51.1**  
Structural Grade: **0**  
O&M Grade: **0**  
Clock Start/From: **10**  
Clock To:  
1st Value: **4.000**  
2nd Value:  
Value Percent:  
Continuous Index:  
Within 8" of Joint:  
Remarks:

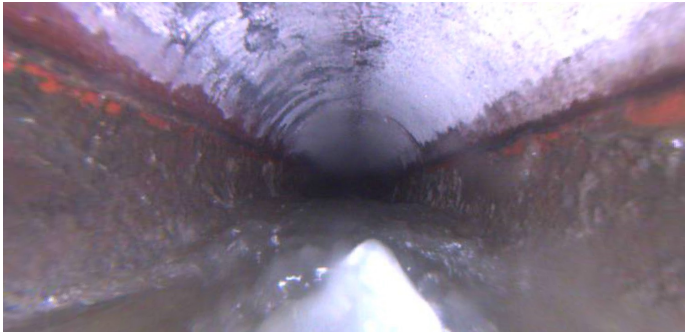
Code: **MCU**  
Description: **Camera Underwater**

Distance (ft): **92.0**  
Structural Grade: **0**  
O&M Grade: **4**  
Clock Start/From:  
Clock To:  
1st Value:  
2nd Value:  
Value Percent:  
Continuous Index: **F02**  
Within 8" of Joint: **NO**  
Remarks:

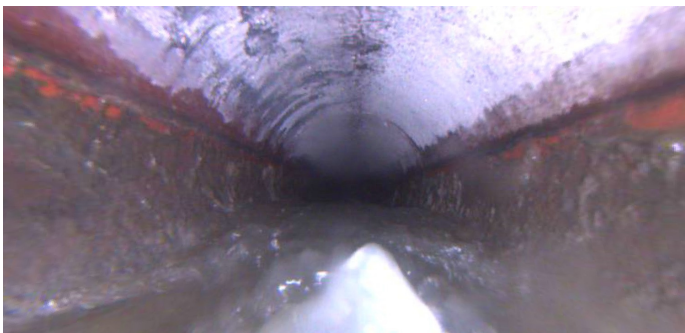
Code: **DAGS**  
Description: **Deposits Attached Grease**

Distance (ft): **92.0**  
Structural Grade: **0**  
O&M Grade: **2**  
Clock Start/From: **8**  
Clock To: **4**  
1st Value:  
2nd Value:  
Value Percent: **5.000**  
Continuous Index: **S03**  
Within 8" of Joint: **NO**  
Remarks:

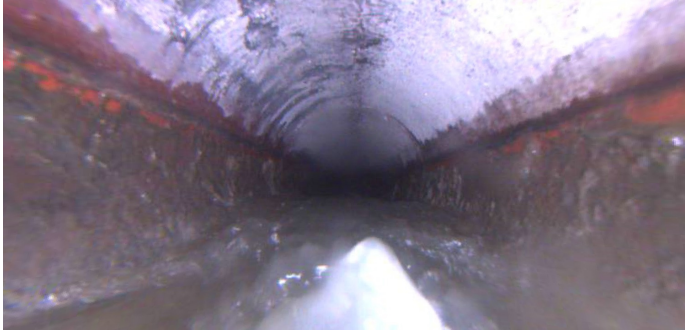
Code: **MWL**  
Description: **Water Level**

Distance (ft): **92.0**  
Structural Grade: **0**  
O&M Grade: **0**  
Clock Start/From:  
Clock To:  
1st Value:  
2nd Value:  
Value Percent: **20.000**  
Continuous Index:  
Within 8" of Joint: **NO**  
Remarks:

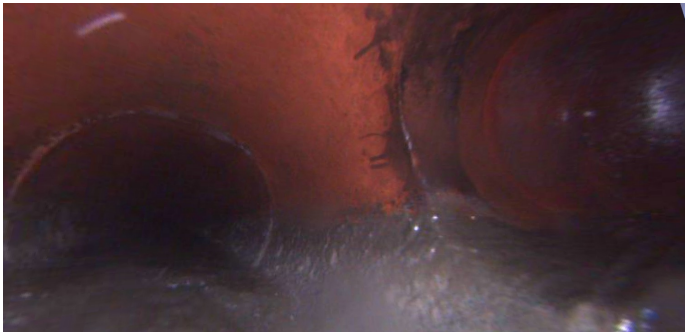
Code: **TFC**  
Description: **Tap Factory Capped**

Distance (ft): **115.3**  
Structural Grade: **0**  
O&M Grade: **0**  
Clock Start/From: **3**  
Clock To:  
1st Value: **4.000**  
2nd Value:  
Value Percent:  
Continuous Index:  
Within 8" of Joint:  
Remarks:

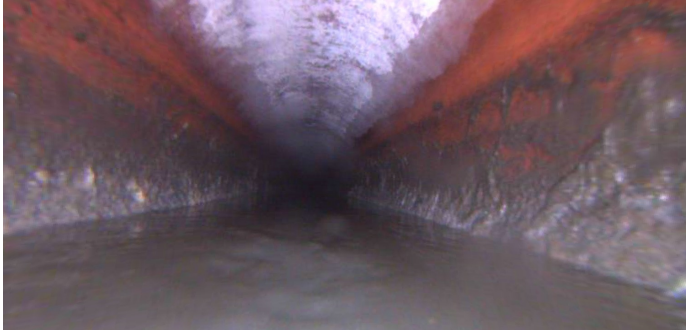
Code: **MWL**  
Description: **Water Level**

Distance (ft): **134.8**  
Structural Grade: **0**  
O&M Grade: **0**  
Clock Start/From:  
Clock To:  
1st Value:  
2nd Value:  
Value Percent: **40.000**  
Continuous Index:  
Within 8" of Joint: **NO**  
Remarks:

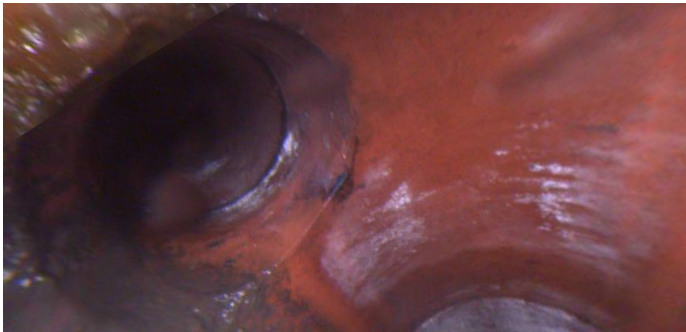
Code: **TF**  
Description: **Tap Factory**

Distance (ft): **143.4**  
Structural Grade: **0**  
O&M Grade: **0**  
Clock Start/From: **10**  
Clock To:  
1st Value: **4.000**  
2nd Value:  
Value Percent:  
Continuous Index:  
Within 8" of Joint:  
Remarks:

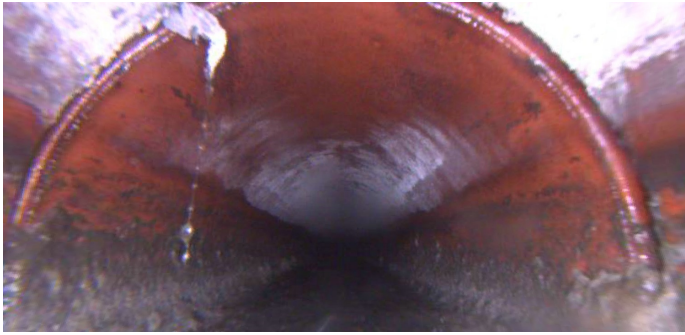
Code: ID  
Description: Infil Dripper

Distance (ft): 221.5  
Structural Grade: 0  
O&M Grade: 3  
Clock Start/From: 11  
Clock To:  
1st Value:  
2nd Value:  
Value Percent:  
Continuous Index:  
Within 8" of Joint: YES  
Remarks:

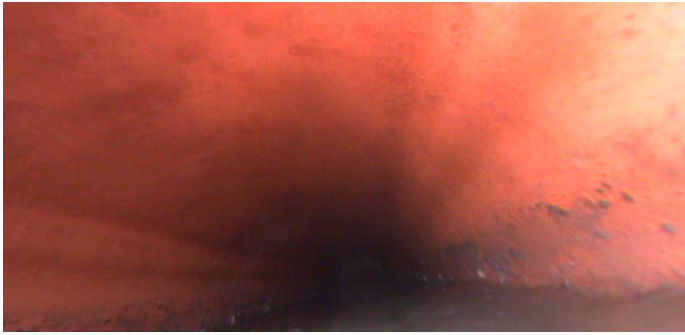
Code: **MCU**  
Description: **Camera Underwater**

Distance (ft): **258.2**  
Structural Grade: **0**  
O&M Grade: **4**  
Clock Start/From:  
Clock To:  
1st Value:  
2nd Value:  
Value Percent:  
Continuous Index: **F04**  
Within 8" of Joint: **NO**  
Remarks:

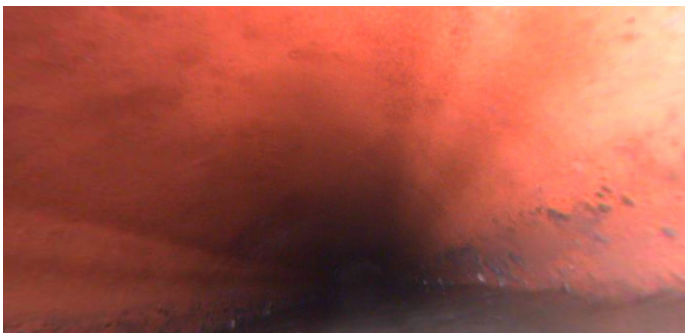
Code: **MWL**  
Description: **Water Level**

Distance (ft): **258.2**  
Structural Grade: **0**  
O&M Grade: **0**  
Clock Start/From:  
Clock To:  
1st Value:  
2nd Value:  
Value Percent: **40.000**  
Continuous Index:  
Within 8" of Joint: **NO**  
Remarks:

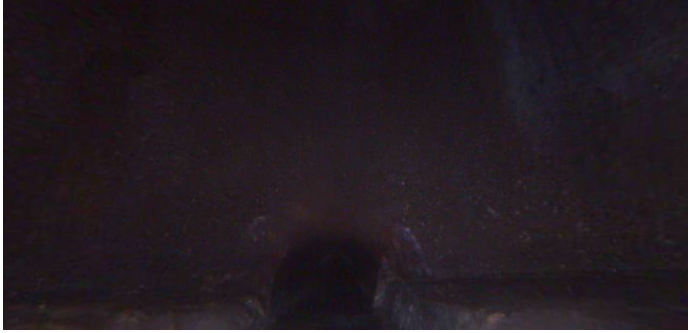
Code:	<b>AMH</b>
Description:	<b>Manhole</b>
Distance (ft):	<b>286.6</b>
Structural Grade:	<b>0</b>
O&M Grade:	<b>0</b>
Clock Start/From:	
Clock To:	
1st Value:	
2nd Value:	
Value Percent:	
Continuous Index:	
Within 8" of Joint:	<b>NO</b>
Remarks:	<b>M-203-009</b>
