## Profile/Photo Observation Report

Street:	<b>MAXWELL ST</b>	Flow Control:	<b>Not Controlled</b>
City:	<b>Hobart, IN</b>	Year Renewed:	
Location:	<b>Other</b>	Tape/Media #:	
Purpose:	<b>Not Known</b>	Dia/Height:	<b>8"</b>
Use:	<b>Sanitary</b>	Material:	<b>VCP</b>
Drain Area:	<b>NA</b>	Lining:	
Category:	<b>NA</b>		
Comment:

Location Details:		Direction of Survey:	<b>Upstream</b>
US MH:	<b>M-203-012</b>	DS MH:	<b>M-203-011</b>
		Total Length Surveyed (ft):	<b>108.7</b>

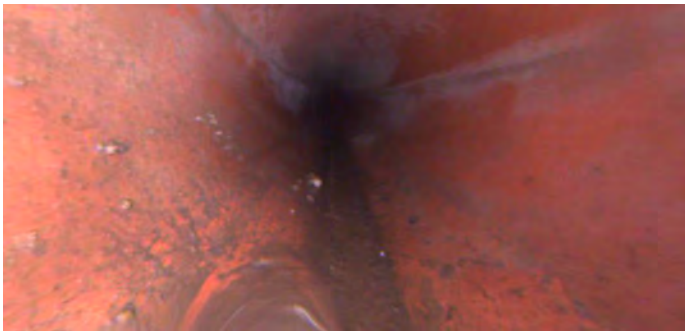
Code: **AMH**  
Description: **Manhole**

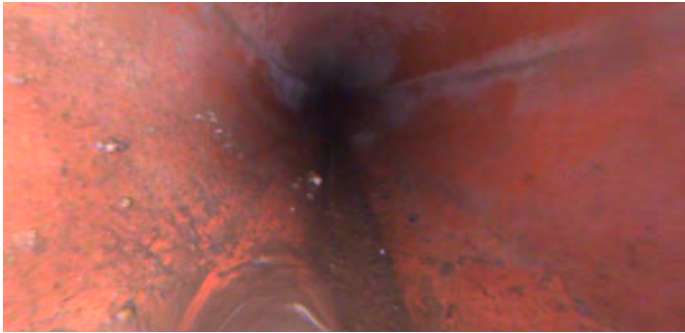
Code:	<b>MWL</b>
Description:	<b>Water Level</b>

Distance (ft):	<b>.0</b>
Structural Grade:	<b>0</b>
O&M Grade:	<b>0</b>
Clock Start/From:	
Clock To:	
1st Value:	
2nd Value:	
Value Percent:	<b>5.000</b>
Continuous Index:	
Within 8" of Joint:	<b>NO</b>
Remarks:

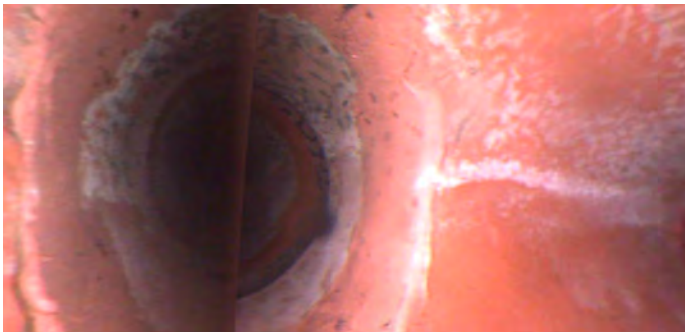
Code:	<b>TF</b>
Description:	<b>Tap Factory</b>

Distance (ft):	<b>5.2</b>
Structural Grade:	<b>0</b>
O&M Grade:	<b>0</b>
Clock Start/From:	<b>9</b>
Clock To:	
1st Value:	<b>4.000</b>
2nd Value:	
Value Percent:	
Continuous Index:	
Within 8" of Joint:	
Remarks:

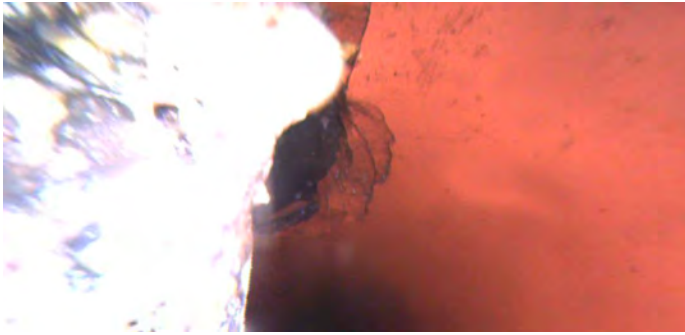
Code: **TBD**  
Description: **Tap Break-in Defective**

Distance (ft): **31.3**  
Structural Grade: **0**  
O&M Grade: **3**  
Clock Start/From: **12**  
Clock To:  
1st Value: **4.000**  
2nd Value:  
Value Percent:  
Continuous Index:  
Within 8" of Joint:  
Remarks: **RML**

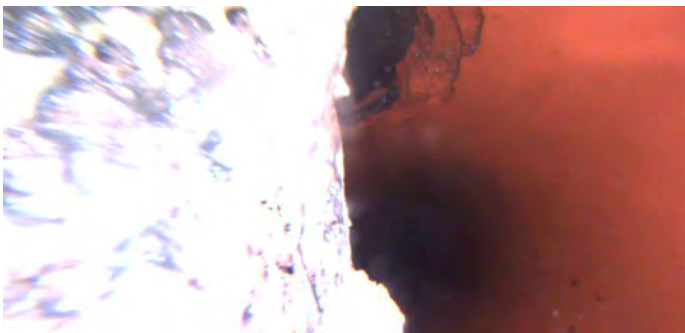
Code: **RML**  
Description: **Roots Medium Lateral**

Distance (ft): **31.3**  
Structural Grade: **0**  
O&M Grade: **3**  
Clock Start/From: **6**  
Clock To: **12**  
1st Value:  
2nd Value:  
Value Percent: **40.000**  
Continuous Index:  
Within 8" of Joint: **NO**  
Remarks:

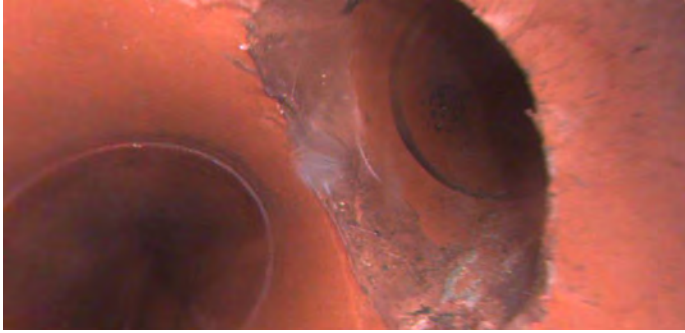
Code: **TF**  
Description: **Tap Factory**

Distance (ft): **41.9**  
Structural Grade: **0**  
O&M Grade: **0**  
Clock Start/From: **9**  
Clock To:  
1st Value: **4.000**  
2nd Value:  
Value Percent:  
Continuous Index:  
Within 8" of Joint:  
Remarks:

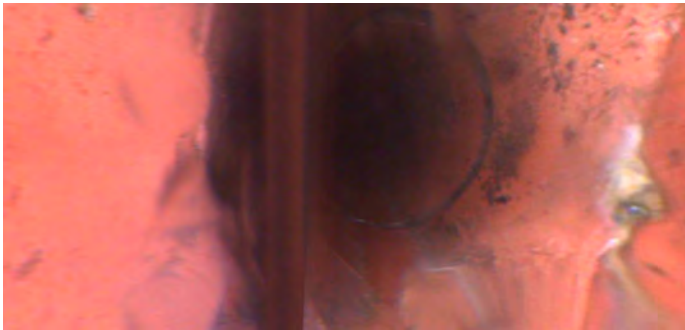
Code: **TFA**  
Description: **Tap Factory Active**

Distance (ft): **63.4**  
Structural Grade: **0**  
O&M Grade: **0**  
Clock Start/From: **3**  
Clock To:  
1st Value: **4.000**  
2nd Value:  
Value Percent:  
Continuous Index:  
Within 8" of Joint:  
Remarks:

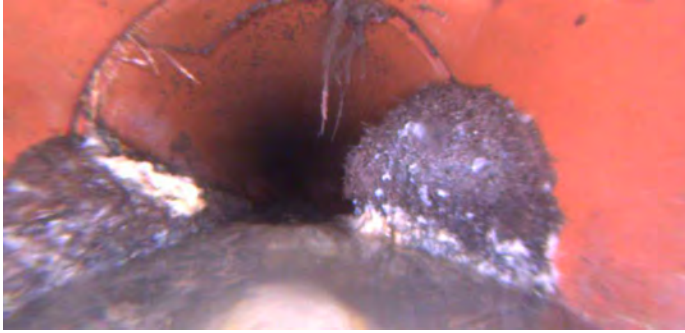
Code: **RMJ**  
Description: **Roots Medium Joint**

Distance (ft): **79.0**  
Structural Grade: **0**  
O&M Grade: **3**  
Clock Start/From: **8**  
Clock To: **4**  
1st Value:  
2nd Value:  
Value Percent: **30.000**  
Continuous Index:  
Within 8" of Joint: **YES**  
Remarks:

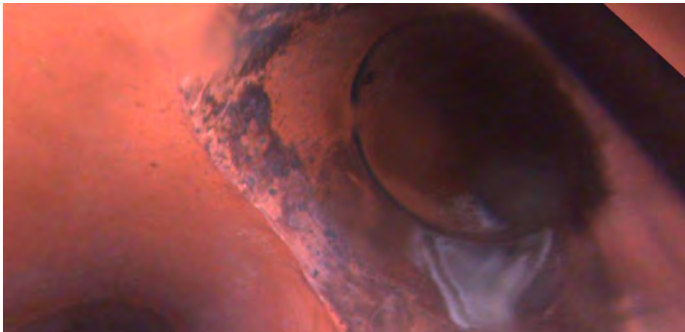
Code: **TF**  
Description: **Tap Factory**

Distance (ft): **84.8**  
Structural Grade: **0**  
O&M Grade: **0**  
Clock Start/From: **2**  
Clock To:  
1st Value: **4.000**  
2nd Value:  
Value Percent:  
Continuous Index:  
Within 8" of Joint:  
Remarks:

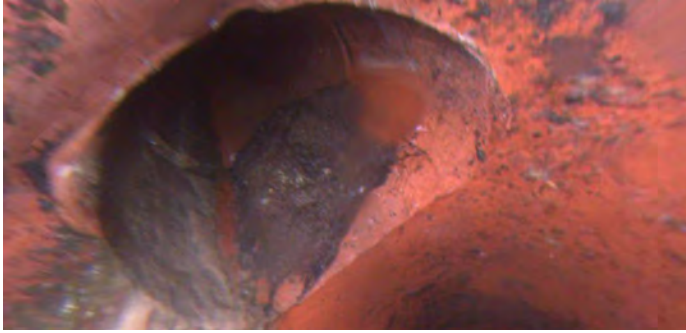
Code: **TF**  
Description: **Tap Factory**

Distance (ft): **101.6**  
Structural Grade: **0**  
O&M Grade: **0**  
Clock Start/From: **10**  
Clock To:  
1st Value: **4.000**  
2nd Value:  
Value Percent:  
Continuous Index:  
Within 8" of Joint:  
Remarks:

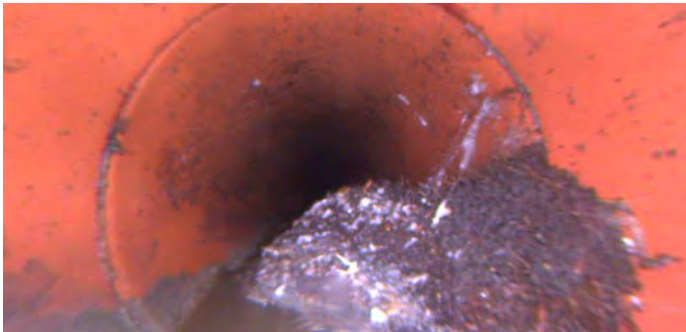
Code: **RMJ**  
Description: **Roots Medium Joint**

Distance (ft): **107.6**  
Structural Grade: **0**  
O&M Grade: **3**  
Clock Start/From: **2**  
Clock To: **6**  
1st Value:  
2nd Value:  
Value Percent: **40.000**  
Continuous Index:  
Within 8" of Joint: **YES**  
Remarks:

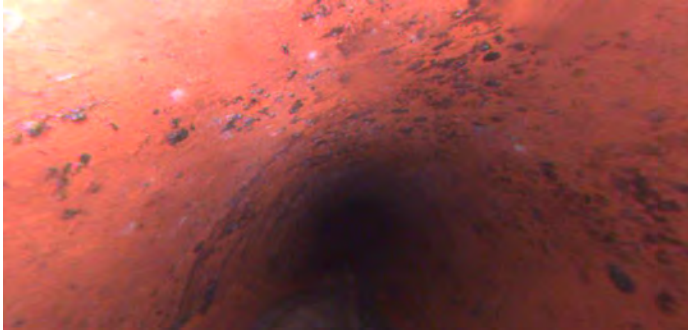
Code:	<b>MSA</b>
Description:	<b>Abandoned Survey</b>
Distance (ft):	<b>108.7</b>
Structural Grade:	<b>0</b>
O&M Grade:	<b>0</b>
Clock Start/From:	
Clock To:	
1st Value:	
2nd Value:	
Value Percent:	
Continuous Index:	
Within 8" of Joint:	<b>NO</b>
Remarks:	<b>ROOTS</b>
