Profile/Photo Observation Report

Location Details:		Direction of Survey:	Upstream
US MH:	M-203-012	DS MH:	M-203-011
		Total Length Surveyed (ft):	108.7

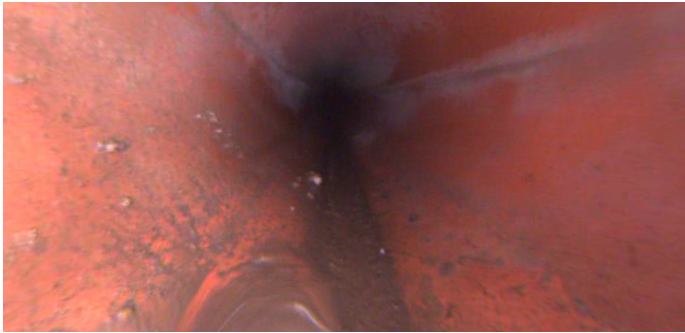
Code:	MWL
Description:	Water Level

Distance (ft):	.0
Structural Grade:	0
O&M Grade:	0
Clock Start/From:	
Clock To:	
1st Value:	
2nd Value:	
Value Percent:	5.000
Continuous Index:	
Within 8" of Joint:	NO
Remarks:

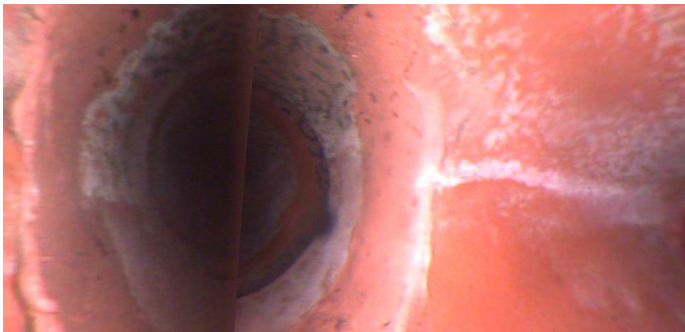
Code:	TF
Description:	Tap Factory

Distance (ft):	5.2
Structural Grade:	0
O&M Grade:	0
Clock Start/From:	9
Clock To:	
1st Value:	4.000
2nd Value:	
Value Percent:	
Continuous Index:	
Within 8" of Joint:	
Remarks:

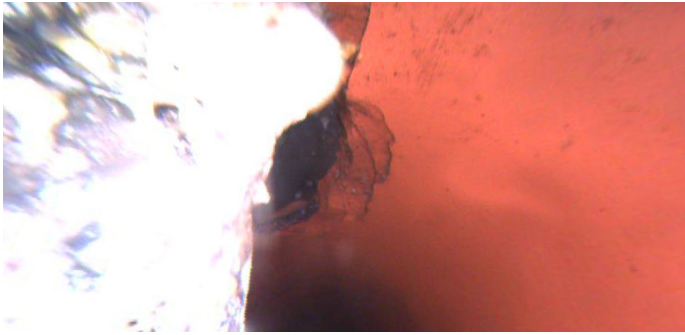
Code: **TBD**
Description: **Tap Break-in Defective**

Distance (ft): **31.3**
Structural Grade: **0**
O&M Grade: **3**
Clock Start/From: **12**
Clock To:
1st Value: **4.000**
2nd Value:
Value Percent:
Continuous Index:
Within 8" of Joint:
Remarks: **RML**

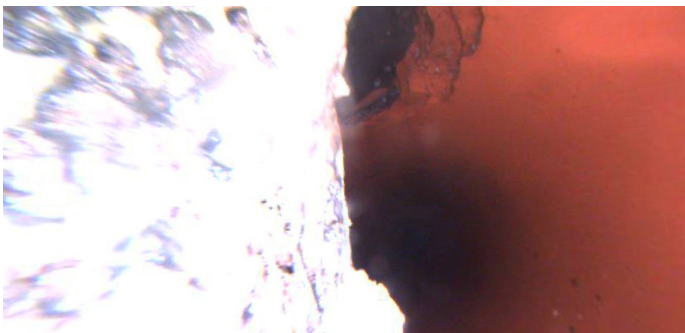
Code: **RML**
Description: **Roots Medium Lateral**

Distance (ft): **31.3**
Structural Grade: **0**
O&M Grade: **3**
Clock Start/From: **6**
Clock To: **12**
1st Value:
2nd Value:
Value Percent: **40.000**
Continuous Index:
Within 8" of Joint: **NO**
Remarks:

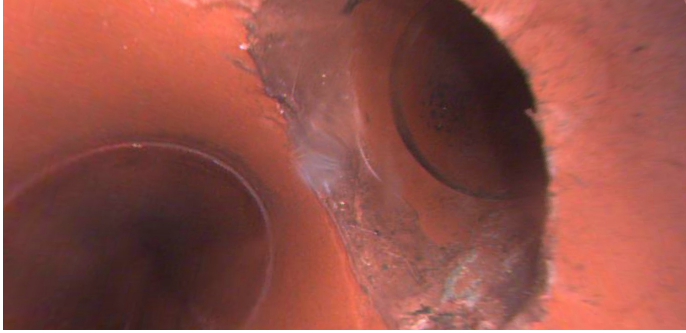
Code: **TF**
Description: **Tap Factory**

Distance (ft): **41.9**
Structural Grade: **0**
O&M Grade: **0**
Clock Start/From: **9**
Clock To:
1st Value: **4.000**
2nd Value:
Value Percent:
Continuous Index:
Within 8" of Joint:
Remarks:

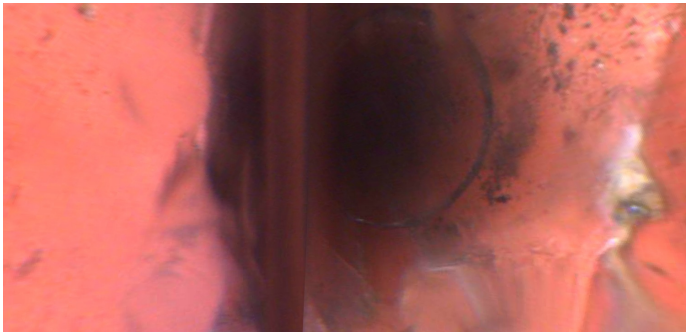
Code: **TFA**
Description: **Tap Factory Active**

Distance (ft): **63.4**
Structural Grade: **0**
O&M Grade: **0**
Clock Start/From: **3**
Clock To:
1st Value: **4.000**
2nd Value:
Value Percent:
Continuous Index:
Within 8" of Joint:
Remarks:

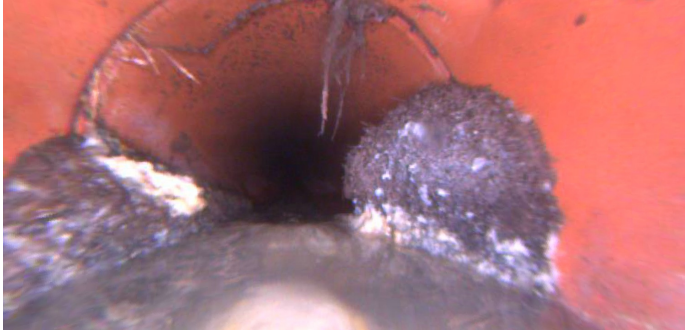
Code: **RMJ**
Description: **Roots Medium Joint**

Distance (ft): **79.0**
Structural Grade: **0**
O&M Grade: **3**
Clock Start/From: **8**
Clock To: **4**
1st Value:
2nd Value:
Value Percent: **30.000**
Continuous Index:
Within 8" of Joint: **YES**
Remarks:

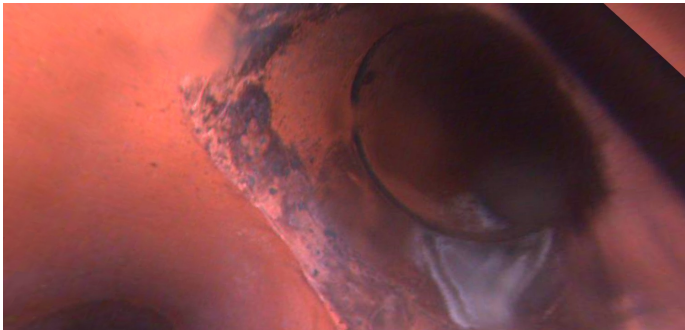
Code: **TF**
Description: **Tap Factory**

Distance (ft): **84.8**
Structural Grade: **0**
O&M Grade: **0**
Clock Start/From: **2**
Clock To:
1st Value: **4.000**
2nd Value:
Value Percent:
Continuous Index:
Within 8" of Joint:
Remarks:

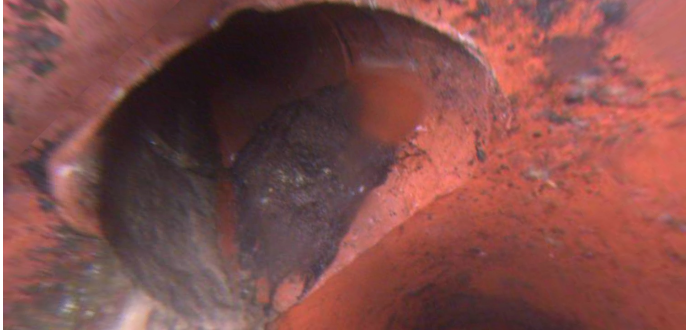
Code: **TF**
Description: **Tap Factory**

Distance (ft): **101.6**
Structural Grade: **0**
O&M Grade: **0**
Clock Start/From: **10**
Clock To:
1st Value: **4.000**
2nd Value:
Value Percent:
Continuous Index:
Within 8" of Joint:
Remarks:

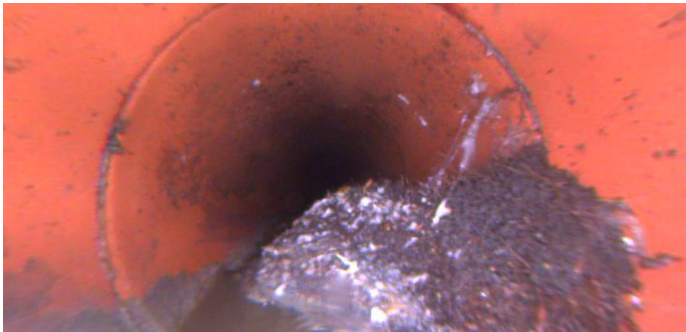
Code: **RMJ**
Description: **Roots Medium Joint**

Distance (ft): **107.6**
Structural Grade: **0**
O&M Grade: **3**
Clock Start/From: **2**
Clock To: **6**
1st Value:
2nd Value:
Value Percent: **40.000**
Continuous Index:
Within 8" of Joint: **YES**
Remarks:

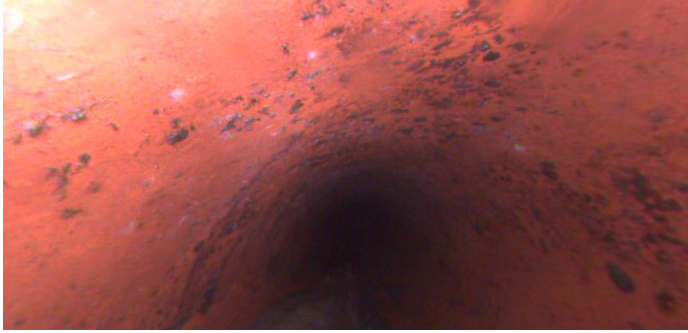
Code:	MSA
Description:	Abandoned Survey
Distance (ft):	108.7
Structural Grade:	0
O&M Grade:	0
Clock Start/From:	
Clock To:	
1st Value:	
2nd Value:	
Value Percent:	
Continuous Index:	
Within 8" of Joint:	NO
Remarks:	ROOTS
