Profile/Photo Observation Report

Date:	10/18/2021	Weather:		Coding:	PACP 6.0
Pipe Length (ft):		Owner:	Hobart, IN	Pre Clean:	Not Known
P.O.#:	875_1	Surveyor:	M. Pielacha	PSR:	P-203-012-013
Customer:	Hobart, IN	Clean Date:		Shape:	C

Street:	Maxwell Street	Flow Control:	
City:	Hobart, IN	Year Renewed:	
Location:	Light Highway	Tape/Media #:	875
Purpose:	Routine Assessment	Dia/Height:	8"
Use:	Sanitary	Material:	VCP
Drain Area:		Lining:	
Category:	NA		
Comment:

Location Details:		Direction of Survey:	Upstream
US MH:	M-203-13	DS MH:	M-203-12
		Total Length Surveyed (ft):	153.6

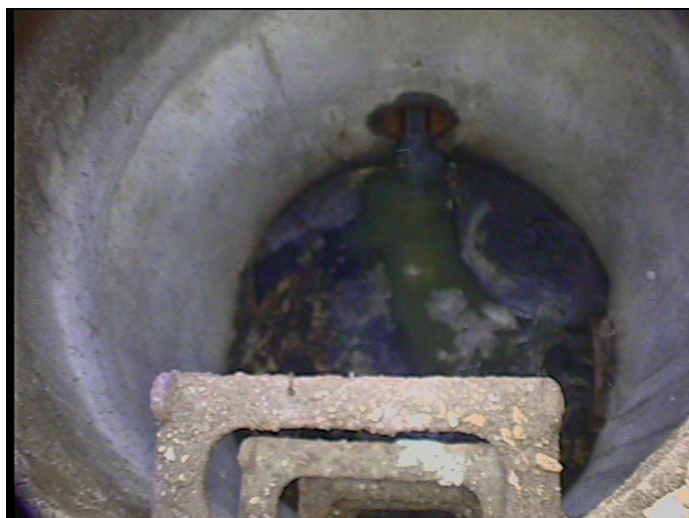
Code: **AMH**
Description: **Manhole**

Distance (ft): **.0**
Structural Grade: **0**
O&M Grade: **0**
Clock Start/From:
Clock To:
1st Value:
2nd Value:
Value Percent:
Continuous Index:
Within 8" of Joint: **NO**
Remarks: **M-203-12**

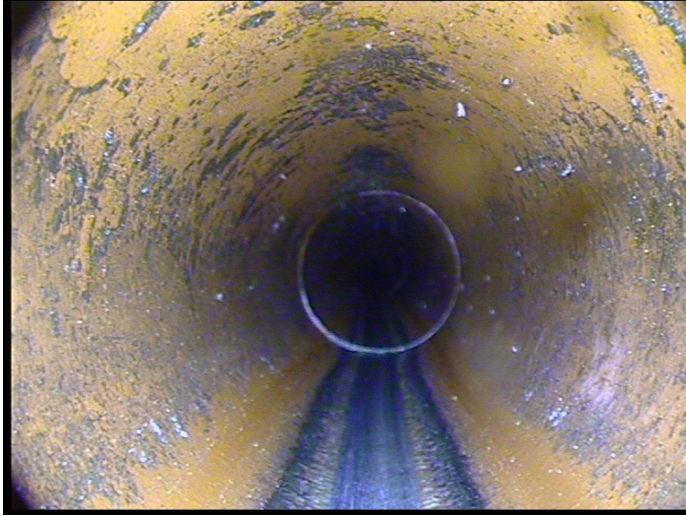
Code: **MWL**
Description: **Water Level**

Distance (ft): **.0**
Structural Grade: **0**
O&M Grade: **0**
Clock Start/From:
Clock To:
1st Value:
2nd Value:
Value Percent: **5.000**
Continuous Index:
Within 8" of Joint: **NO**
Remarks:

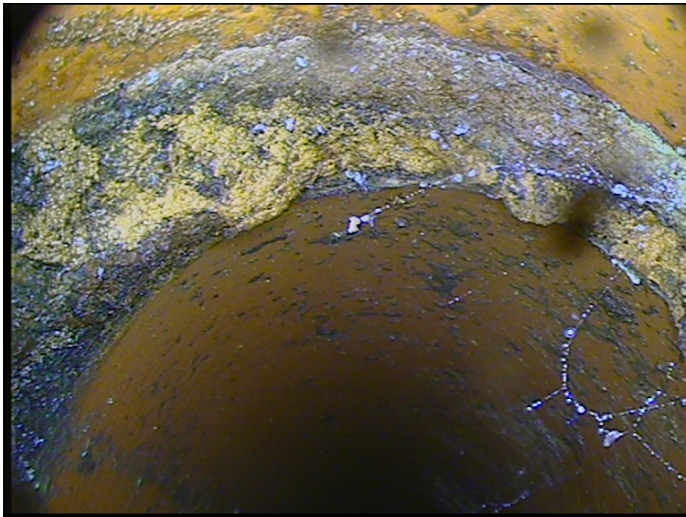
Code: **DAE**
Description: **Deposits Attached Encrustation**

Distance (ft): **28.3**
Structural Grade: **0**
O&M Grade: **2**
Clock Start/From: **7**
Clock To: **5**
1st Value:
2nd Value:
Value Percent: **5.000**
Continuous Index:
Within 8" of Joint: **YES**
Remarks:

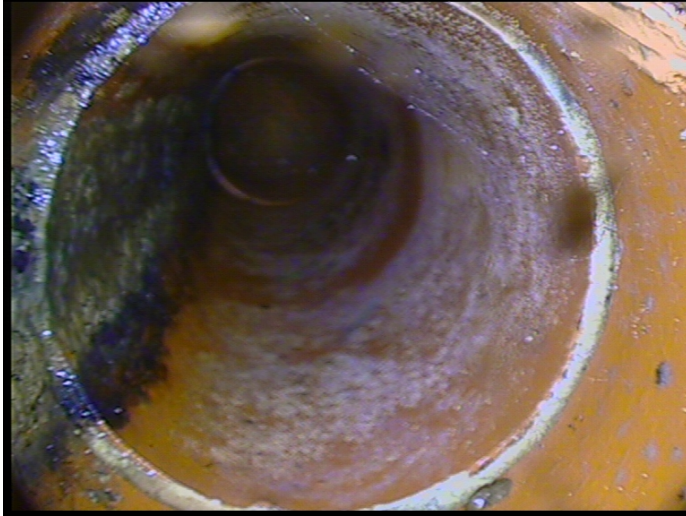
Code: **TF**
Description: **Tap Factory**

Distance (ft): **62.6**
Structural Grade: **0**
O&M Grade: **0**
Clock Start/From: **10**
Clock To:
1st Value: **4.000**
2nd Value:
Value Percent:
Continuous Index:
Within 8" of Joint: **NO**
Remarks:

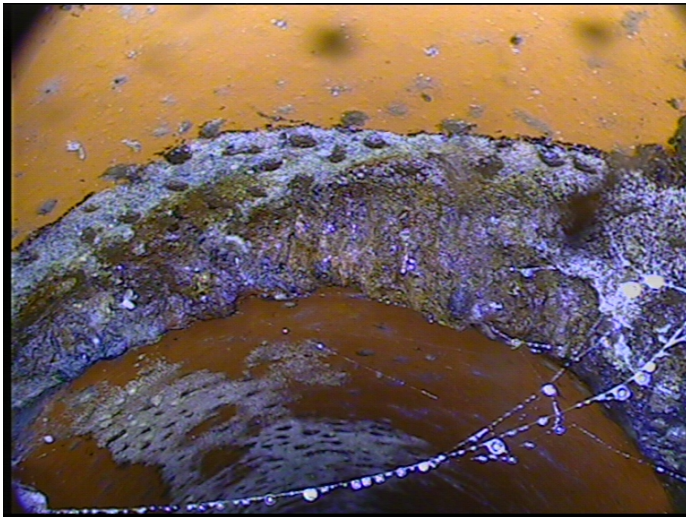
Code: **DAE**
Description: **Deposits Attached Encrustation**

Distance (ft): **72.8**
Structural Grade: **0**
O&M Grade: **2**
Clock Start/From: **7**
Clock To: **5**
1st Value:
2nd Value:
Value Percent: **5.000**
Continuous Index:
Within 8" of Joint: **YES**
Remarks:

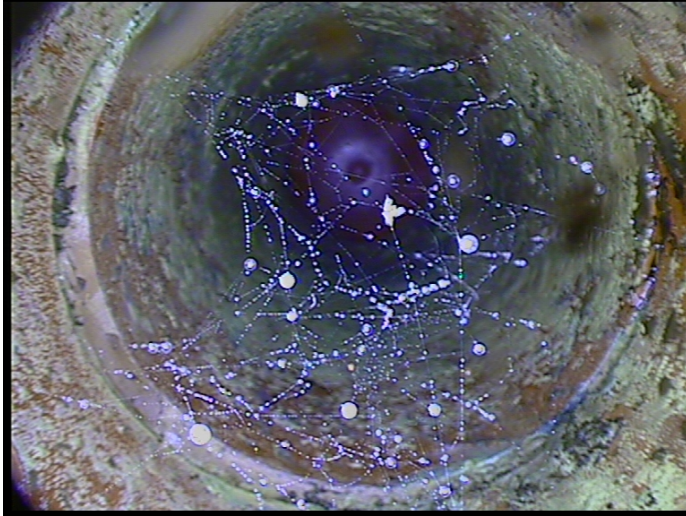
Code: **TF**
Description: **Tap Factory**

Distance (ft): **84.7**
Structural Grade: **0**
O&M Grade: **0**
Clock Start/From: **3**
Clock To:
1st Value: **4.000**
2nd Value:
Value Percent:
Continuous Index:
Within 8" of Joint: **NO**
Remarks:

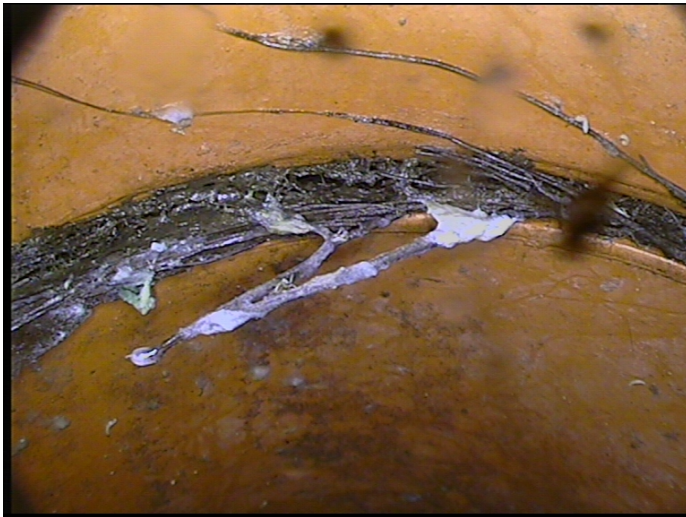
Code: **RFJ**
Description: **Roots Fine Joint**

Distance (ft): **145.2**
Structural Grade: **0**
O&M Grade: **1**
Clock Start/From: **7**
Clock To: **5**
1st Value:
2nd Value:
Value Percent:
Continuous Index:
Within 8" of Joint: **YES**
Remarks:

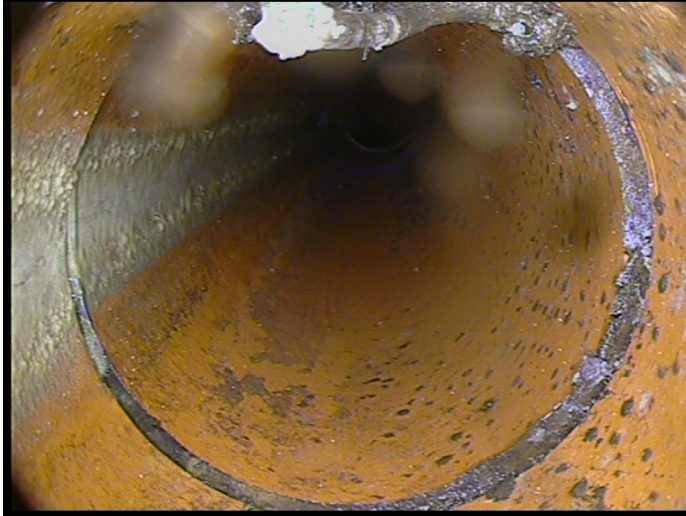
Code: **TF**
Description: **Tap Factory**

Distance (ft): **146.8**
Structural Grade: **0**
O&M Grade: **0**
Clock Start/From: **10**
Clock To:
1st Value: **4.000**
2nd Value:
Value Percent:
Continuous Index:
Within 8" of Joint: **NO**
Remarks:

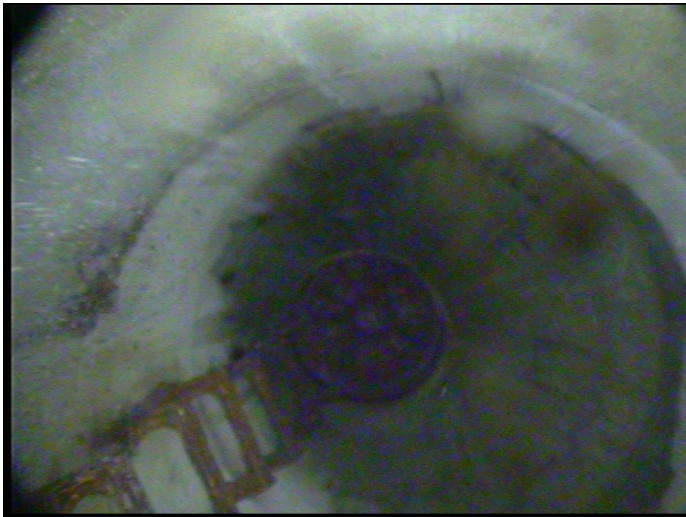
Code: **AMH**
Description: **Manhole**

Distance (ft): **153.6**
Structural Grade: **0**
O&M Grade: **0**
Clock Start/From:
Clock To:
1st Value:
2nd Value:
Value Percent:
Continuous Index:
Within 8" of Joint: **NO**
Remarks: **M-203-13**
