Profile/Photo Observation Report

| Street: | MAXWELL ST & W 38TH AVE | Flow Control: | Not Controlled |
| City: | Hobart, IN | Year Renewed: | |

| US MH: | M-203-014 | DS MH: | M-203-013 |

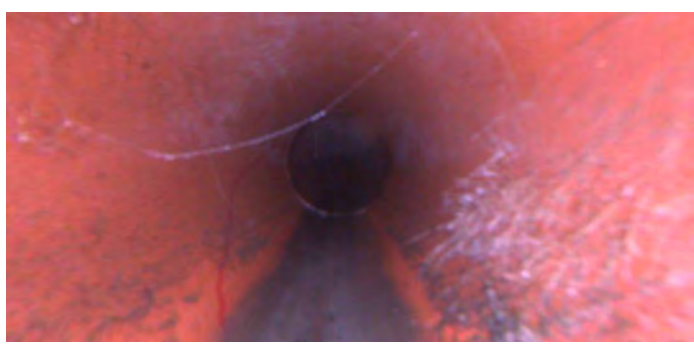
Code: **AMH**
Description: **Manhole**

Distance (ft): **.0**
Structural Grade: **0**
O&M Grade: **0**
Clock Start/From:
Clock To:
1st Value:
2nd Value:
Value Percent:
Continuous Index:
Within 8" of Joint: **NO**
Remarks: **M-203-014**

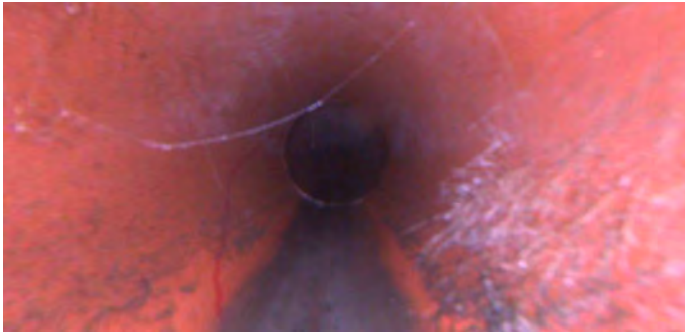
| Code: | MWL |
| Description: | Water Level |

| Value Percent: | 5.000 |

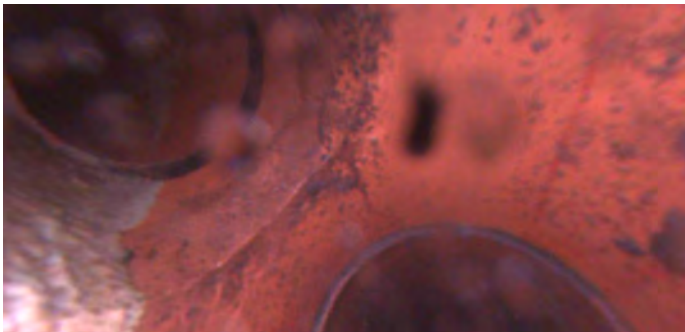
| Code: | TF |
| Description: | Tap Factory |

| Distance (ft): | 160.9 |
| Clock Start/From: | 10 |
| 1st Value: | 4.000 |

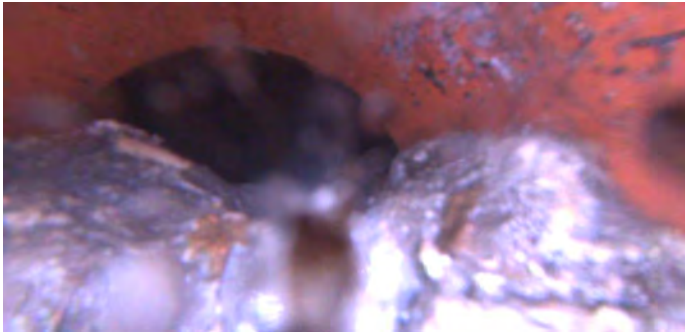
| | Position | Code | Observation | Video (sec) | Grade |
|--|---|---|---|---|---|
| | 166.3 | OBZ | Obstacle Other | 377 | M 5 |

Code: **OBZ**
Description: **Obstacle Other**

Distance (ft): **166.3**
Structural Grade: **0**
O&M Grade: **5**
Clock Start/From: **2**
Clock To: **10**
1st Value:
2nd Value:
Value Percent: **80.000**
Continuous Index:
Within 8" of Joint: **NO**
Remarks: **MISC**

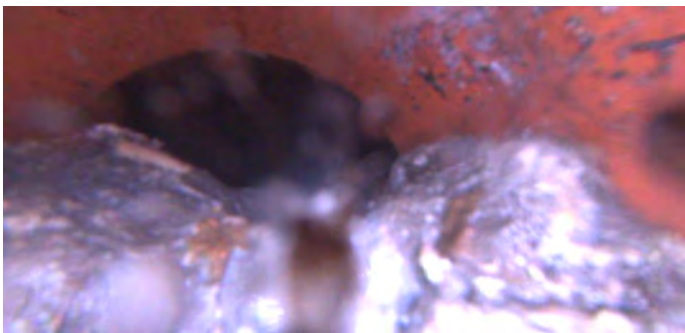
Code: **MSA**
Description: **Abandoned Survey**

Distance (ft): **166.3**
Structural Grade: **0**
O&M Grade: **0**
Clock Start/From:
Clock To:
1st Value:
2nd Value:
Value Percent:
Continuous Index:
Within 8" of Joint: **NO**
Remarks: **OBZ**
