## Profile/Photo Observation Report

| P.O.#: | <b>874_1</b> | Surveyor: | <b>M. Pielacha</b> | PSR: | <b>P-203-015-014</b> |

| US MH: | <b>M-203-14</b> | DS MH: | <b>M-203-15</b> |

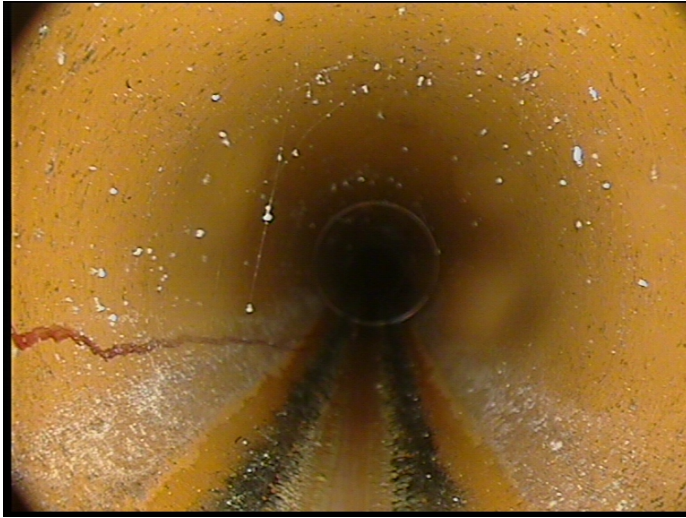
Code: **MWL**  
Description: **Water Level**

Distance (ft): **.0**  
Structural Grade: **0**  
O&M Grade: **0**  
Clock Start/From:  
Clock To:  
1st Value:  
2nd Value:  
Value Percent: **5.000**  
Continuous Index:  
Within 8" of Joint: **NO**  
Remarks:

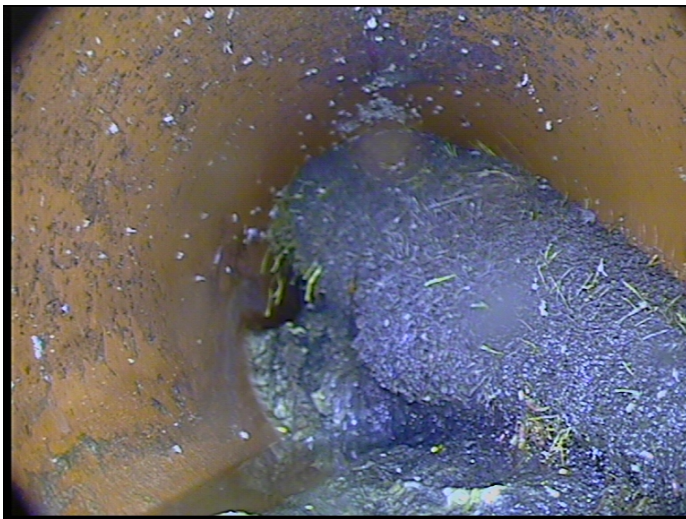
Code: **RBJ**  
Description: **Roots Ball Joint**

Distance (ft): **32.7**  
Structural Grade: **0**  
O&M Grade: **4**  
Clock Start/From: **7**  
Clock To: **5**  
1st Value:  
2nd Value:  
Value Percent: **70.000**  
Continuous Index:  
Within 8" of Joint: **YES**  
Remarks:

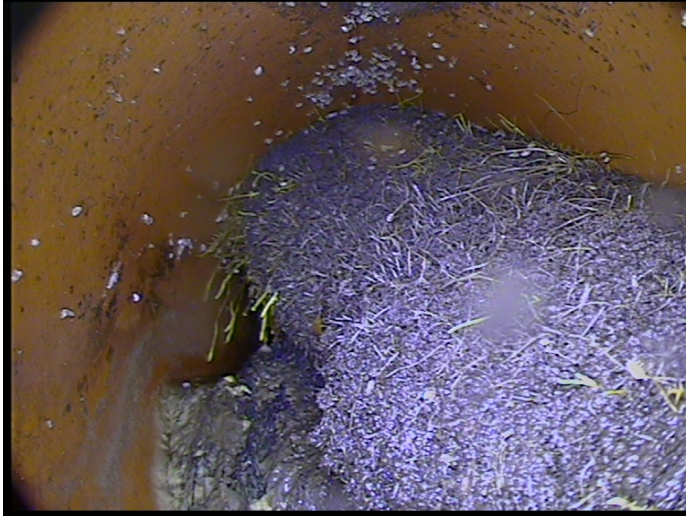
| Code: | <b>MSA</b> |
| Description: | <b>Abandoned Survey</b> |
| Distance (ft): | <b>33.2</b> |
| Remarks: | <b>Large root ball</b> |
