Profile/Photo Observation Report

Street:	ALLEY BETWEEN MAXWELL ST & PA	Flow Control:	Not Controlled
City:	Hobart, IN	Year Renewed:	
Location:	Light Highway	Tape/Media #:	
Purpose:	Routine Assessment	Dia/Height:	10"
Use:	Sanitary	Material:	VCP
Drain Area:	NA	Lining:	
Category:	NA		
Comment:

Location Details:		Direction of Survey:	Upstream
US MH:	M-203-016	DS MH:	M-203-018
		Total Length Surveyed (ft):	101.1

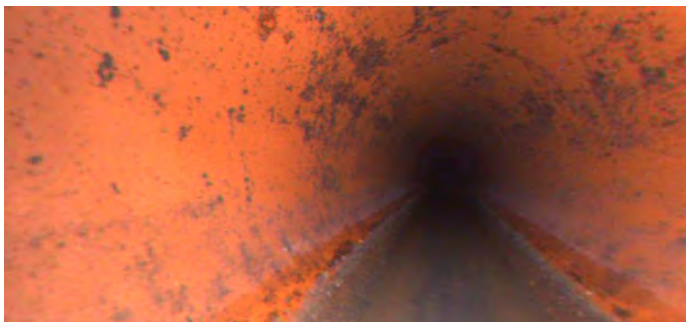
Code: **AMH**
Description: **Manhole**

Distance (ft): **.0**
Structural Grade: **0**
O&M Grade: **0**
Clock Start/From:
Clock To:
1st Value:
2nd Value:
Value Percent:
Continuous Index:
Within 8" of Joint: **NO**
Remarks: **M-203-018**

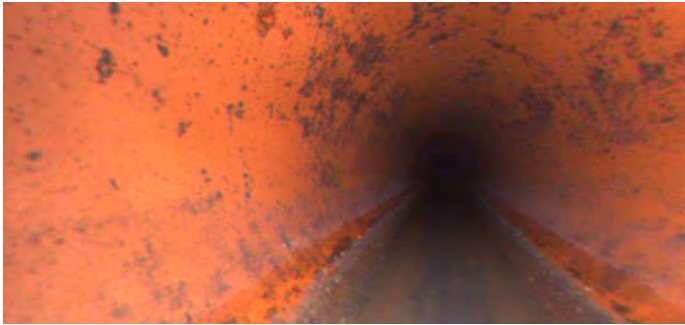
Code:	MWL
Description:	Water Level

Distance (ft):	.0
Structural Grade:	0
O&M Grade:	0
Clock Start/From:	
Clock To:	
1st Value:	
2nd Value:	
Value Percent:	5.000
Continuous Index:	
Within 8" of Joint:	NO
Remarks:

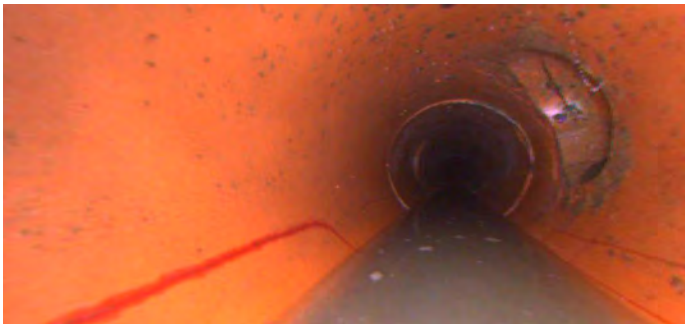
Code:	TF
Description:	Tap Factory

Distance (ft):	64.6
Structural Grade:	0
O&M Grade:	0
Clock Start/From:	2
Clock To:	
1st Value:	4.000
2nd Value:	
Value Percent:	
Continuous Index:	
Within 8" of Joint:	
Remarks:

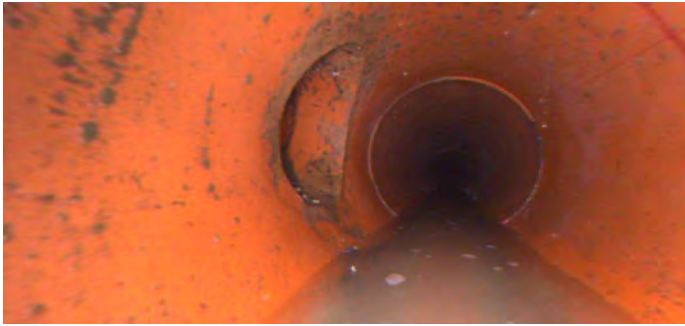
Code: **TF**
Description: **Tap Factory**

Distance (ft): **67.0**
Structural Grade: **0**
O&M Grade: **0**
Clock Start/From: **9**
Clock To:
1st Value: **4.000**
2nd Value:
Value Percent:
Continuous Index:
Within 8" of Joint:
Remarks:

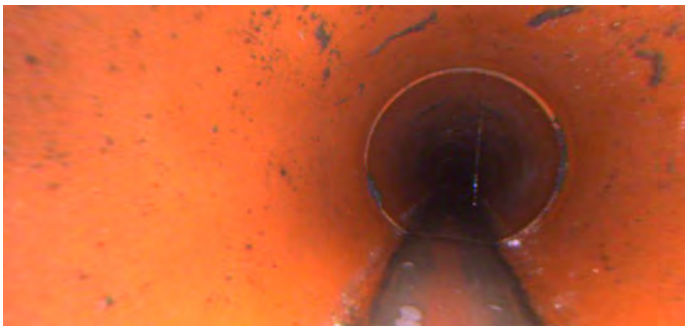
Code: **RFJ**
Description: **Roots Fine Joint**

Distance (ft): **82.1**
Structural Grade: **0**
O&M Grade: **1**
Clock Start/From: **8**
Clock To: **3**
1st Value:
2nd Value:
Value Percent:
Continuous Index:
Within 8" of Joint: **YES**
Remarks:

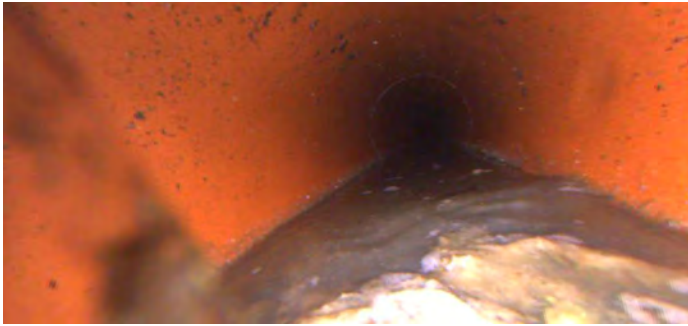
Code:	MSA
Description:	Abandoned Survey
Distance (ft):	101.1
Structural Grade:	0
O&M Grade:	0
Clock Start/From:	
Clock To:	
1st Value:	
2nd Value:	
Value Percent:	
Continuous Index:	
Within 8" of Joint:	NO
Remarks:	camera stopped
