Profile/Photo Observation Report

Street:	PARKER ST	Flow Control:	Not Controlled
City:	Hobart, IN	Year Renewed:	
Location:	Light Highway	Tape/Media #:	
Purpose:	Routine Assessment	Dia/Height:	10"
Use:	Sanitary	Material:	VCP
Drain Area:	NA	Lining:	
Category:	NA		
Comment:

Location Details:		Direction of Survey:	Upstream
US MH:	M-203-019	DS MH:	M-203-018
		Total Length Surveyed (ft):	86.7

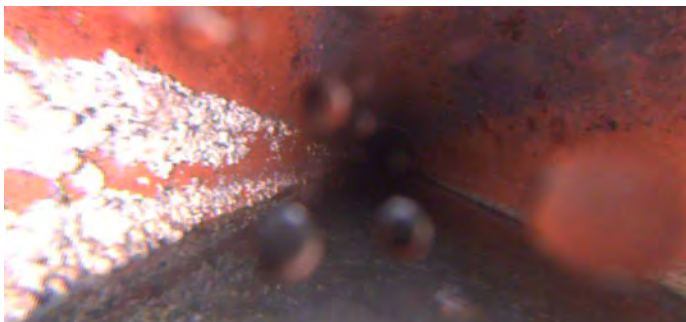
Code: **AMH**
Description: **Manhole**

Distance (ft): **.0**
Structural Grade: **0**
O&M Grade: **0**
Clock Start/From:
Clock To:
1st Value:
2nd Value:
Value Percent:
Continuous Index:
Within 8" of Joint: **NO**
Remarks: **M-203-018**

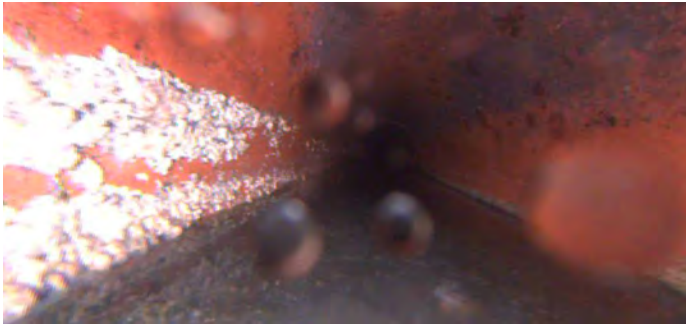
Code:	MWL
Description:	Water Level

Distance (ft):	.0
Structural Grade:	0
O&M Grade:	0
Clock Start/From:	
Clock To:	
1st Value:	
2nd Value:	
Value Percent:	5.000
Continuous Index:	
Within 8" of Joint:	NO
Remarks:

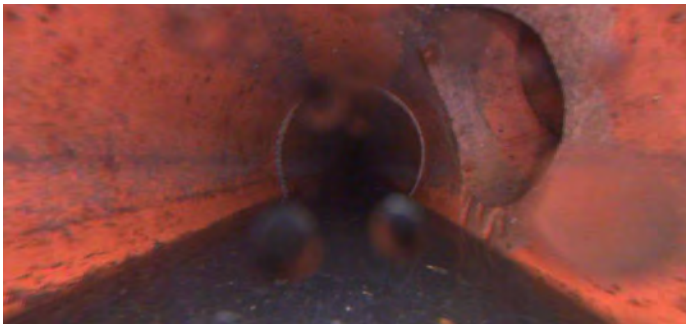
Code:	TF
Description:	Tap Factory

Distance (ft):	44.4
Structural Grade:	0
O&M Grade:	0
Clock Start/From:	3
Clock To:	
1st Value:	4.000
2nd Value:	
Value Percent:	
Continuous Index:	
Within 8" of Joint:	
Remarks:

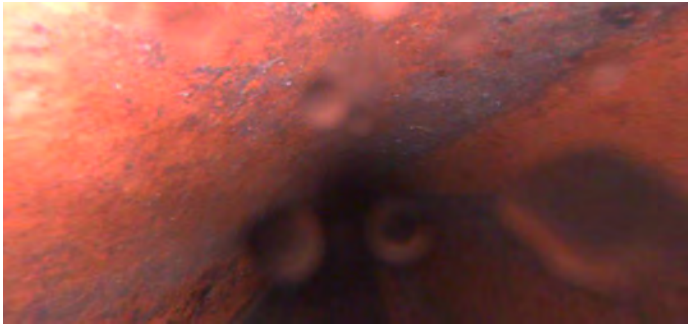
Code:	MSA
Description:	Abandoned Survey
Distance (ft):	86.7
Structural Grade:	0
O&M Grade:	0
Clock Start/From:	
Clock To:	
1st Value:	
2nd Value:	
Value Percent:	
Continuous Index:	
Within 8" of Joint:	NO
Remarks:	camera stopped
