Profile/Photo Observation Report

Street:	Maxwell St	Flow Control:	Not Controlled
City:	Hobart, IN	Year Renewed:	
Location:	Light Highway	Tape/Media #:	
Purpose:	Routine Assessment	Dia/Height:	10"
Use:	Sanitary	Material:	VCP
Drain Area:	NA	Lining:	
Category:	NA		
Comment:

Location Details:		Direction of Survey:	Upstream
US MH:	M-203-019	DS MH:	M-203-018
		Total Length Surveyed (ft):	86.7

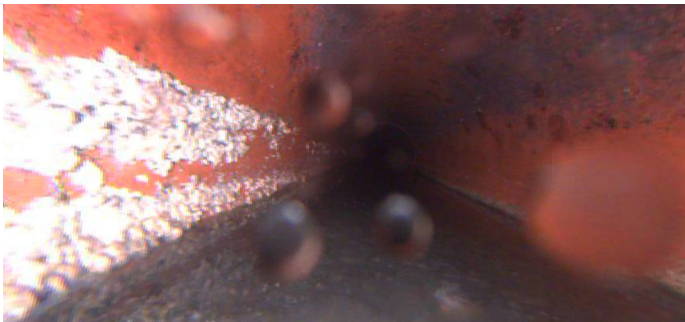
Code: **AMH**
Description: **Manhole**

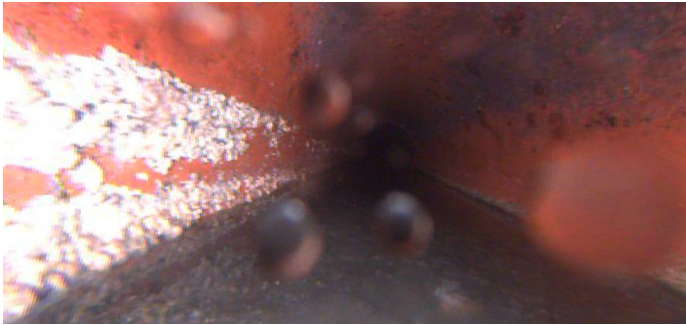
Code:	MWL
Description:	Water Level

Distance (ft):	.0
Structural Grade:	0
O&M Grade:	0
Clock Start/From:	
Clock To:	
1st Value:	
2nd Value:	
Value Percent:	5.000
Continuous Index:	
Within 8" of Joint:	NO
Remarks:

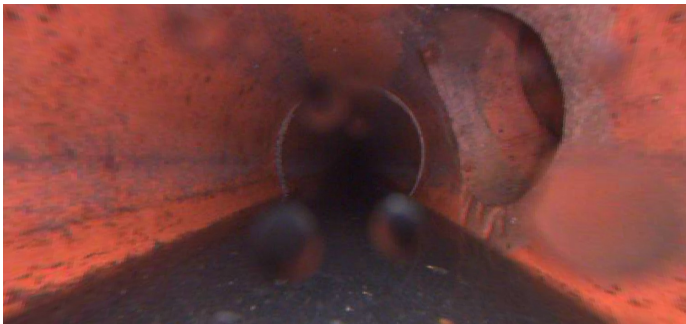
Code:	TF
Description:	Tap Factory

Distance (ft):	44.4
Structural Grade:	0
O&M Grade:	0
Clock Start/From:	3
Clock To:	
1st Value:	4.000
2nd Value:	
Value Percent:	
Continuous Index:	
Within 8" of Joint:	
Remarks:

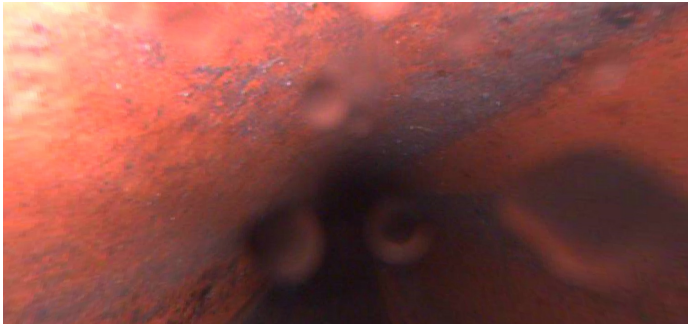
Code:	MSA
Description:	Abandoned Survey
Distance (ft):	86.7
Structural Grade:	0
O&M Grade:	0
Clock Start/From:	
Clock To:	
1st Value:	
2nd Value:	
Value Percent:	
Continuous Index:	
Within 8" of Joint:	NO
Remarks:	camera stopped
