Profile/Photo Observation Report

Street:	OFF LAKE WOOD DR	Flow Control:	Not Controlled
City:	Hobart, IN	Year Renewed:	
Location:	Other	Tape/Media #:	
Purpose:	Not Known	Dia/Height:	10"
Use:	Sanitary	Material:	VCP
Drain Area:	NA	Lining:	
Category:	NA		
Comment:

Location Details:		Direction of Survey:	Upstream
US MH:	M-704-071	DS MH:	M-704-072
		Total Length Surveyed (ft):	6.5

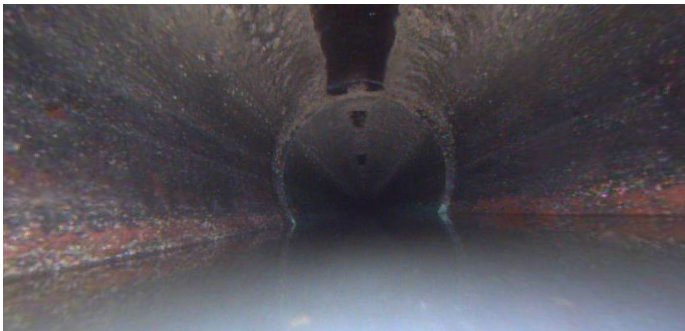
Code: **AMH**
Description: **Manhole**

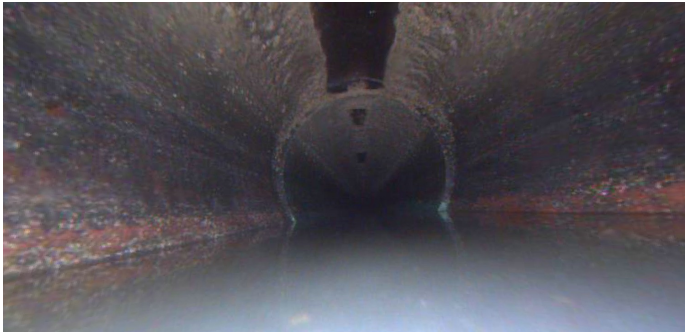
Code:	MWL
Description:	Water Level

Distance (ft):	.0
Structural Grade:	0
O&M Grade:	0
Clock Start/From:	
Clock To:	
1st Value:	
2nd Value:	
Value Percent:	30.000
Continuous Index:	
Within 8" of Joint:	NO
Remarks:

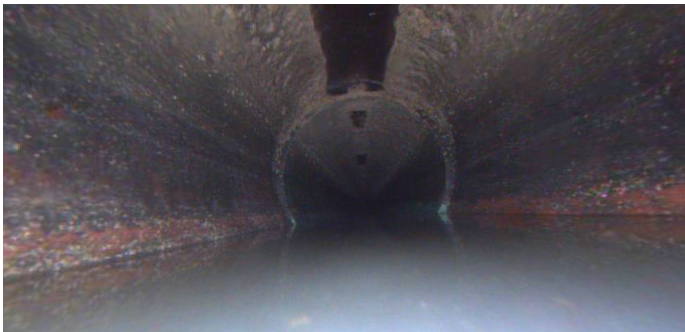
Code:	DAGS
Description:	Deposits Attached Grease

Distance (ft):	.0
Structural Grade:	0
O&M Grade:	2
Clock Start/From:	8
Clock To:	4
1st Value:	
2nd Value:	
Value Percent:	5.000
Continuous Index:	
Within 8" of Joint:	NO
Remarks:

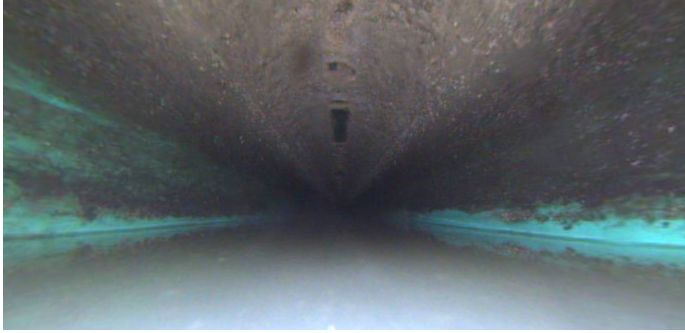
Code: **MMC**
Description: **Material Change**

Distance (ft): **2.9**
Structural Grade: **0**
O&M Grade: **0**
Clock Start/From:
Clock To:
1st Value:
2nd Value:
Value Percent:
Continuous Index:
Within 8" of Joint: **NO**
Remarks: **PVC**

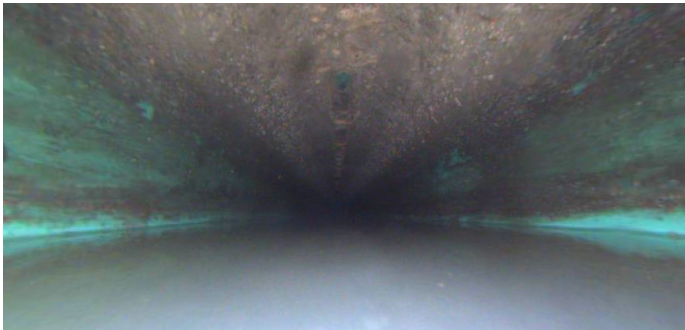
Code: **MSA**
Description: **Abandoned Survey**

Distance (ft): **6.5**
Structural Grade: **0**
O&M Grade: **0**
Clock Start/From:
Clock To:
1st Value:
2nd Value:
Value Percent:
Continuous Index:
Within 8" of Joint: **NO**
Remarks: **DEBRIS UNDER WATER**
