Profile/Photo Observation Report

Date:	03/27/2018	Weather:		Coding:	PACP 6.0
Pipe Length (ft):	100.5	Owner:	NA	Pre Clean:	Not Known
P.O.#:		Surveyor:	Jen Costello	PSR:	P-203-020-019
Customer:		Clean Date:	01/01/1900	Shape:	C

Street:	PARKER ST	Flow Control:	Not Controlled
City:	Hobart, IN	Year Renewed:	
Location:	Other	Tape/Media #:	
Purpose:	Not Known	Dia/Height:	10"
Use:	Sanitary	Material:	VCP
Drain Area:	NA	Lining:	
Category:	NA		
Comment:	cnl

Location Details:		Direction of Survey:	Downstream
US MH:	M-203-020	DS MH:	M-203-019
		Total Length Surveyed (ft):	5.5

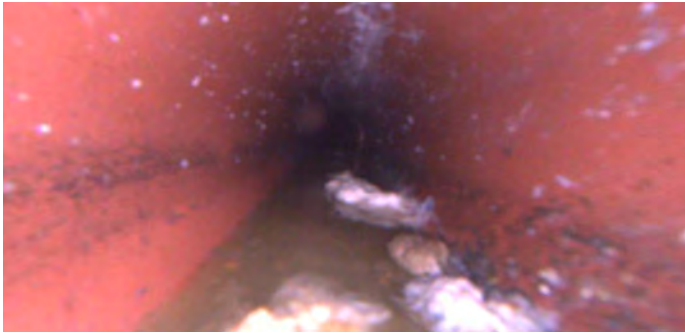
Code:	MWL
Description:	Water Level

Distance (ft):	.0
Structural Grade:	0
O&M Grade:	0
Clock Start/From:	
Clock To:	
1st Value:	
2nd Value:	
Value Percent:	10.000
Continuous Index:	
Within 8" of Joint:	NO
Remarks:

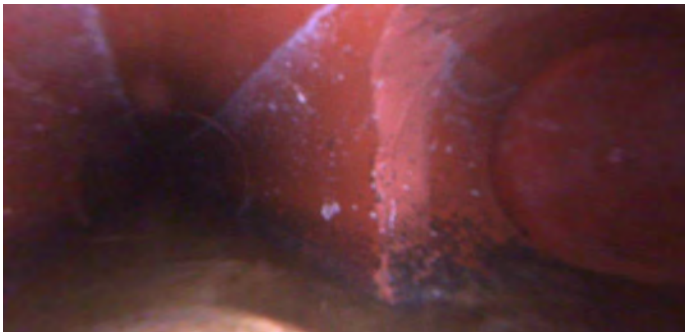
Code:	TFC
Description:	Tap Factory Capped

Distance (ft):	4.4
Structural Grade:	0
O&M Grade:	0
Clock Start/From:	3
Clock To:	
1st Value:	4.000
2nd Value:	
Value Percent:	
Continuous Index:	
Within 8" of Joint:	
Remarks:

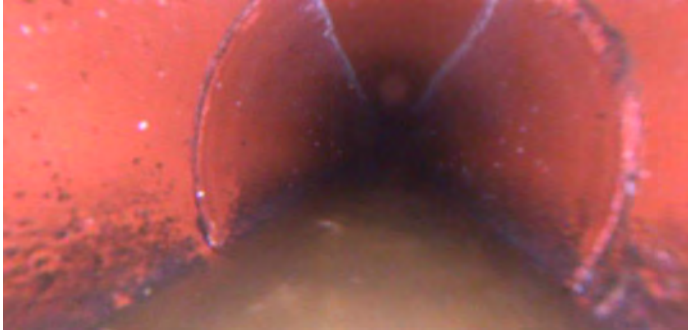
Code:	MSA
Description:	Abandoned Survey
Distance (ft):	5.5
Structural Grade:	0
O&M Grade:	0
Clock Start/From:	
Clock To:	
1st Value:	
2nd Value:	
Value Percent:	
Continuous Index:	
Within 8" of Joint:	NO
Remarks:	debris under water
