## Profile/Photo Observation Report

Street:	<b>ALLEY WAY</b>	Flow Control:	<b>Not Controlled</b>
City:	<b>Hobart, IN</b>	Year Renewed:	
Location:	<b>Other</b>	Tape/Media #:	
Purpose:	<b>Not Known</b>	Dia/Height:	<b>10"</b>
Use:	<b>Sanitary</b>	Material:	<b>VCP</b>
Drain Area:	<b>NA</b>	Lining:	
Category:	<b>NA</b>		
Comment:	<b>cnl</b>

Location Details:		Direction of Survey:	<b>Downstream</b>
US MH:	<b>M-203-020</b>	DS MH:	<b>M-203-019</b>
		Total Length Surveyed (ft):	<b>5.5</b>

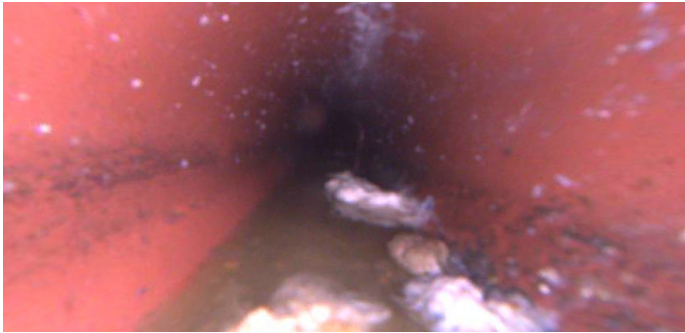
Code:	<b>MWL</b>
Description:	<b>Water Level</b>

Distance (ft):	<b>.0</b>
Structural Grade:	<b>0</b>
O&M Grade:	<b>0</b>
Clock Start/From:	
Clock To:	
1st Value:	
2nd Value:	
Value Percent:	<b>10.000</b>
Continuous Index:	
Within 8" of Joint:	<b>NO</b>
Remarks:

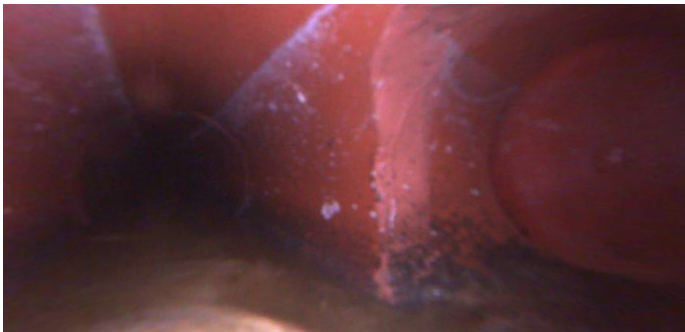
Code:	<b>TFC</b>
Description:	<b>Tap Factory Capped</b>

Distance (ft):	<b>4.4</b>
Structural Grade:	<b>0</b>
O&M Grade:	<b>0</b>
Clock Start/From:	<b>3</b>
Clock To:	
1st Value:	<b>4.000</b>
2nd Value:	
Value Percent:	
Continuous Index:	
Within 8" of Joint:	
Remarks:

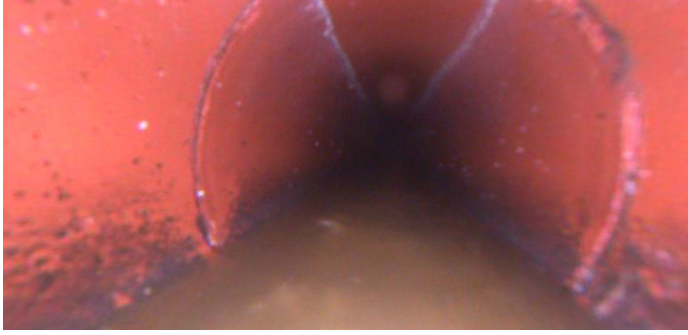
Code:	<b>MSA</b>
Description:	<b>Abandoned Survey</b>
Distance (ft):	<b>5.5</b>
Structural Grade:	<b>0</b>
O&M Grade:	<b>0</b>
Clock Start/From:	
Clock To:	
1st Value:	
2nd Value:	
Value Percent:	
Continuous Index:	
Within 8" of Joint:	<b>NO</b>
Remarks:	<b>debris under water</b>
